Appendix B
WSSC T. Howard Duckett (Rocky Gorge) Reservoir
Horse Trail Reconnaissance Report

WSSC T. Howard Duckett (Rocky Gorge) Reservoir Horse Trail Reconnaissance Report

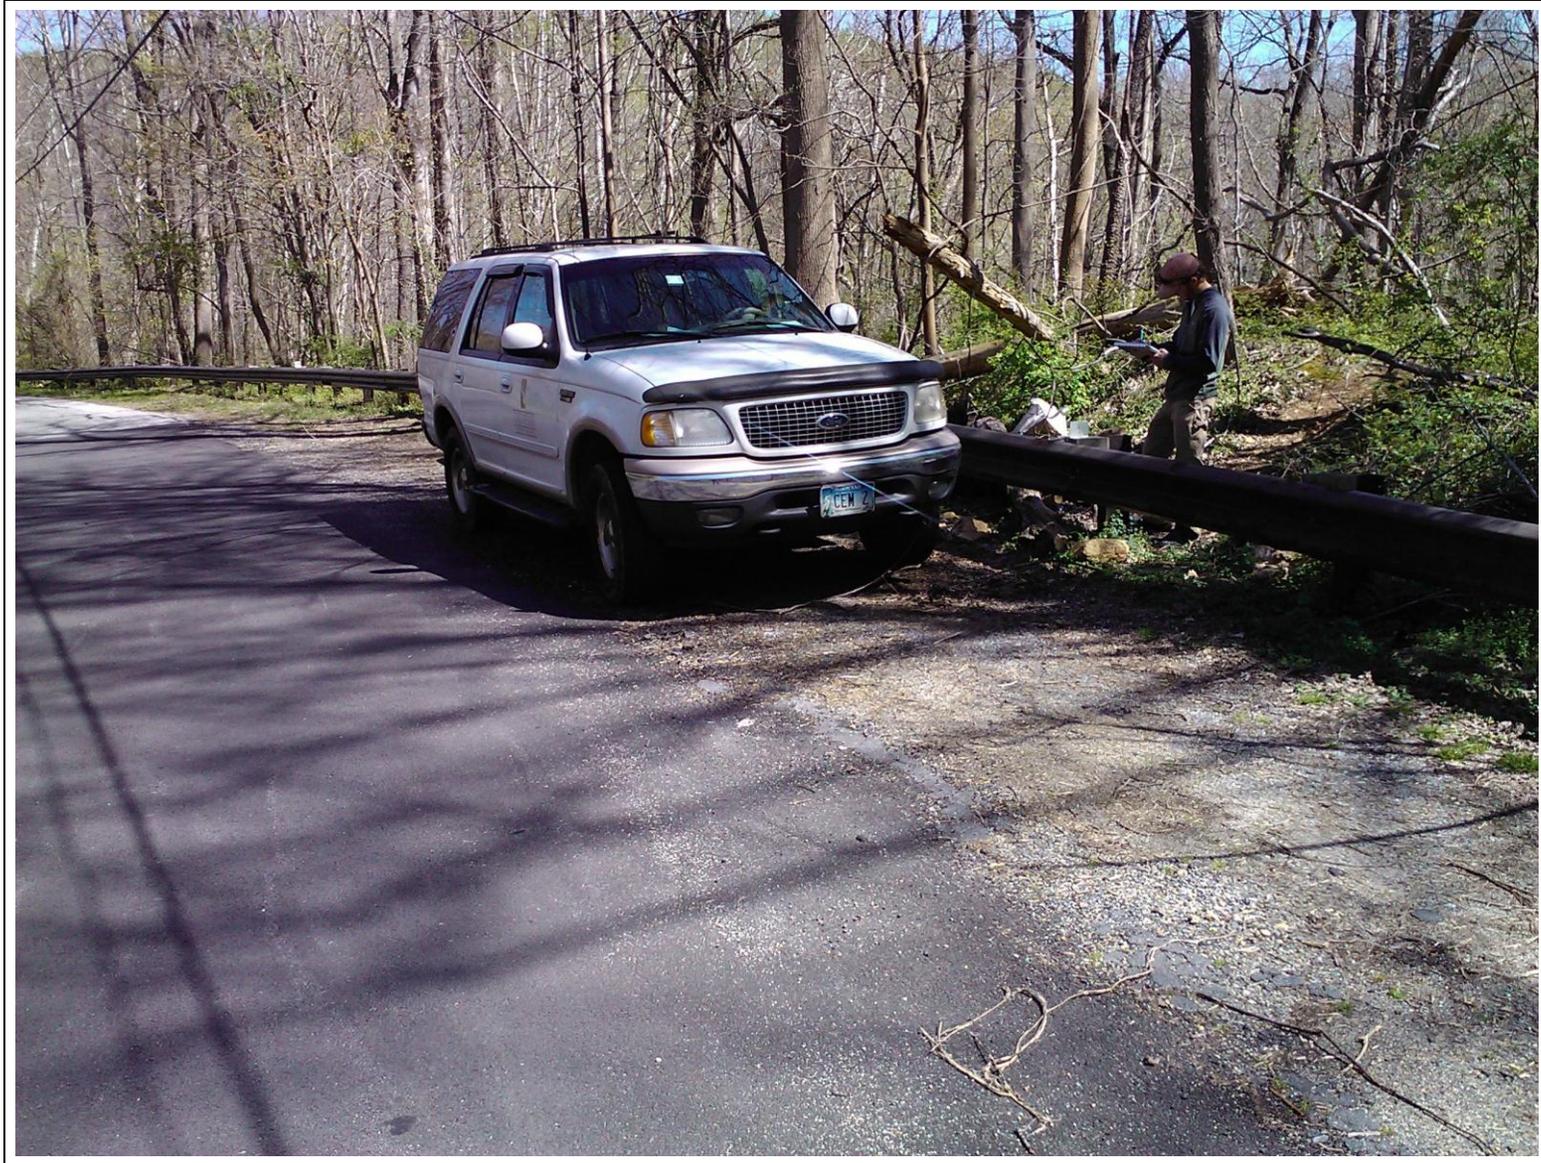
Section 1 of the trail can be accessed via either Tucker Lane or Ednor Road (Map 1). Designated recreational access parking along Tucker Lane is unmarked roadside parking along a curve in a narrow road with a guardrail on one side (Photo 1). This roadside parking area is not suitable for horse trailers due to the narrowness of the road, and would be unsafe for loading and unloading horses. Designated recreational access parking along Ednor Road is a marked gravel parking area (Photo 2). The area is large enough to accommodate two (2) trailer rigs. The parking lot is level and graveled which provide safe loading and unloading conditions for horses. The parking area is large enough to turn a trailer rig around to safely re-enter Ednor Road.

Photo 1: Tucker Lane roadside parking.

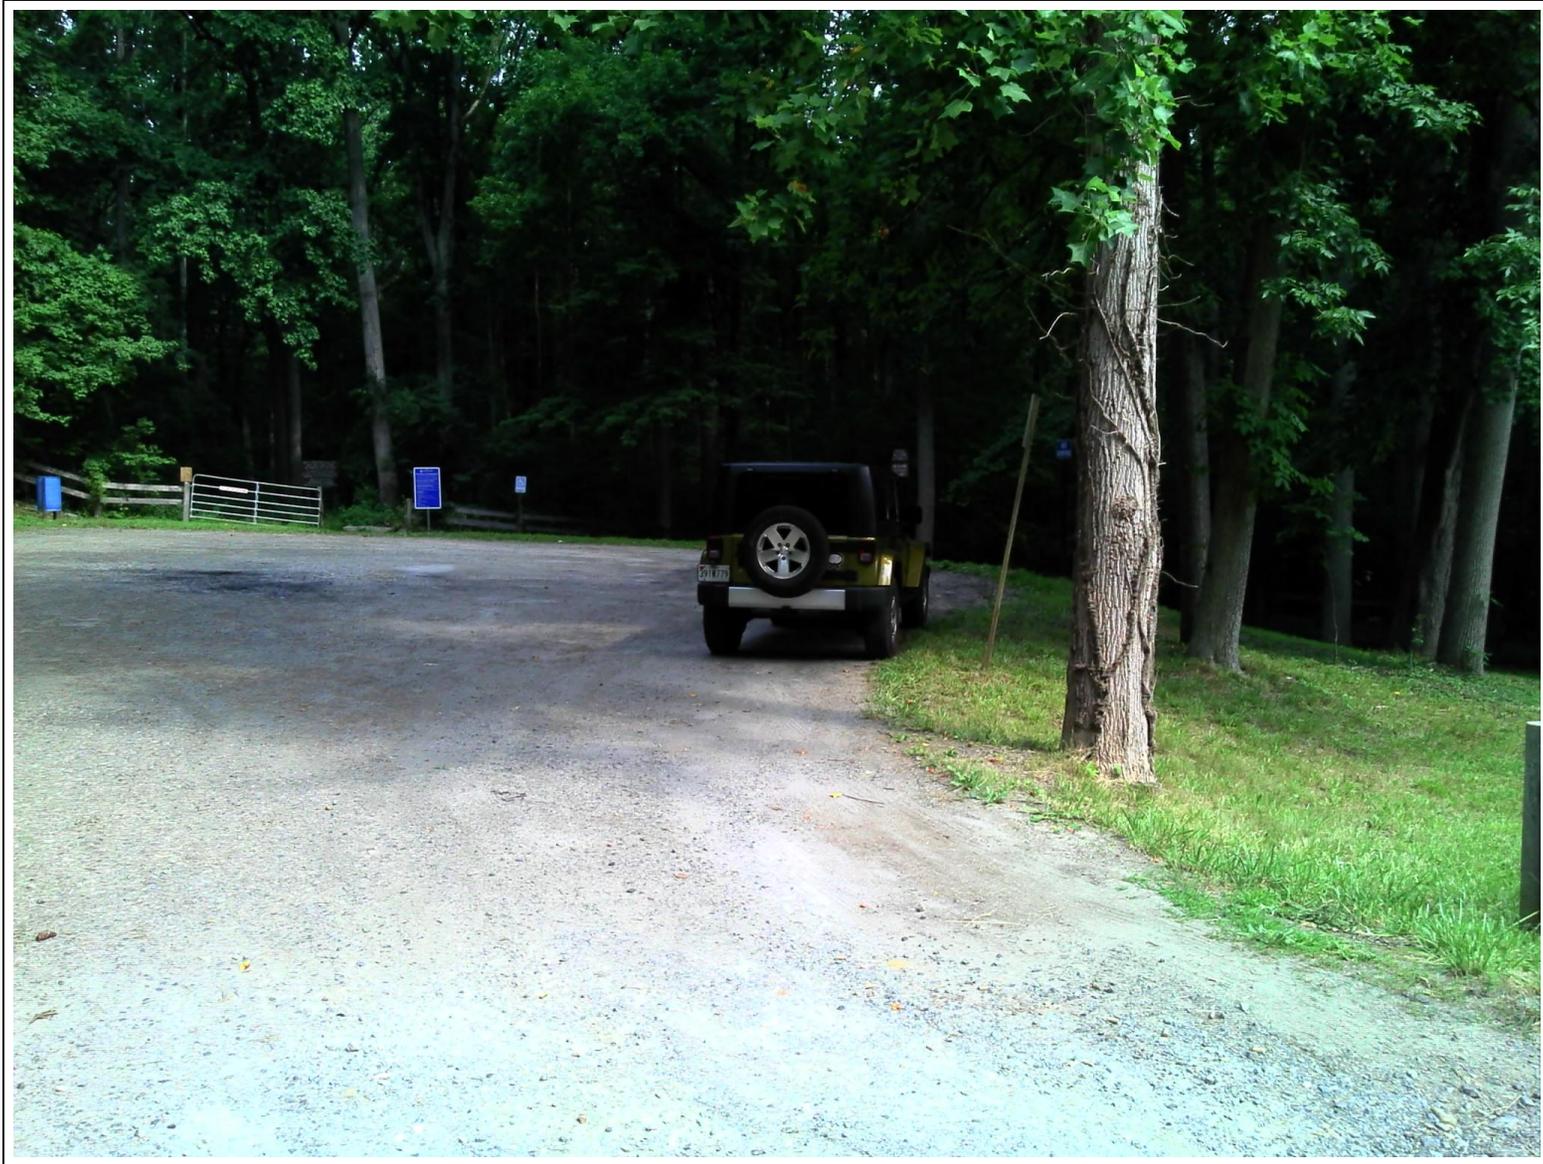
Photo 2: Ednor Road west side parking.

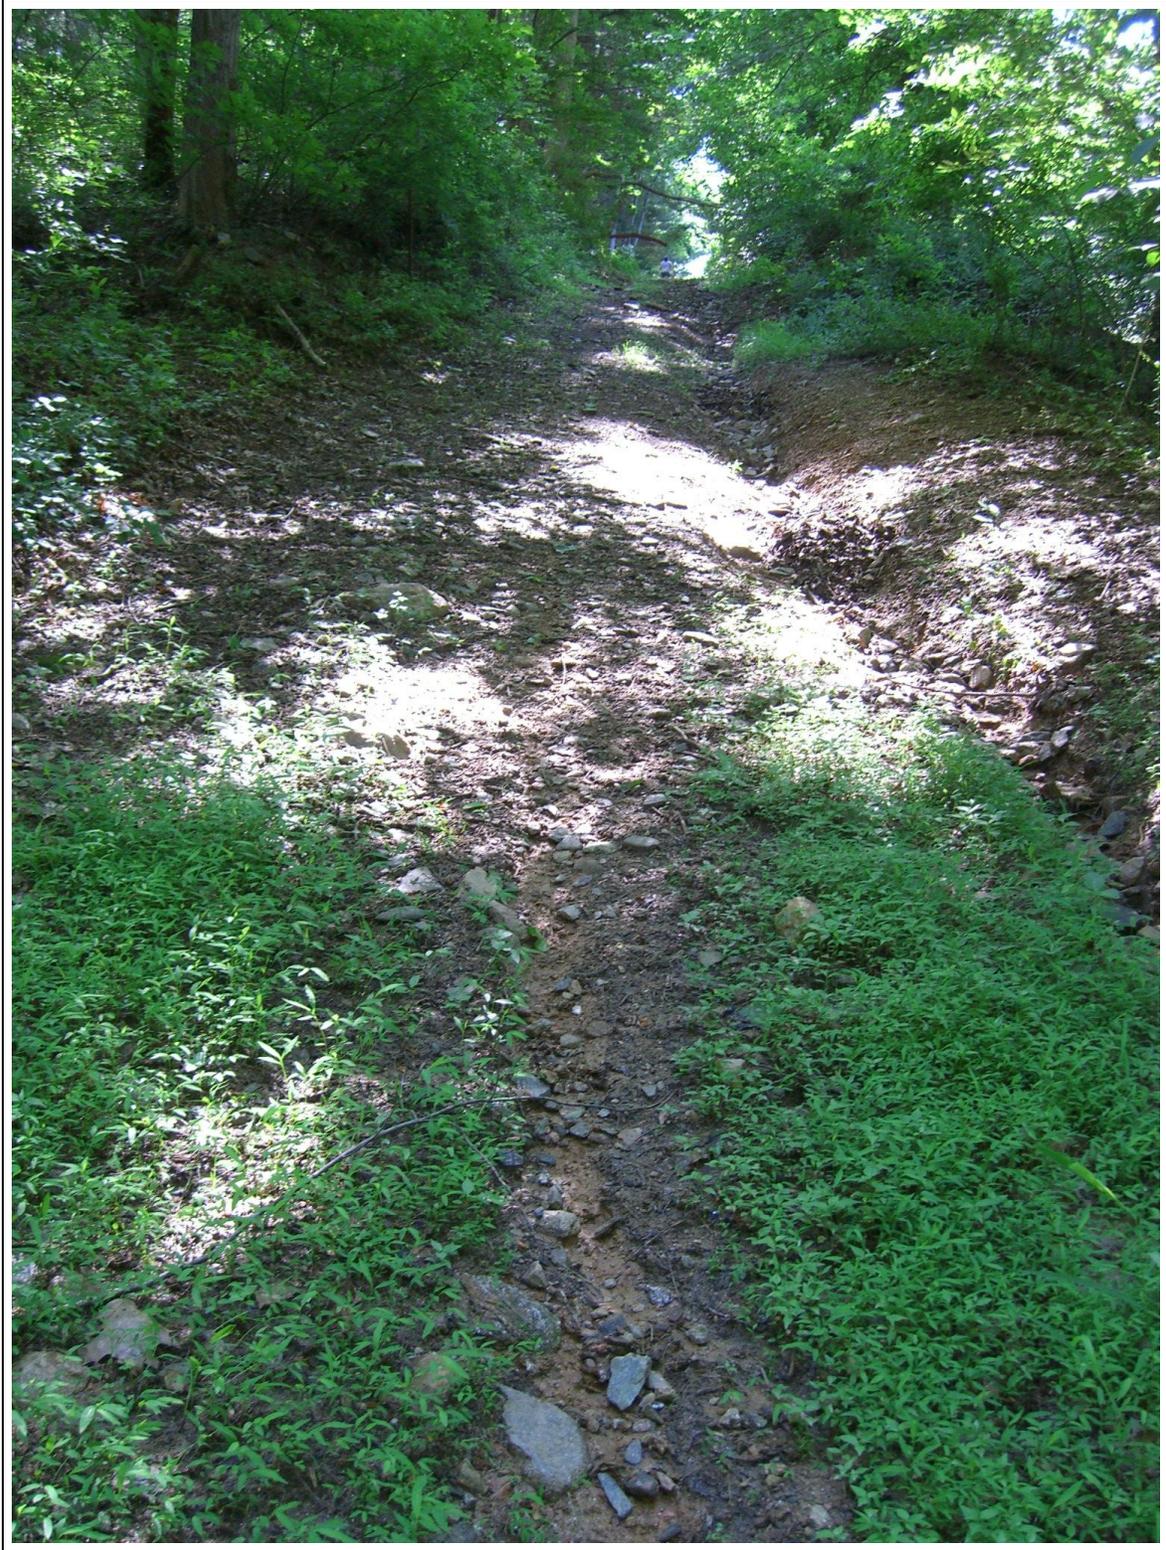
Section 1 was given an overall trail rating of 1. This trail section is characterized by steep terrain, with several significant stretches of very steep terrain where the access road goes straight up and down the hillsides, and stormwater runoff has created substantial areas of serious erosion, gullies and washouts. The footing in these areas is primarily loose boulder to cobble-size rock, interspersed with areas of crumbling subsoil and bedrock. One particularly steep section of the trail was given a rating of 0 and deemed impassable on horseback in its current condition, due to the extremely steep terrain (maximum slope >45 degrees), and rocky, eroding footing (Photo 3).

Photo 3: Section 1 extremely steep hill (maximum slope >45 degrees) that is impassable on horseback

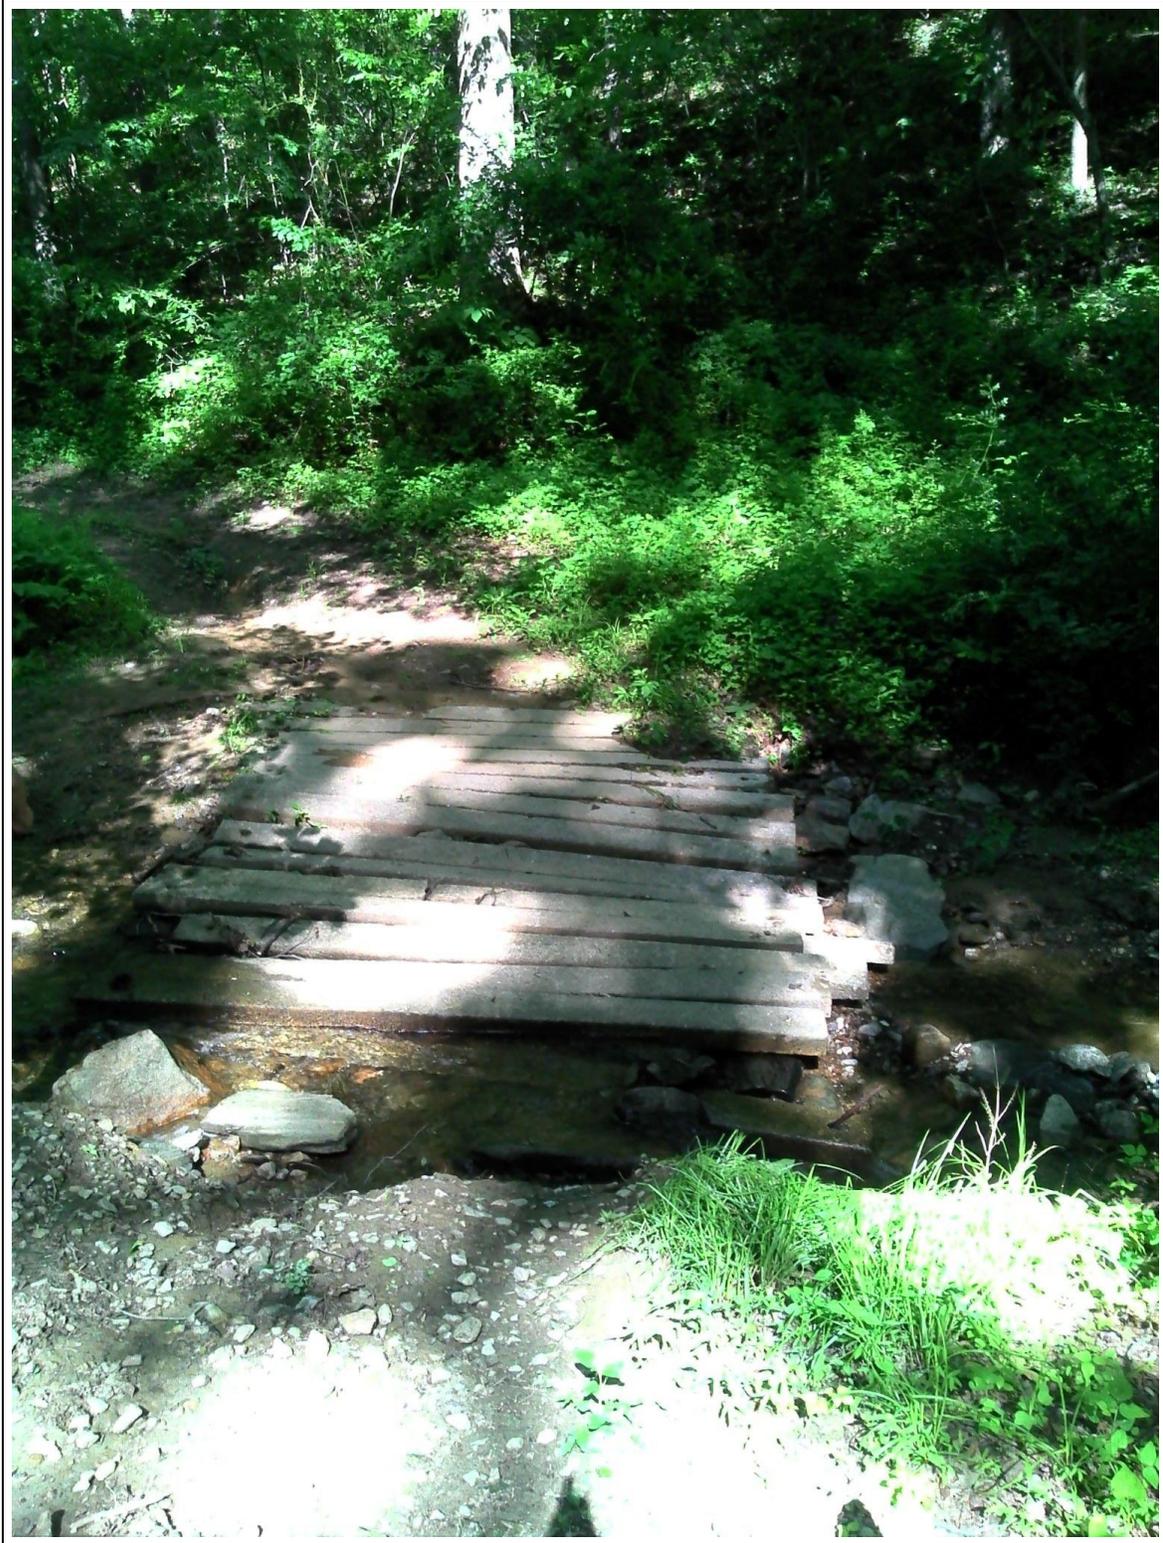
There are two stream crossings along this trail section, one of the stream crossings was rated 2, and was deemed passable, but difficult due to stream erosion, steep banks and rocky footing. The other stream crossing was rated 1 and was observed to be difficult to cross on horseback due to stream bank erosion, a partial wash-out of concrete railroad ties, steep banks, and several large boulders (Photo 4).

Photo 4: Section 1 stream crossing with washed out railroad ties

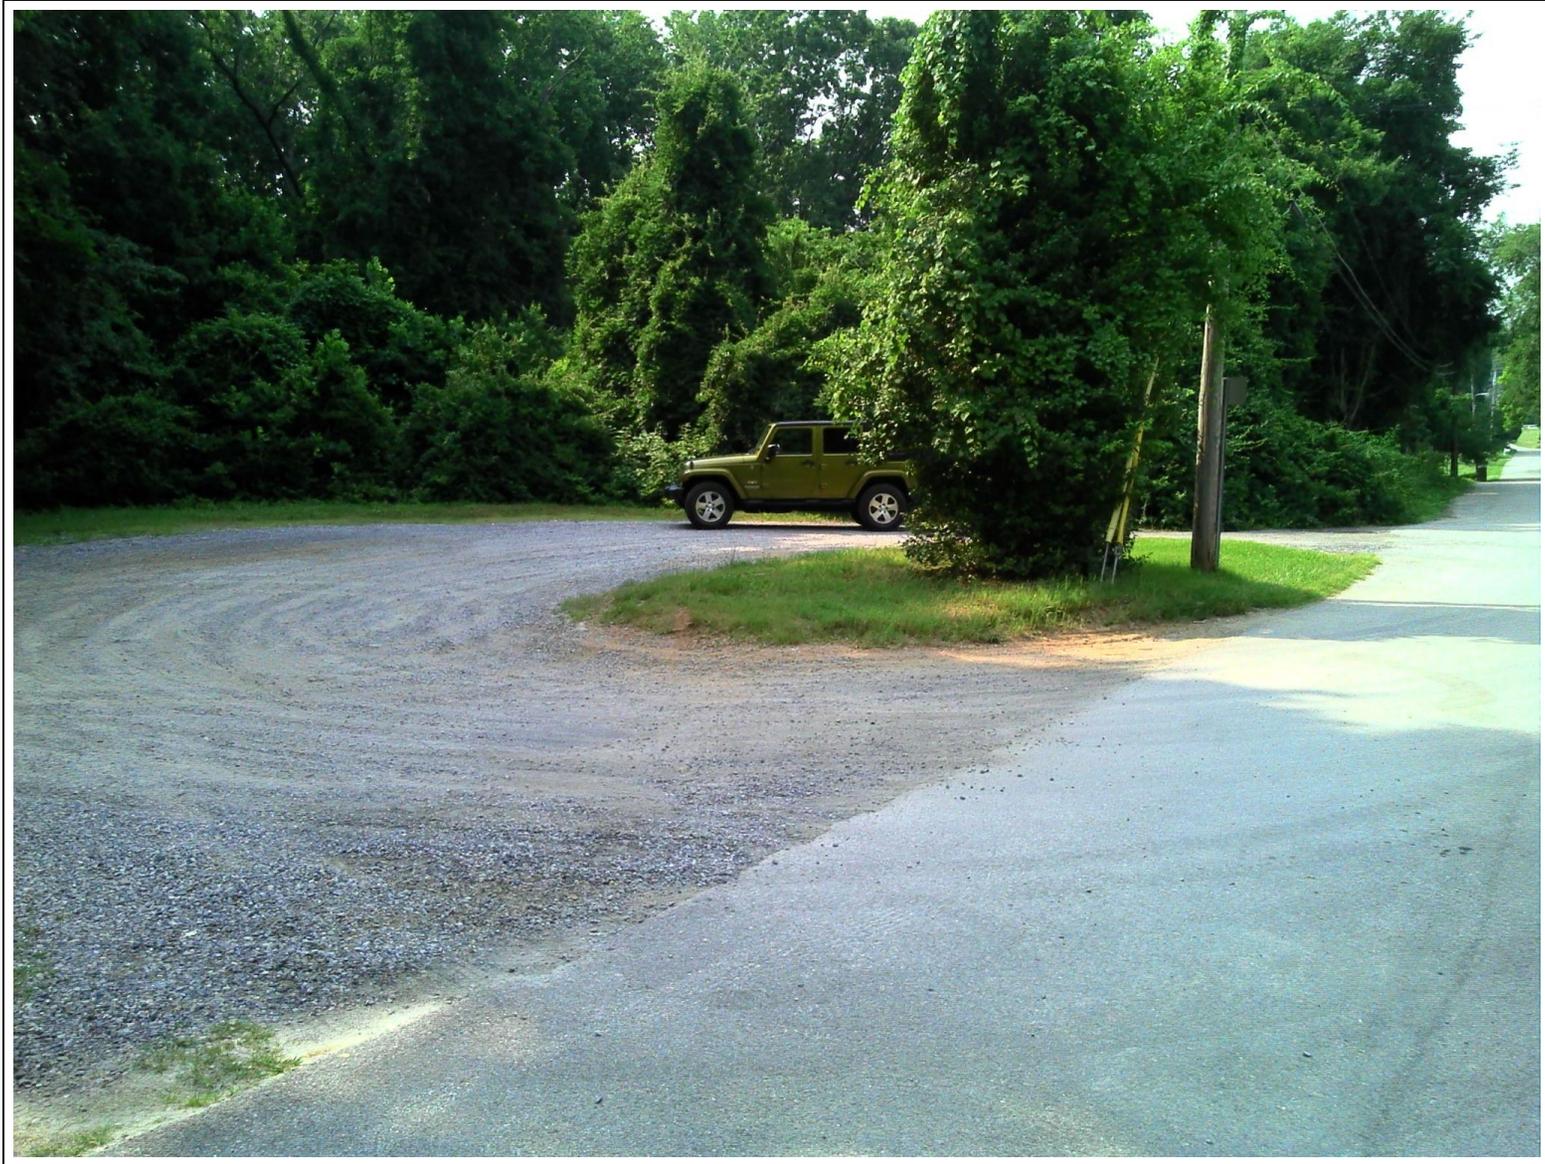
Section 2 of the trail can be accessed by either Ednor Road or Brogden Road (Map 1). Parking for this section is available at the Ednor Road access point and the Brogden Road access point. Parking along Ednor Road is as described above, on the west side of Ednor Road. Thus, equestrians wishing to access Section 2 from Ednor Road would be required to cross the road to gain access to the trail. Ednor Road is a moderately used road, and the road crossing at this location is suitable for horses. However, there are no road signs indicating an equestrian crossing at this location. Parking on the east side of Ednor Road is also available, but is not suitable for horse trailers, due to the small size of the parking area. Parking at the Brogden Road access point is available in the form of a small, circular, gravel parking lot in a residential area at the end of Brogden Road (Photo 5). The parking area is large enough to accommodate 2 trailer rigs. The parking lot is level and graveled which provides safe loading/unloading conditions. The parking area is large enough to turn a trailer rig around to safely re-enter Brogden Road.

Photo 5: Brogden Road parking.

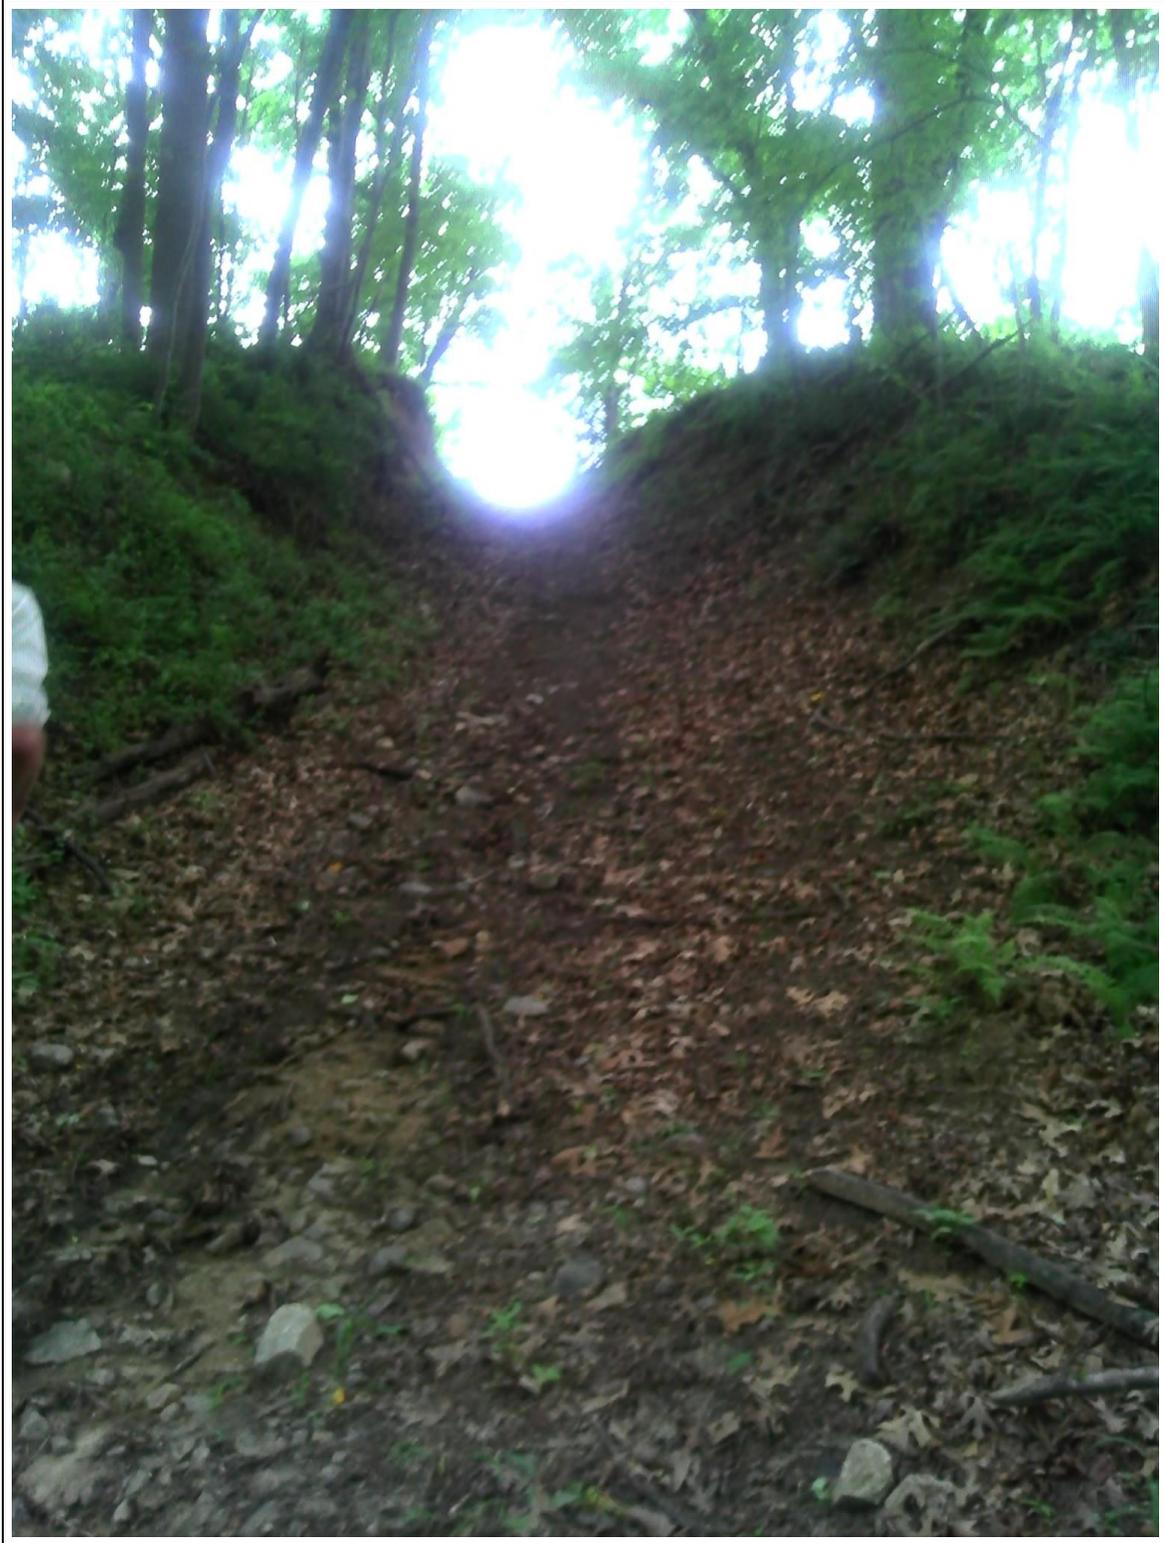
Section 2 was given an overall trail rating of 2. This rating was based on limited access to this stretch of trail from both the Ednor Road and Brogden Road access points. From the Ednor Road side, the trail quickly climbs a very steep hill, where steep terrain, combined with erosion and poor footing conditions make the trail very difficult to travel on horseback (Photo 6). From the Brogden Road access, the trail section is characterized by moderately steep terrain, with several significant stretches of very steep terrain where runoff has created significant areas of erosion, gullies and washouts. The footing in these areas is primarily loose cobble-size rock, interspersed with areas of crumbling subsoil and bedrock (Photo 7). No stream crossings were encountered in the stretch of Section 2 that was assessed on June 4, 2012.

Photo 6: Section 2 steep hill near Ednor Road.

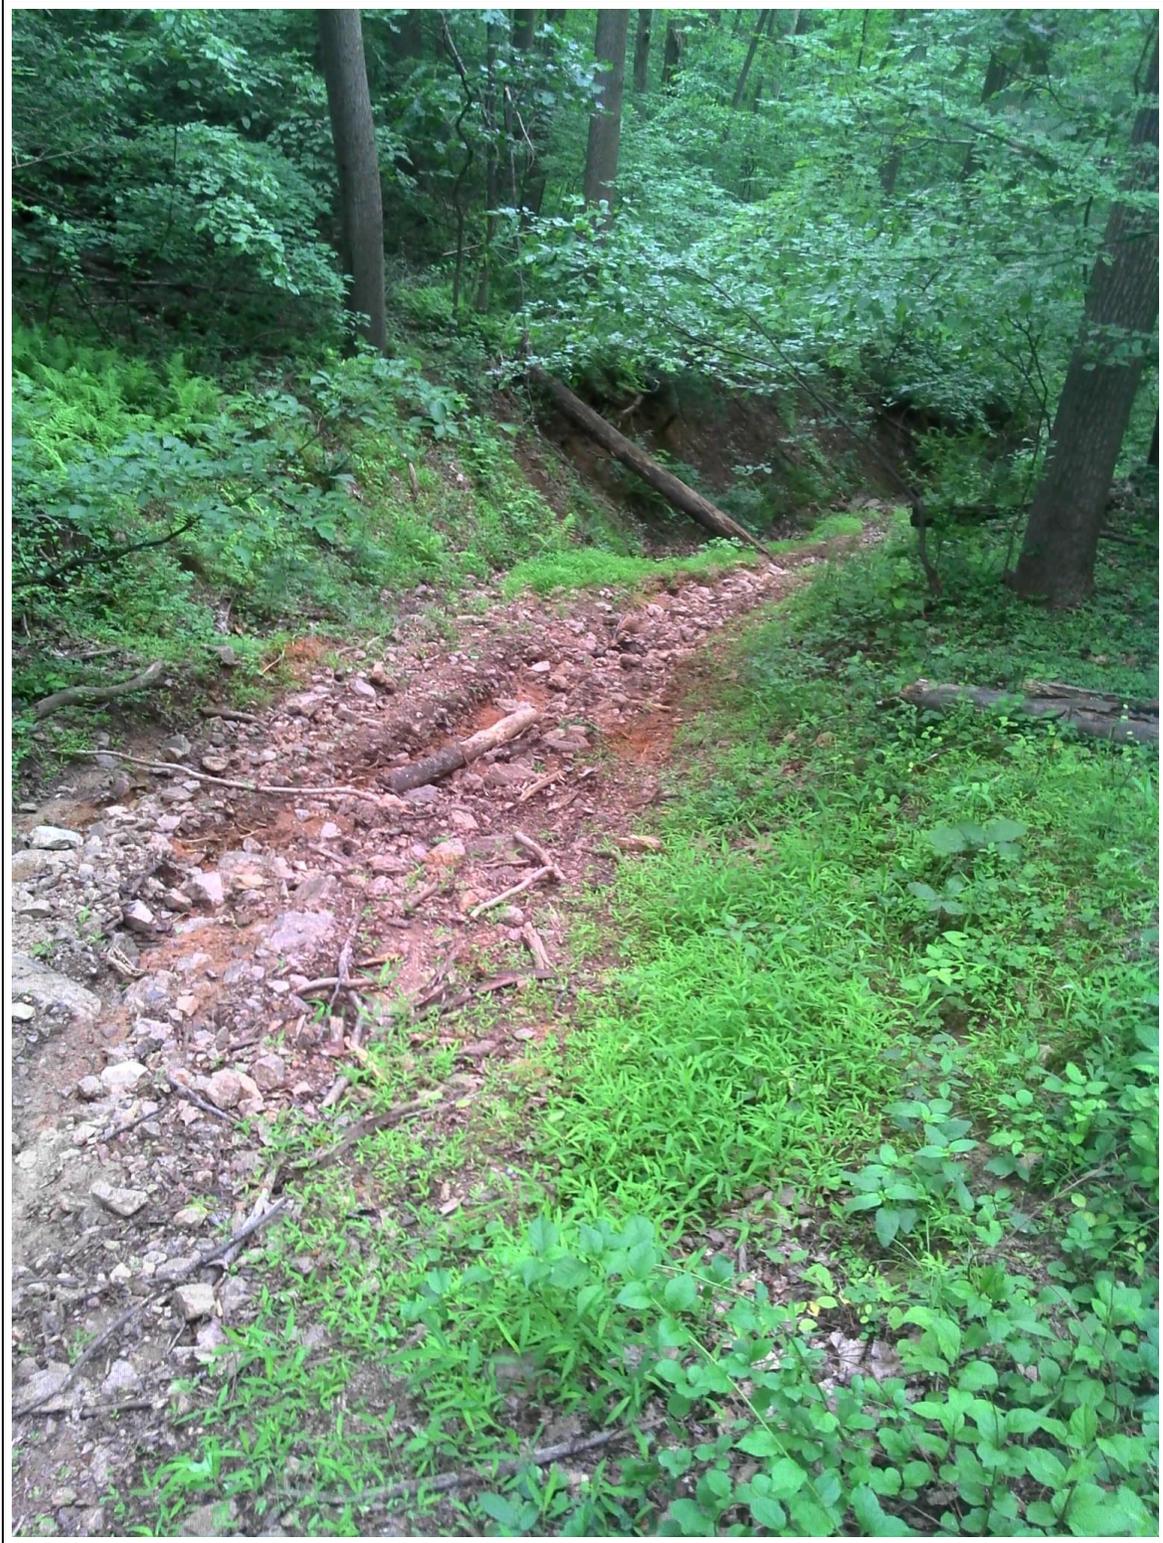
Photo 7: Section 2 typical steep hill with erosion and rock footing.

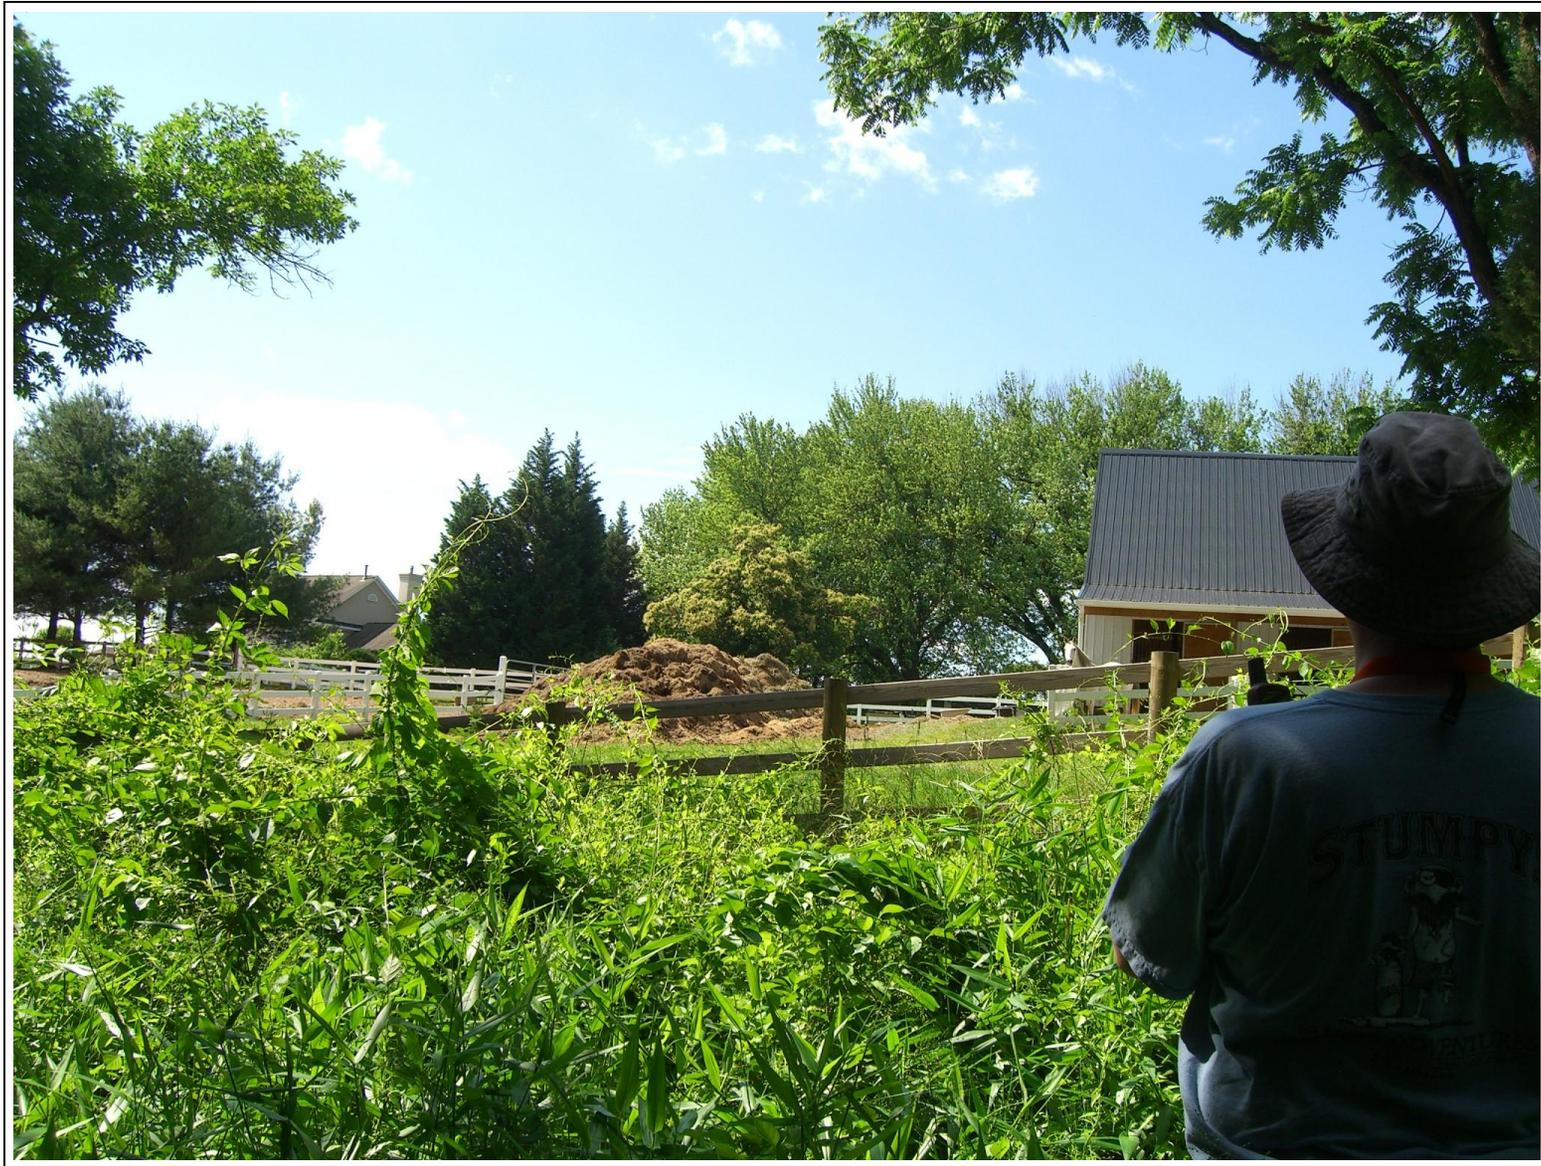
There appeared to be evidence of private equestrian access to the Ednor Road end of this section of the trail from a farm located off Link Road. This same farm has an active horse barn on private property immediately adjacent to the WSSC buffer along this section of the trail (Photo 8). There was no direct evidence of horse use observed along Section 2.

Photo 8: Section 2 horse farm – near Ednor Road.

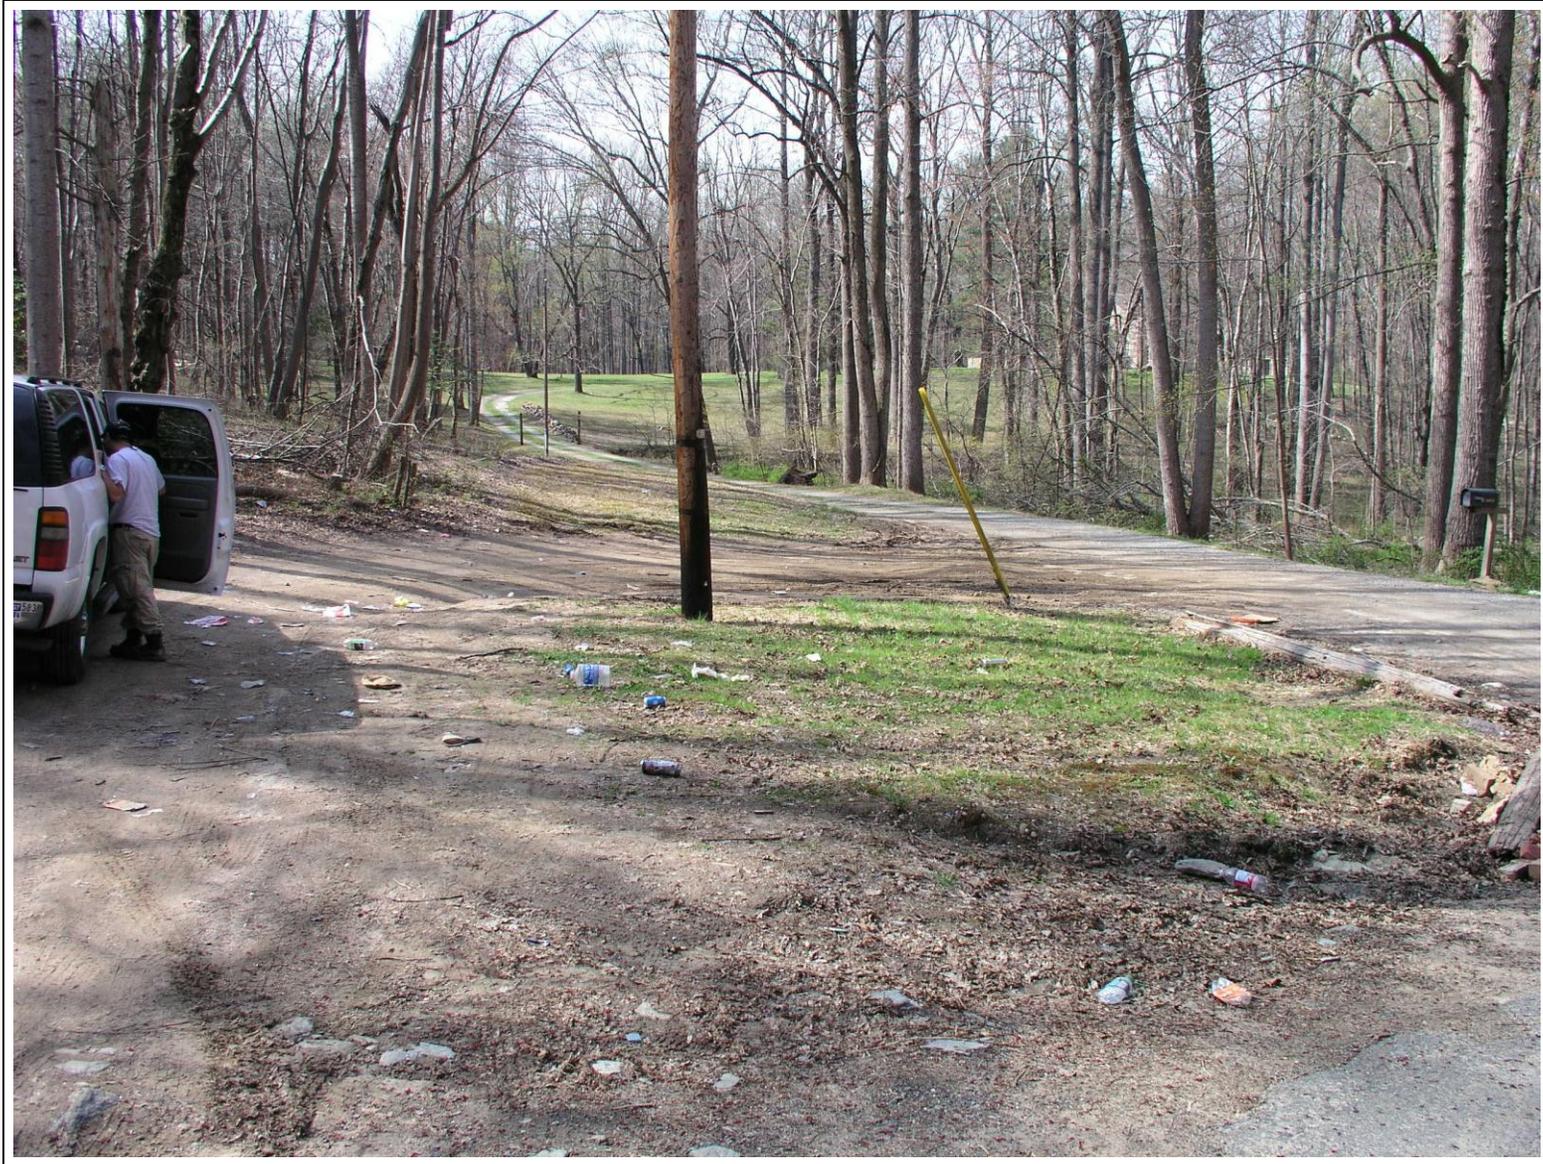
along Brogden Road is as described above. Parking at the Batson Road access point is available in a residential area at the end of Batson Road, and is not suitable for horse trailers (Photo 9). There is no designated parking lot at this location, and it would be difficult to get a trailer rig turned around. Also, there is no suitable area for loading or unloading horses and a large amount of litter was observed (Photo 9).

Photo 9: Batson Road parking.

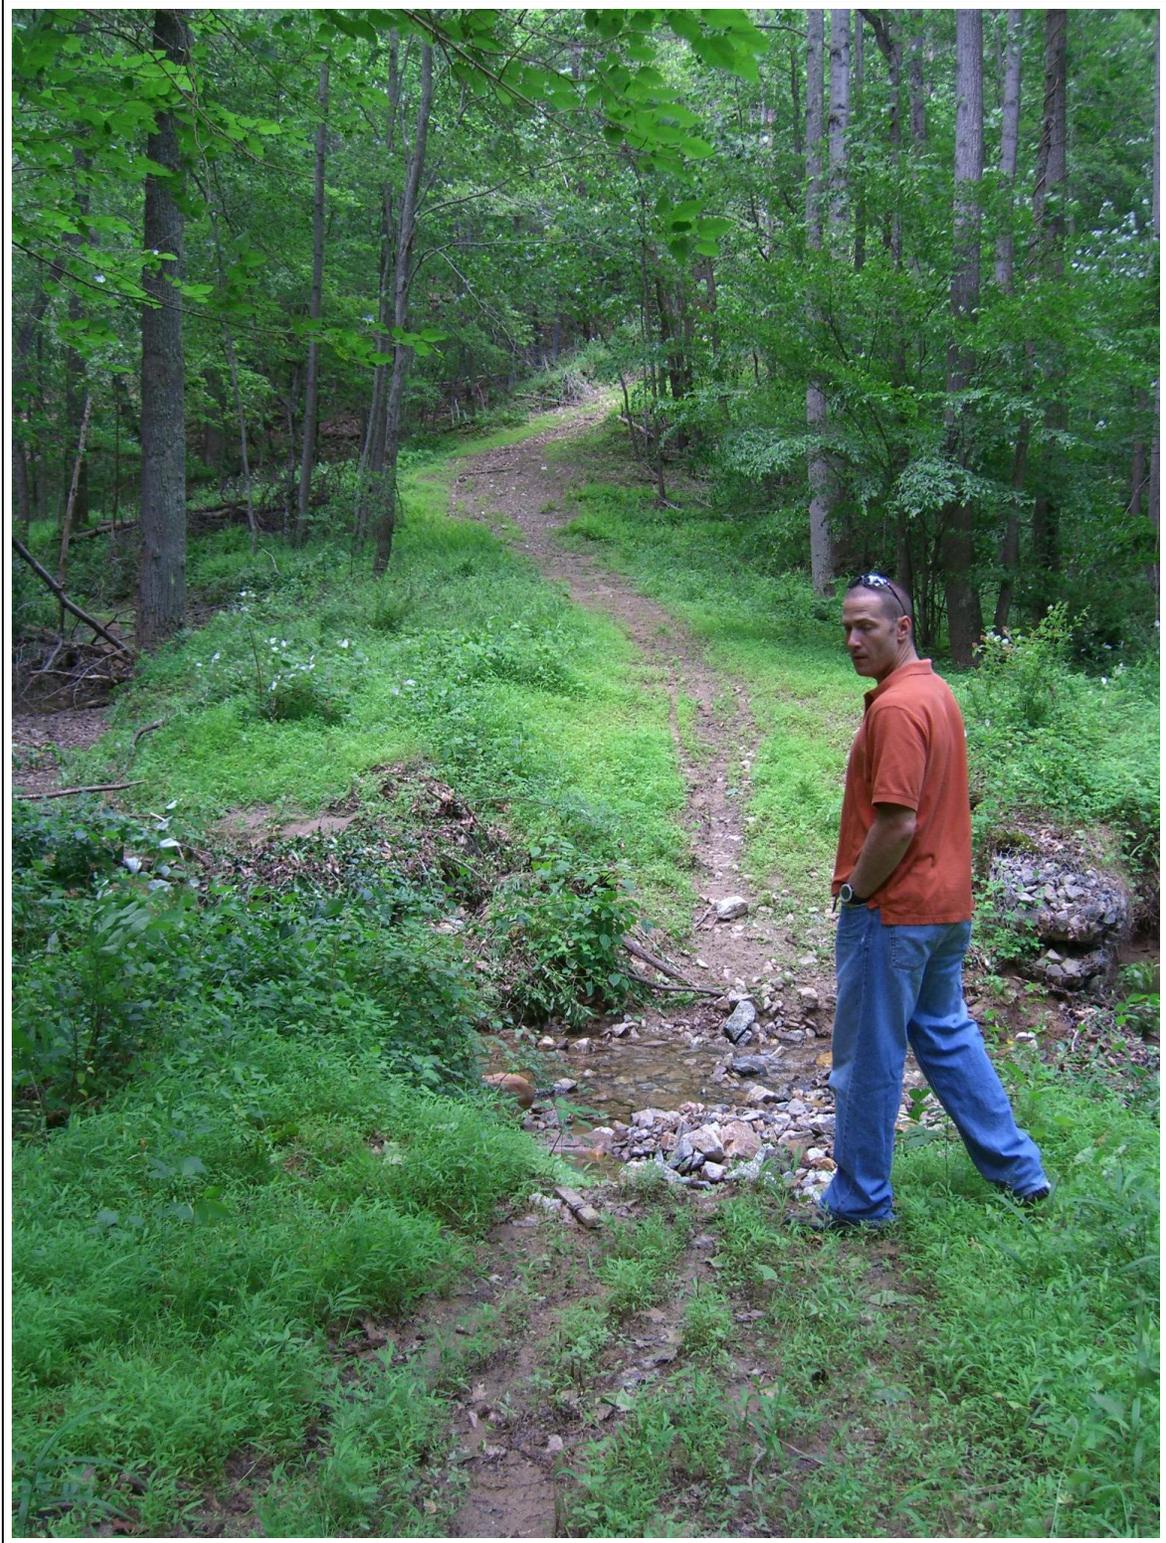
Section 3 was given an overall trail rating of 3. The terrain along this short section of the trail is moderate, with a few areas of moderately steep terrain, with reasonable footing (Photo 10). There were a few areas of rocky footing, but nothing that would be an impediment to horses. No serious obstacles or stream crossings were encountered along this trail section.

Photo 10: Section 3 moderate hill trail with some erosion.

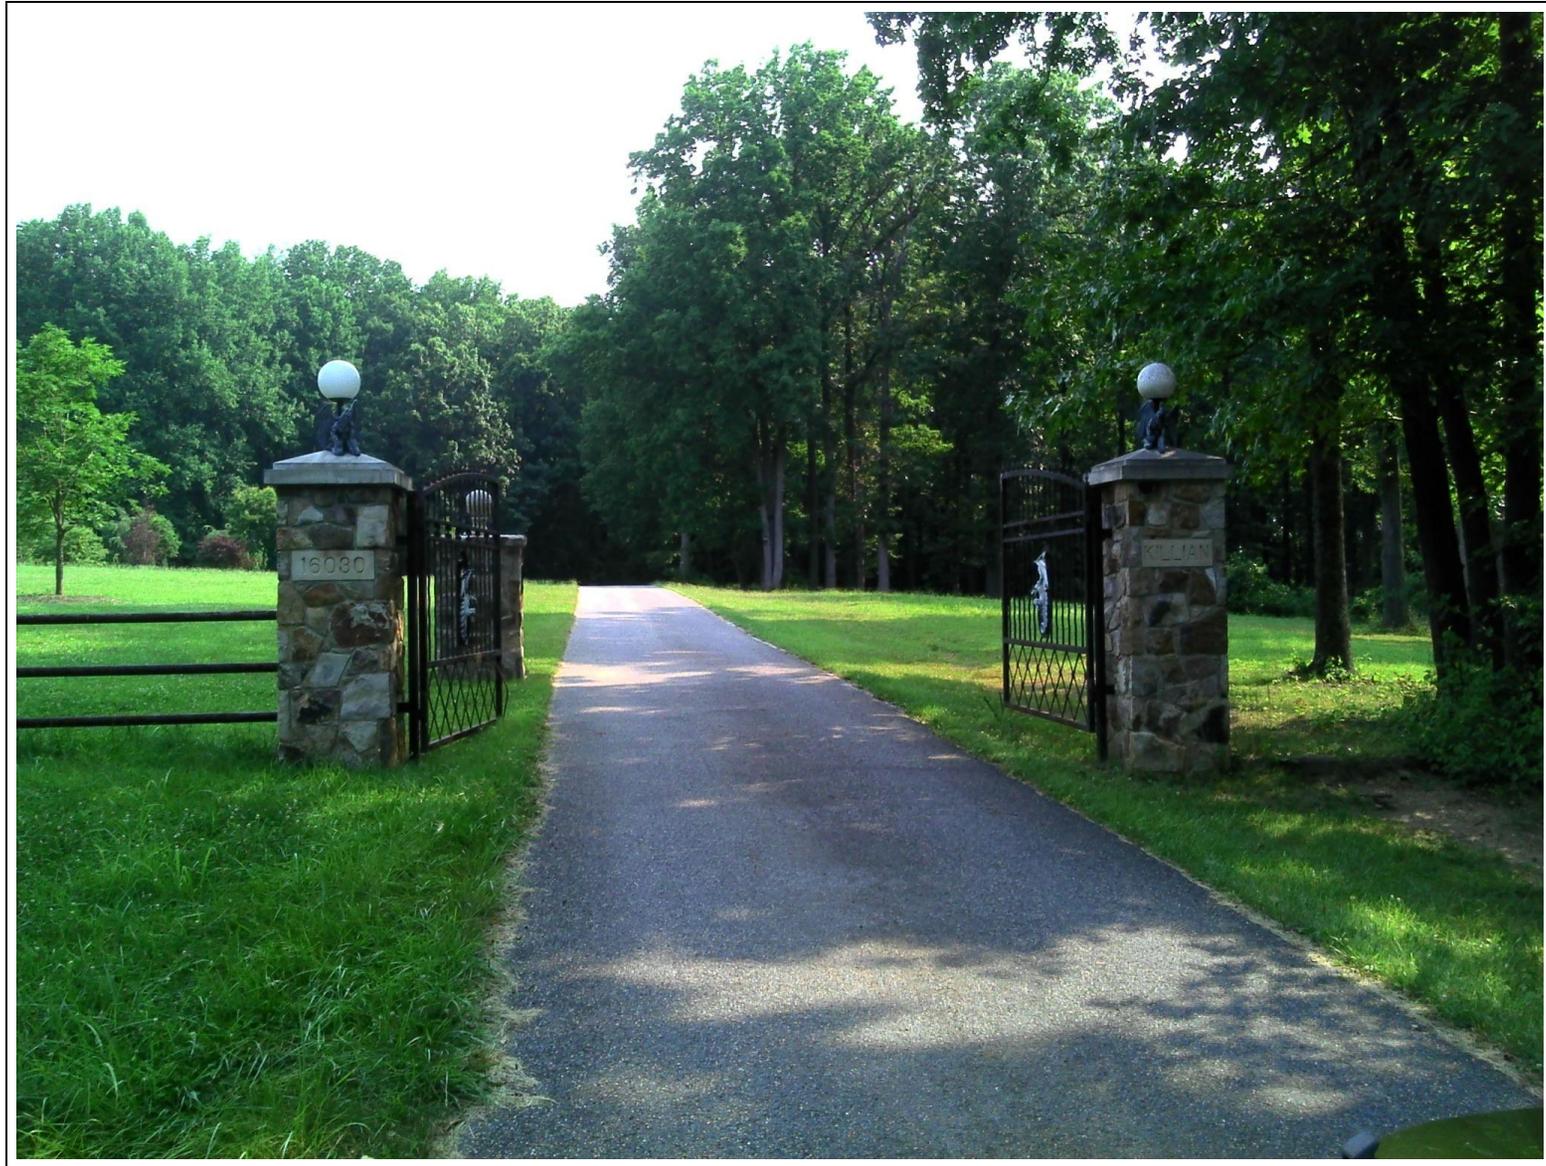
Access to this section is available at both the Batson Road and Kruhm Road access points (Map 1). As described above, there is no suitable parking for horse trailers at the Batson Road access, but there is suitable parking at the nearby Brogden Road access. Parking at the Kruhm Road access is roadside parking along Kruhm Road, just outside a gated private property at the terminal end of Kruhm Road (Photo 11). Roadside parking in this area is flat and safe from a traffic perspective, but there is no place to turn around a trailer rig, and therefore is not suitable for horse trailers.

Photo 11: Kruhm Road parking.
