Appendix B
WSSC T. Howard Duckett (Rocky Gorge) Reservoir
Horse Trail Reconnaissance Report

WSSC T. Howard Duckett (Rocky Gorge) Reservoir Horse Trail Reconnaissance Report

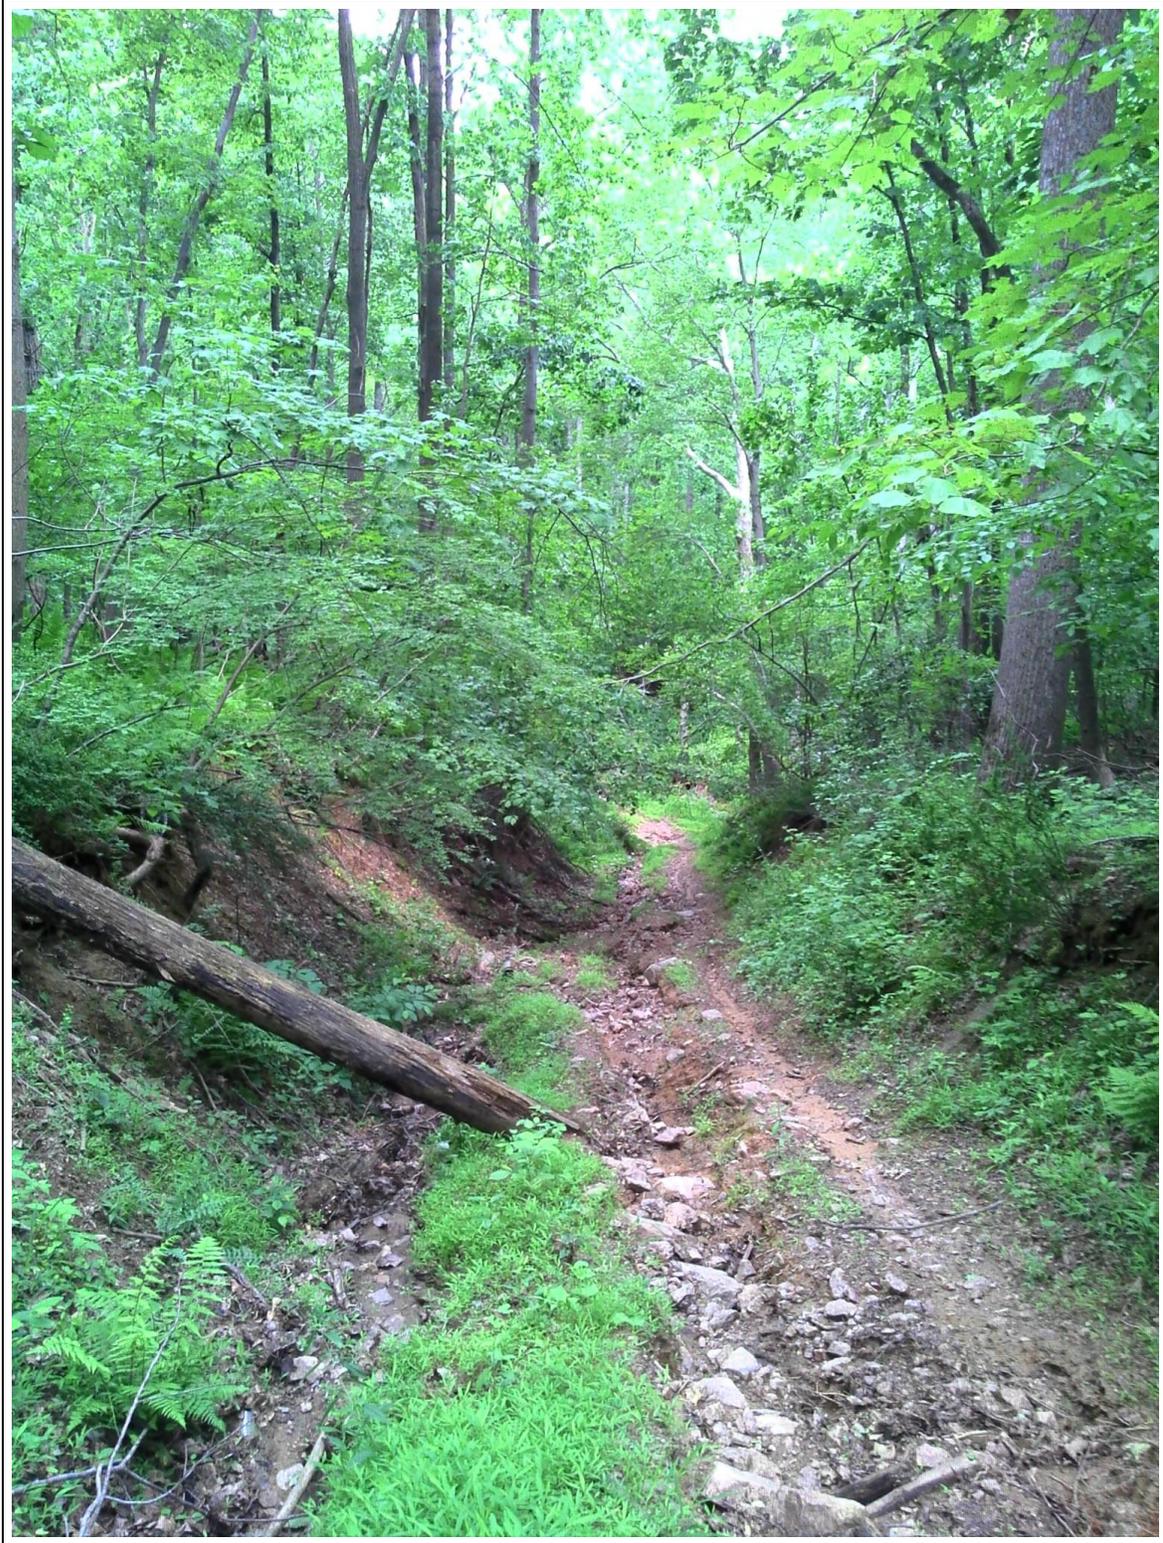
Section 4 was given an overall trail rating of 3. The terrain along this section of the trail is moderate, with a few areas of moderately steep terrain, with reasonable footing. There was one steep section encountered where access road erosion has created some gullies, making footing on relatively steep terrain difficult (Photo 12). This section was rated 2. There was also a stream crossing comprised of concrete railroad ties. The ties had algae growing on them creating slippery conditions for horses, and one of the ties was damaged and had exposed iron rebar that could catch a horse's shoe causing loss of shoe or possible hoof damage or leg injury (Photo 13). This stream crossing was rated 2. No other serious obstacles or stream crossings were encountered along this trail section. Evidence of recent horse use was observed along this section.

Photo 12: Section 4 steep hill with some erosion and gullies.

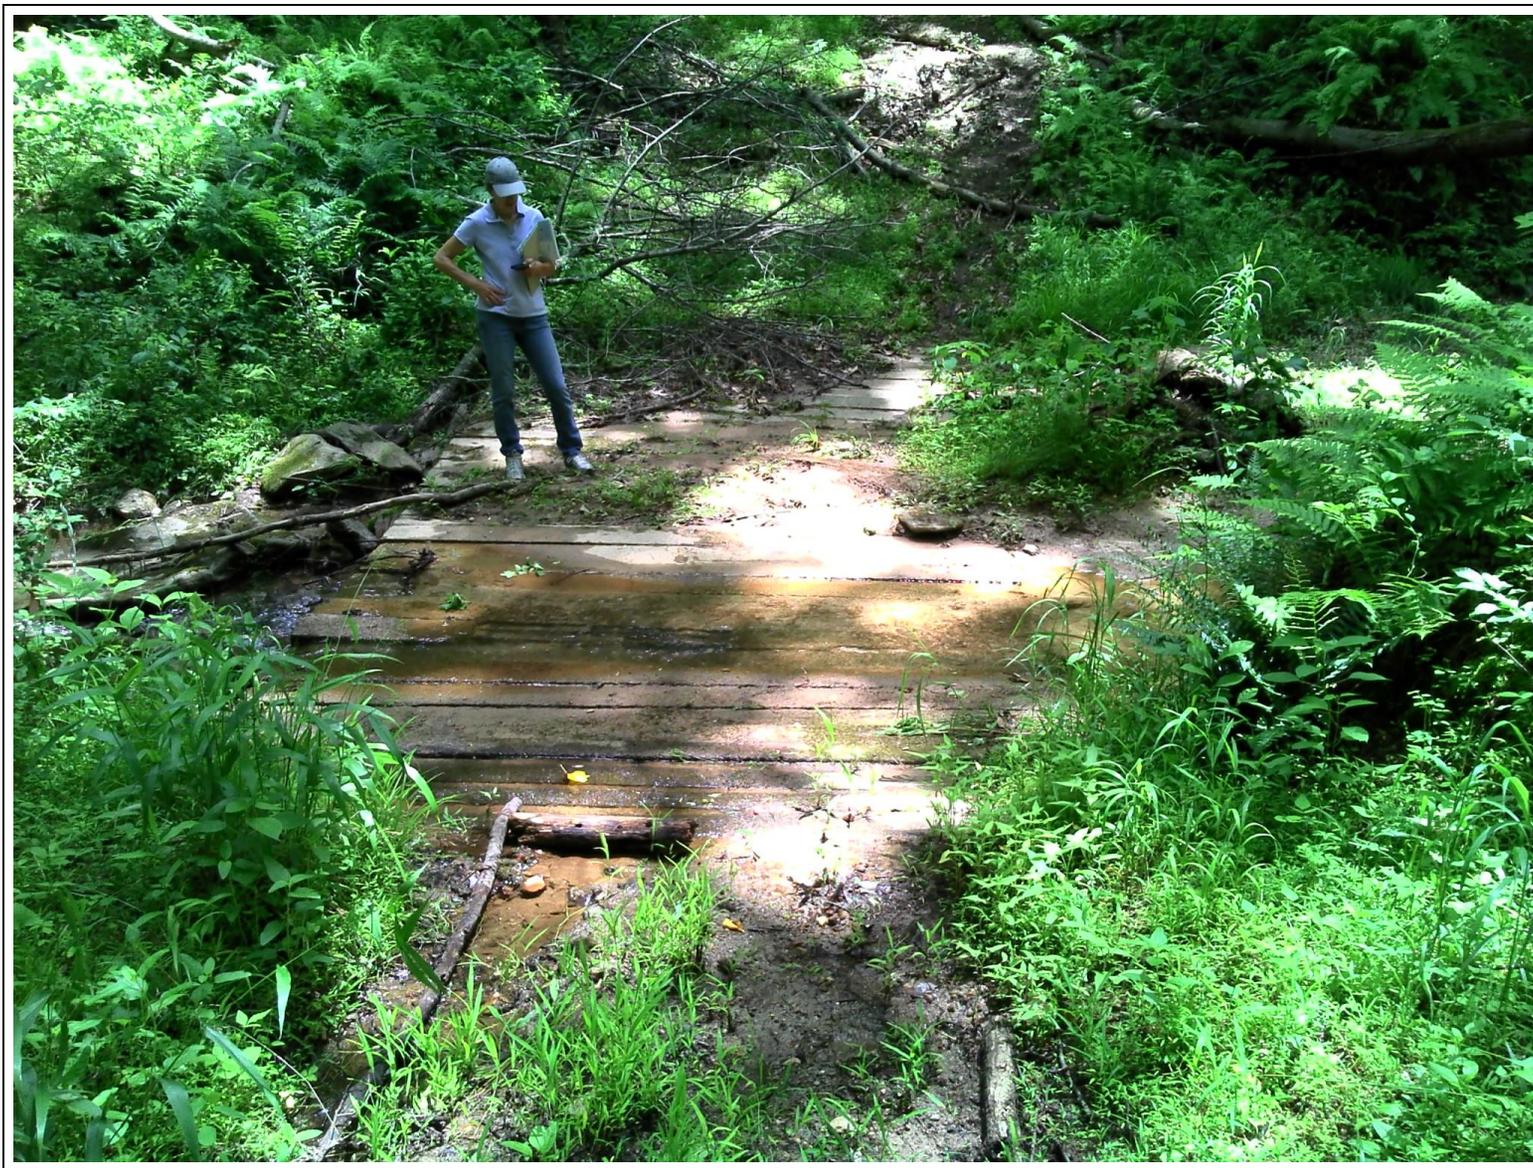
Photo 13: Section 4 stream crossing with railroad ties/rebar.

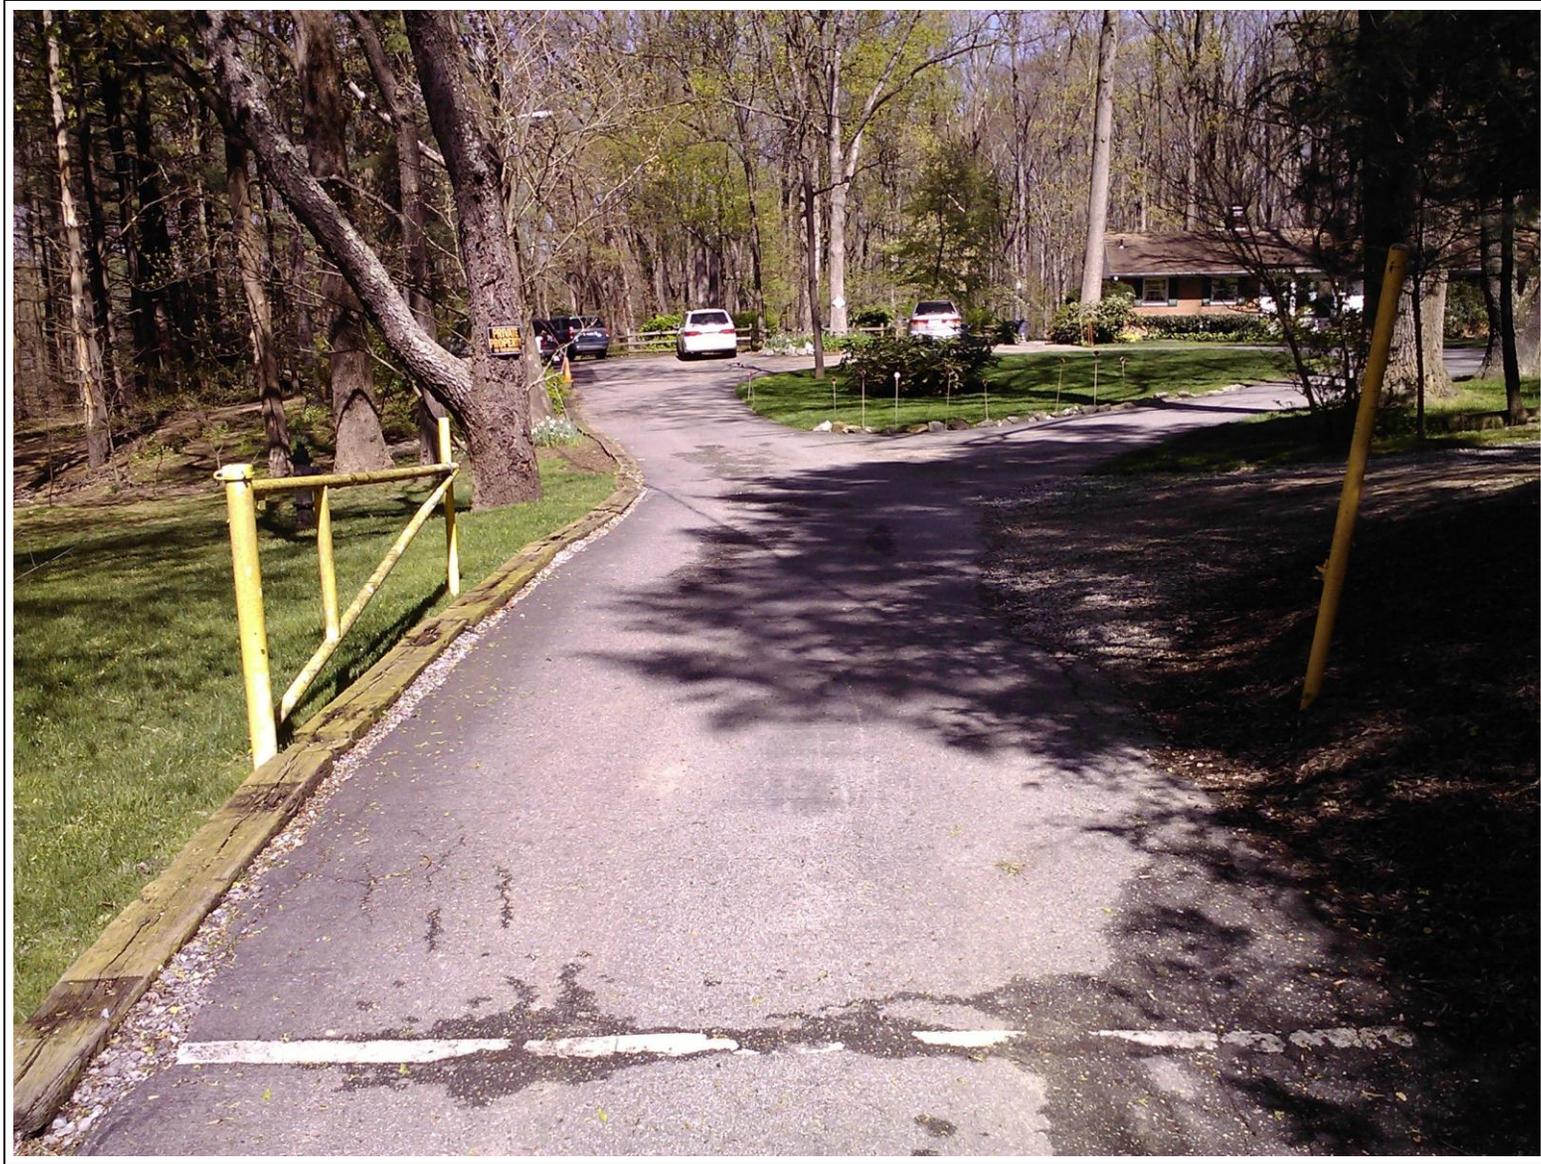
is no designated parking area at the Burton Lane access. Burtons Lane ends at a private residence, and roadside parking is very limited due to the narrow residential road. In addition, property on both sides of the road is marked “no trespassing” (Photo 14). Even if roadside parking was available at this location, the location is not suitable for horse trailers as there is nowhere to turn around a trailer rig.

Photo 14: Burtons Lane parking.

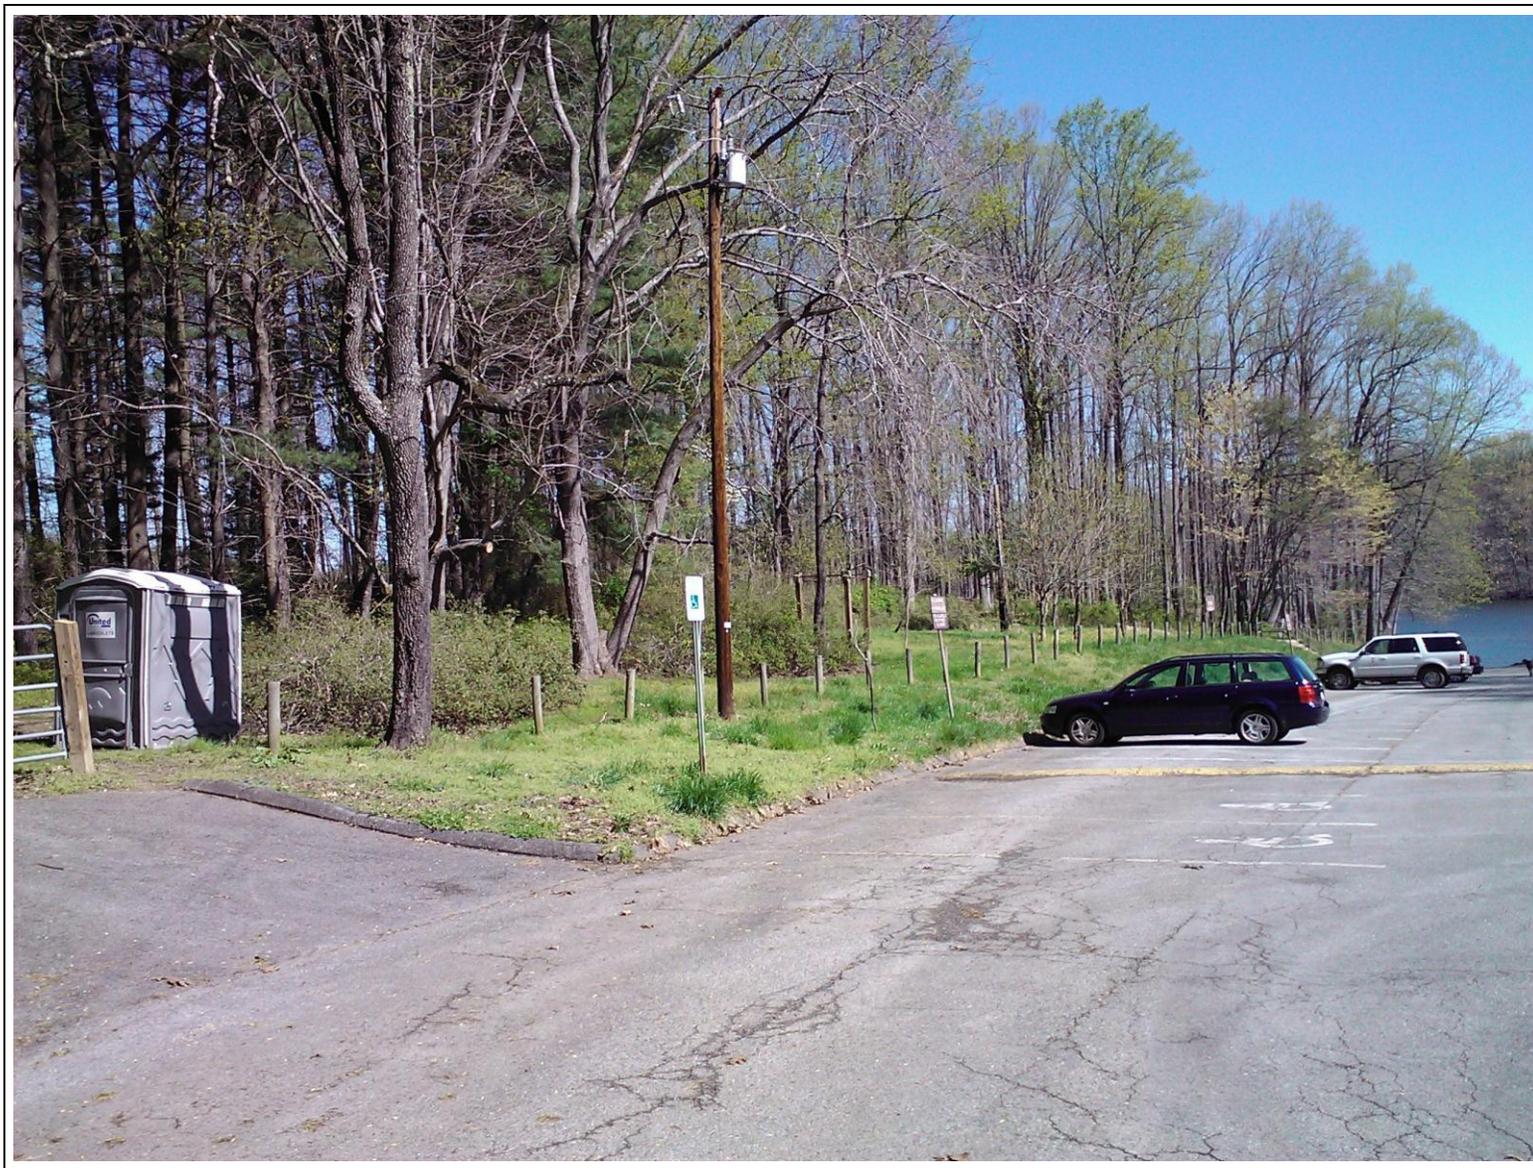
Access for this section is available at both the Burtons Lane access and Supplee Lane access points (Map 1). As noted above, there is no designated parking along Burtons Lane, and the roadside parking that is available is not suitable for horse trailers. There is a large recreational parking lot at the Supplee Lane access area (Photo 15). The parking lot is paved and is designed to accommodate cars. No area of the parking lot is designated for horse trailer rigs or equestrian use, but the parking lot is large enough to accommodate an estimated 4-6 trailer rigs. Paved parking is not the most suitable for loading and unloading horses, as pavement can be slippery. However, the Supplee Lane parking area is relatively flat and could be used for horse trailers.

Photo 15: Supplee Lane Recreation Area parking.

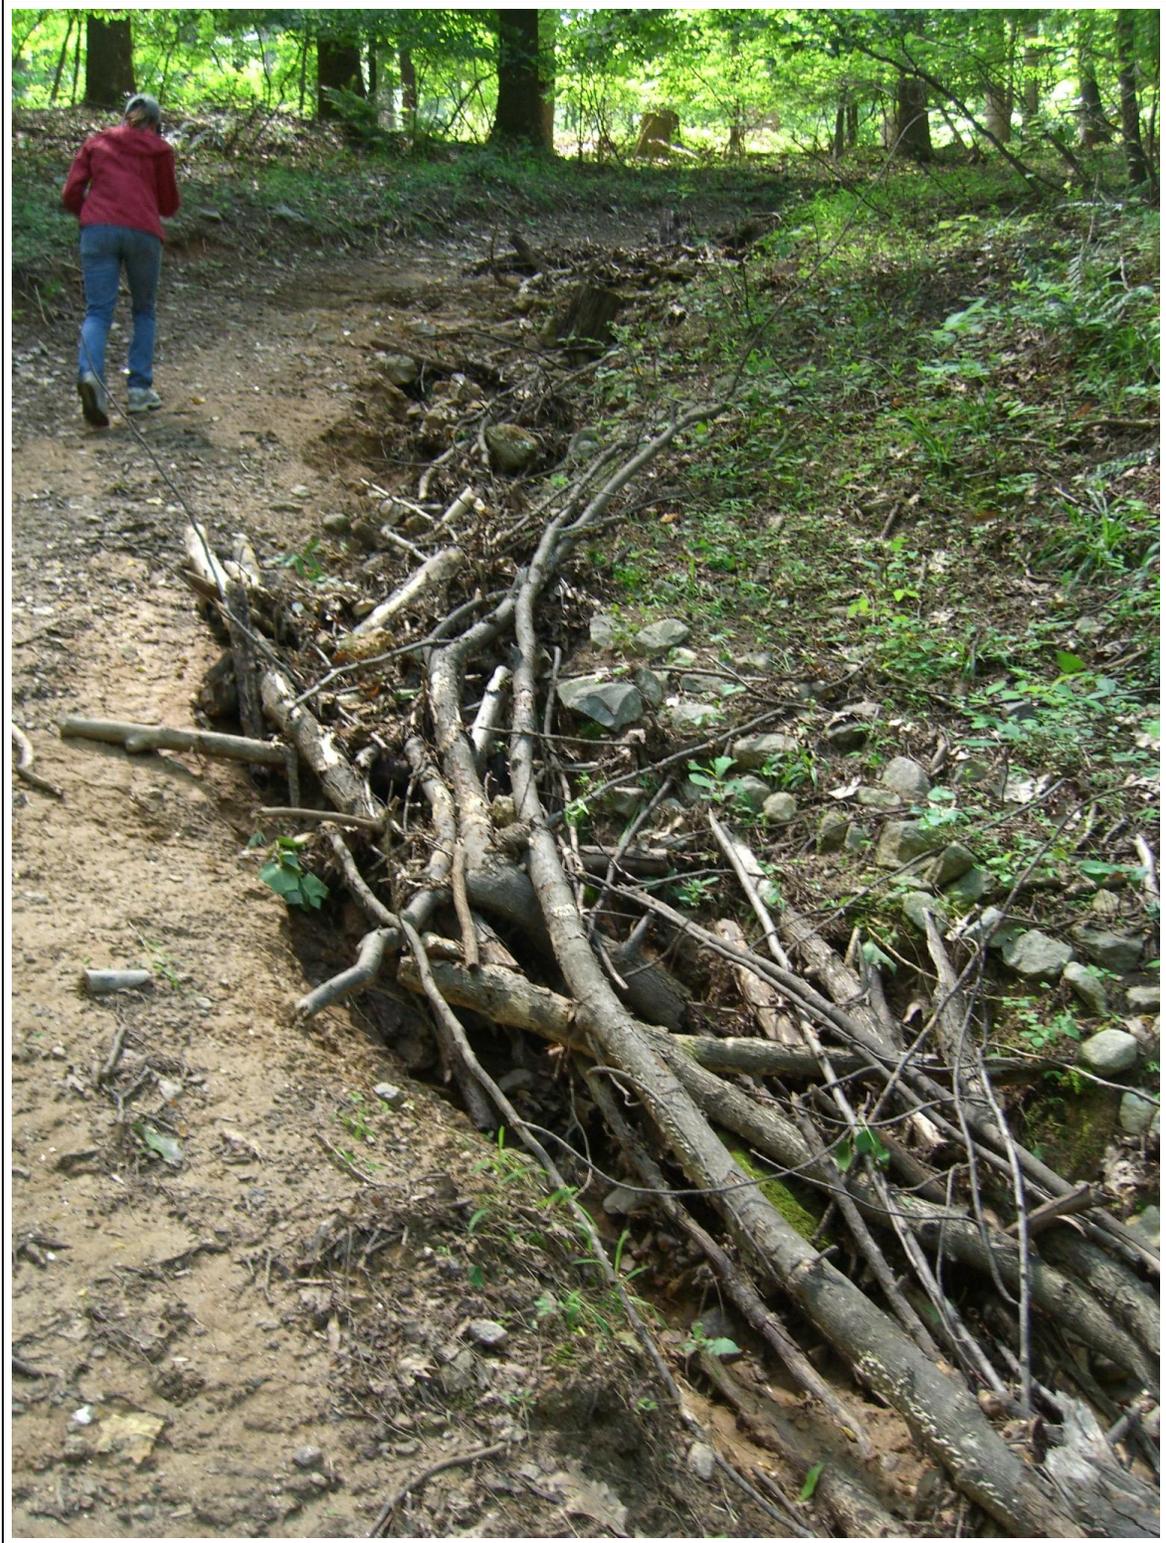
Section 6 was surveyed in its entirety by foot and was given an overall rating of 3. The terrain along this section of the trail is mostly moderate, with a few areas of moderately steep terrain, but with reasonable footing. There were a few areas of rocky footing encountered, but with one exception, nothing that would be an impediment to horses. One particularly steep section of the trail was given a rating of 1 and deemed unsuitable for horseback riding in its current condition due to the steep terrain, rocky and unstable footing, serious erosion and deep gullies (Photo 16). There are no stream crossings on this section of the access road, as all streams are directed through culverts under the access road.

Photo 16: Section 6 steep hill with deep erosion/gully.

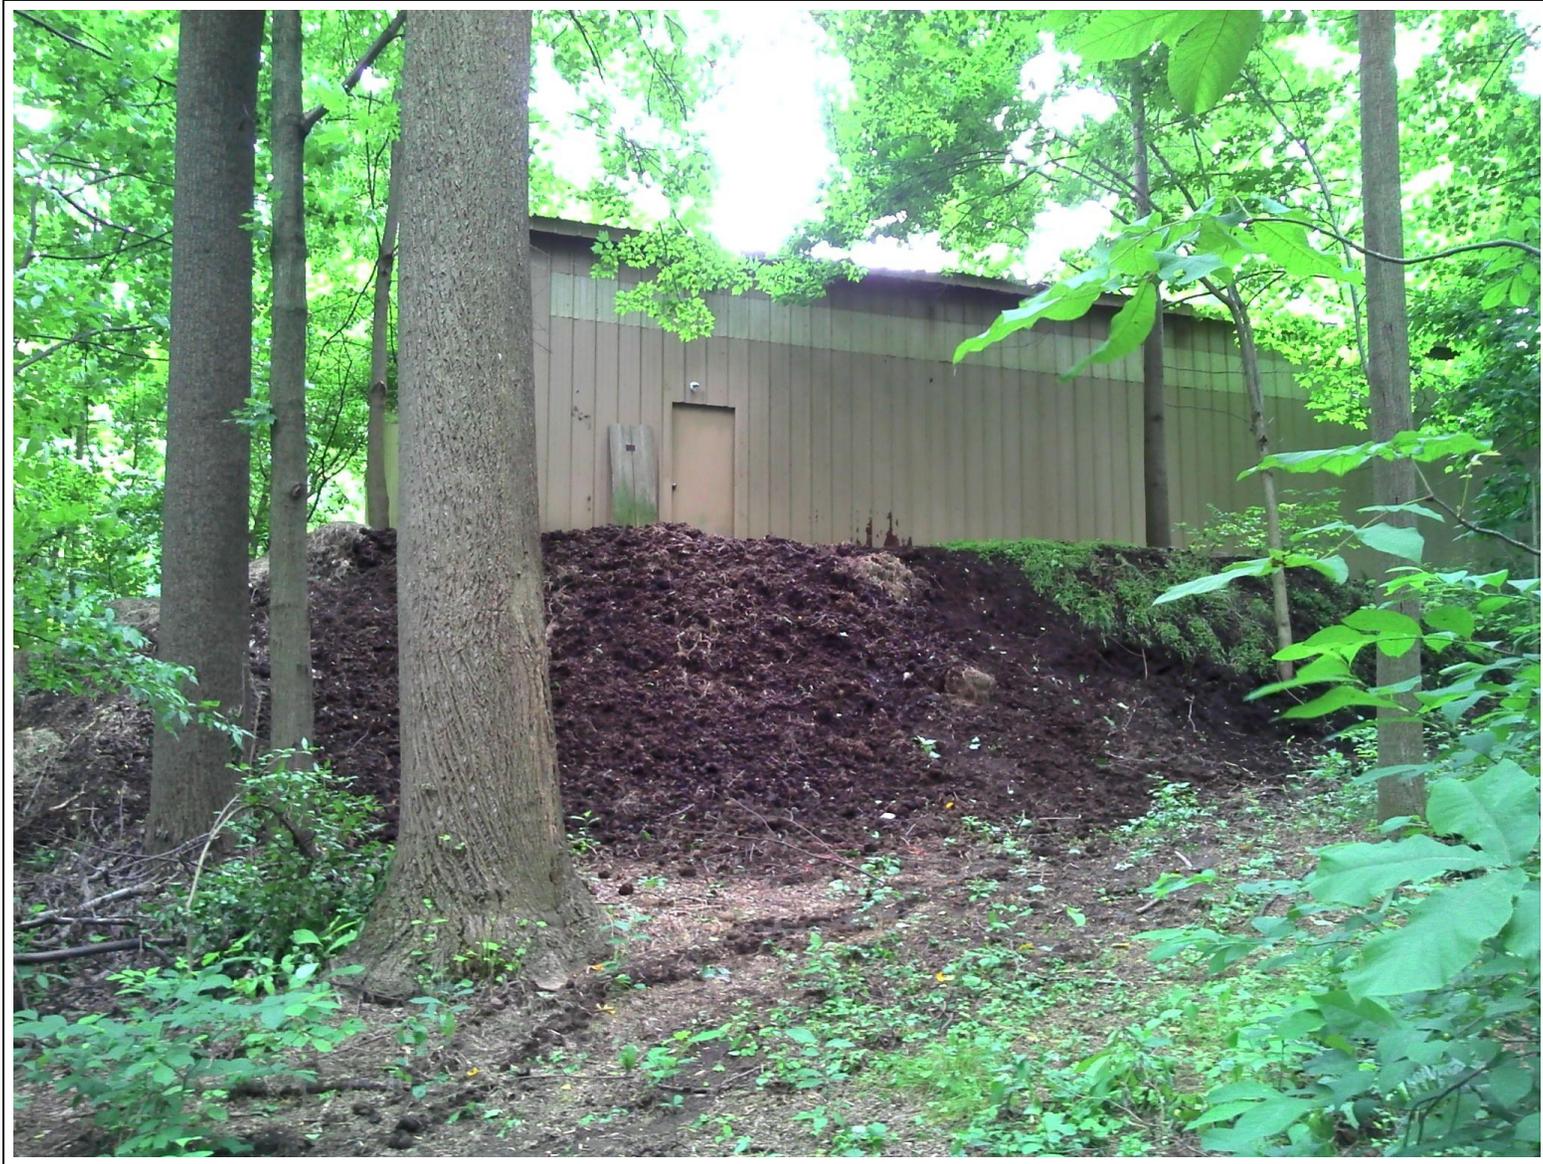
One active horse barn on private property immediately adjacent to the WSSC buffer was observed along this section of the trail with a substantial manure pile almost directly adjoining the WSSC property boundary (Photo 17).

Photo 17: Section 6 horse farm with manure pile.

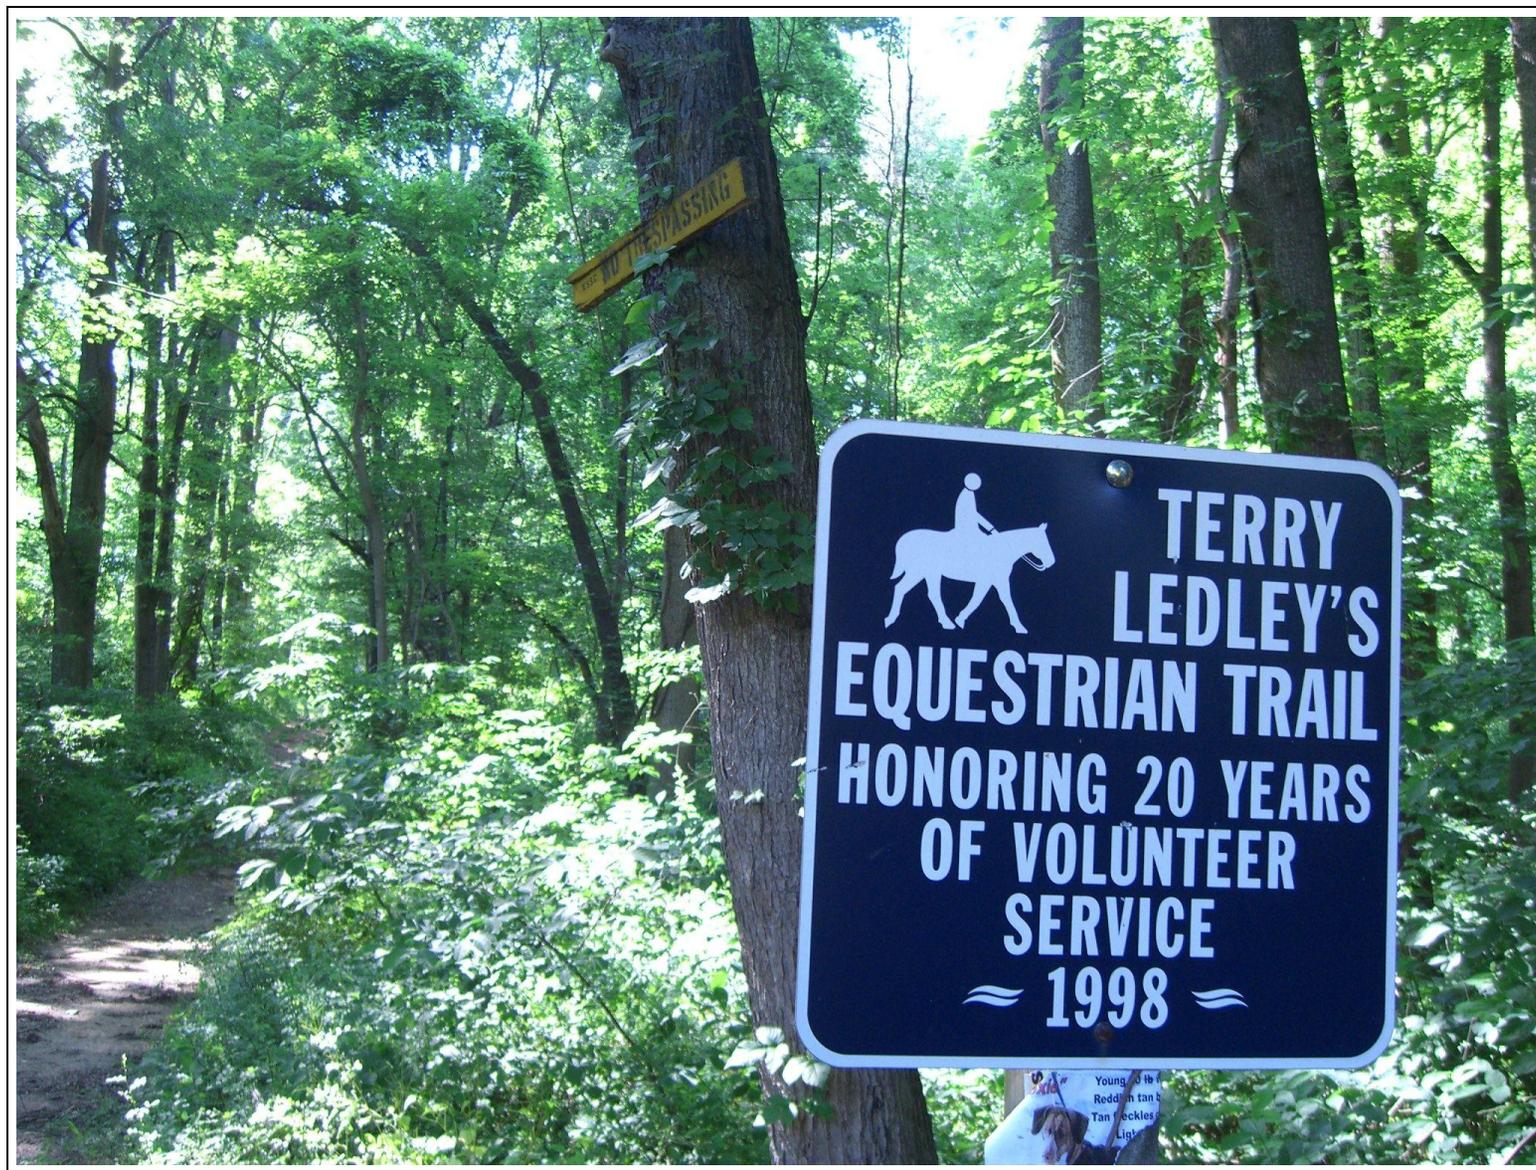
Access to the Terry Ledley Equestrian Trail is provided at the Supplee Lane Recreation Area. The suitability for horse trailer parking available at this area is described above. This trail is also accessible from the designated access road equestrian trail, which could also be accessed from the Burtons Lane access point. The trail begins off of the designated access road equestrian trail on the west side of the transmission line crossing near the Supplee Lane access point. The trailhead is marked with a sign designating it as “Terry Ledley’s Equestrian Trail” (Photo 18).

Photo 18: Terry Ledley Equestrian Trail sign.

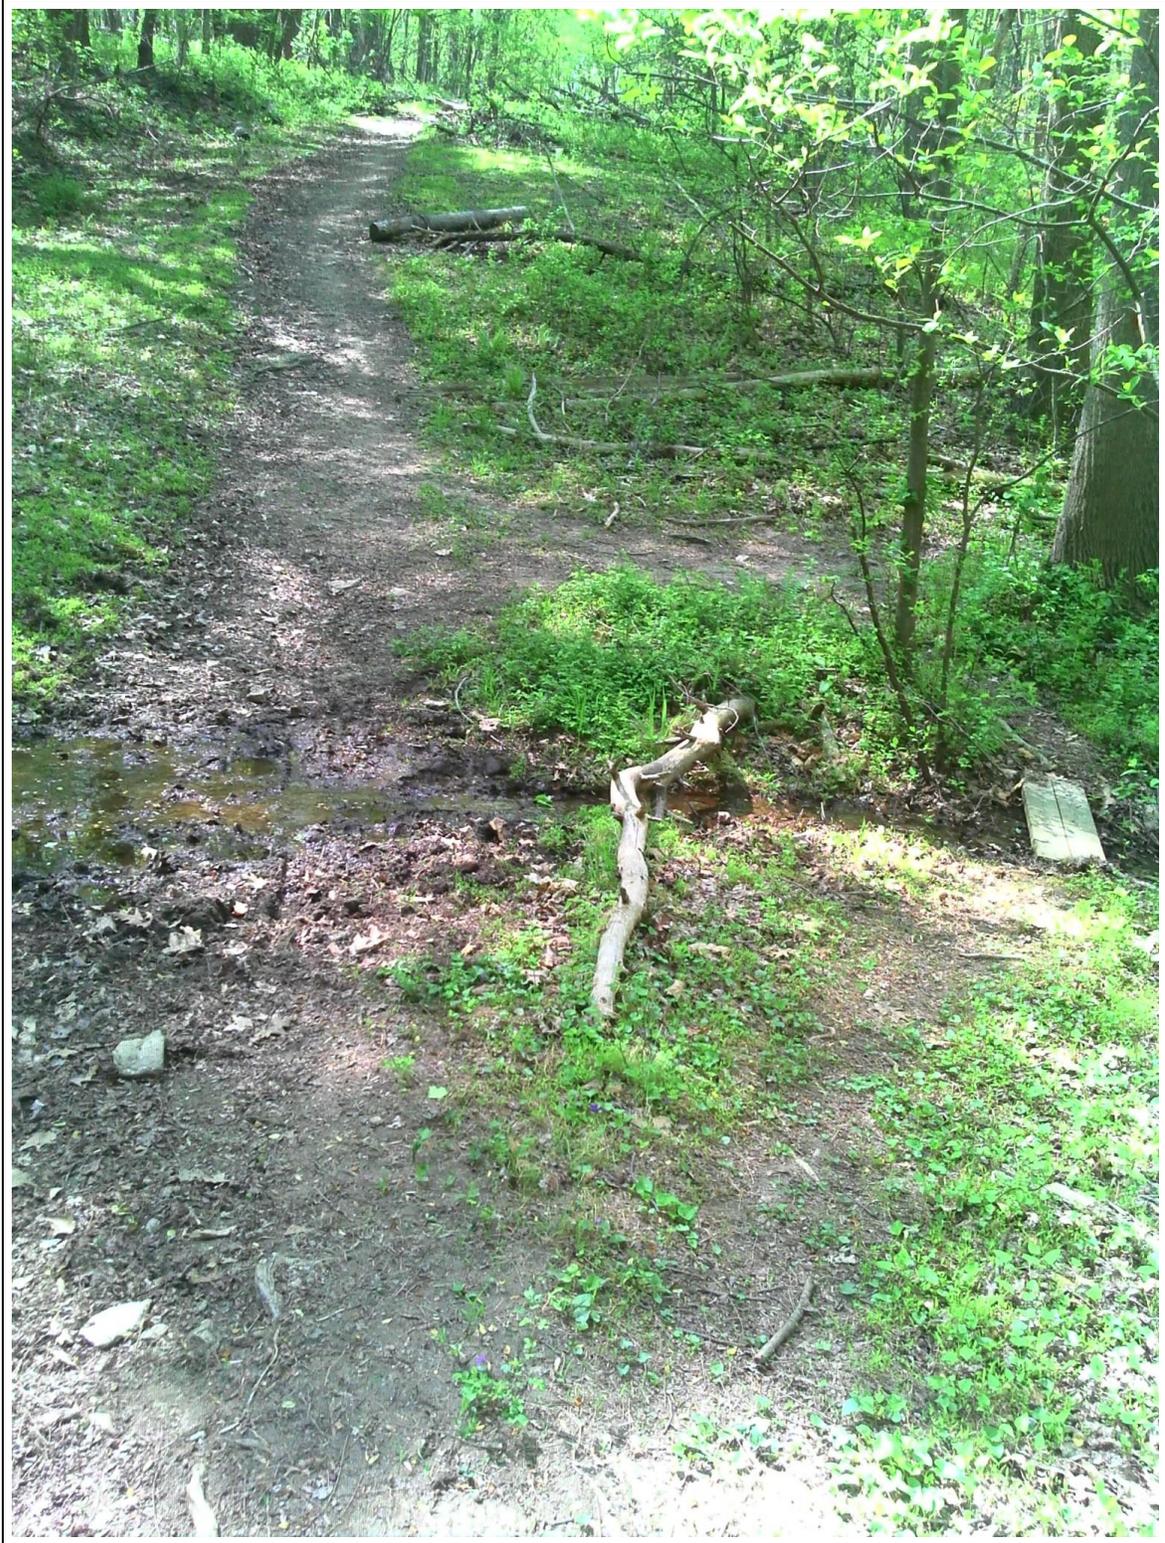
A significant portion of the marked (orange blaze marks) trail was walked on foot on June 4, 2012, and this trail section was given an overall rating of 5. The trail was found to be in excellent condition for use by horses. The terrain was mostly flat to gently undulating. The footing was firm and generally free from rocks, loose footing or deep footing. Two stream crossings were encountered. Both stream crossings were gradual bank descents into a shallow stream (Photo 19). The footing was good at both crossing, comprised primarily of sand, gravel and some cobble. There was little evidence of erosion at either of the stream crossings. The trail travels generally westward between the designated access road equestrian trail and the reservoir. The reservoir was visible in some locations, and in three locations the trail approached to within 100 feet of the reservoir (Photo 20). Side trails off the orange blaze marked trail led to the reservoir shoreline in several locations, but no evidence of equestrian use of the side trails was observed. There was little or no erosion observed along any portion of the trail. Considerable evidence of recent equestrian use of the trail was observed on June 4, 2012.

Photo 19: Terry Ledley Equestrian Trail stream crossing.

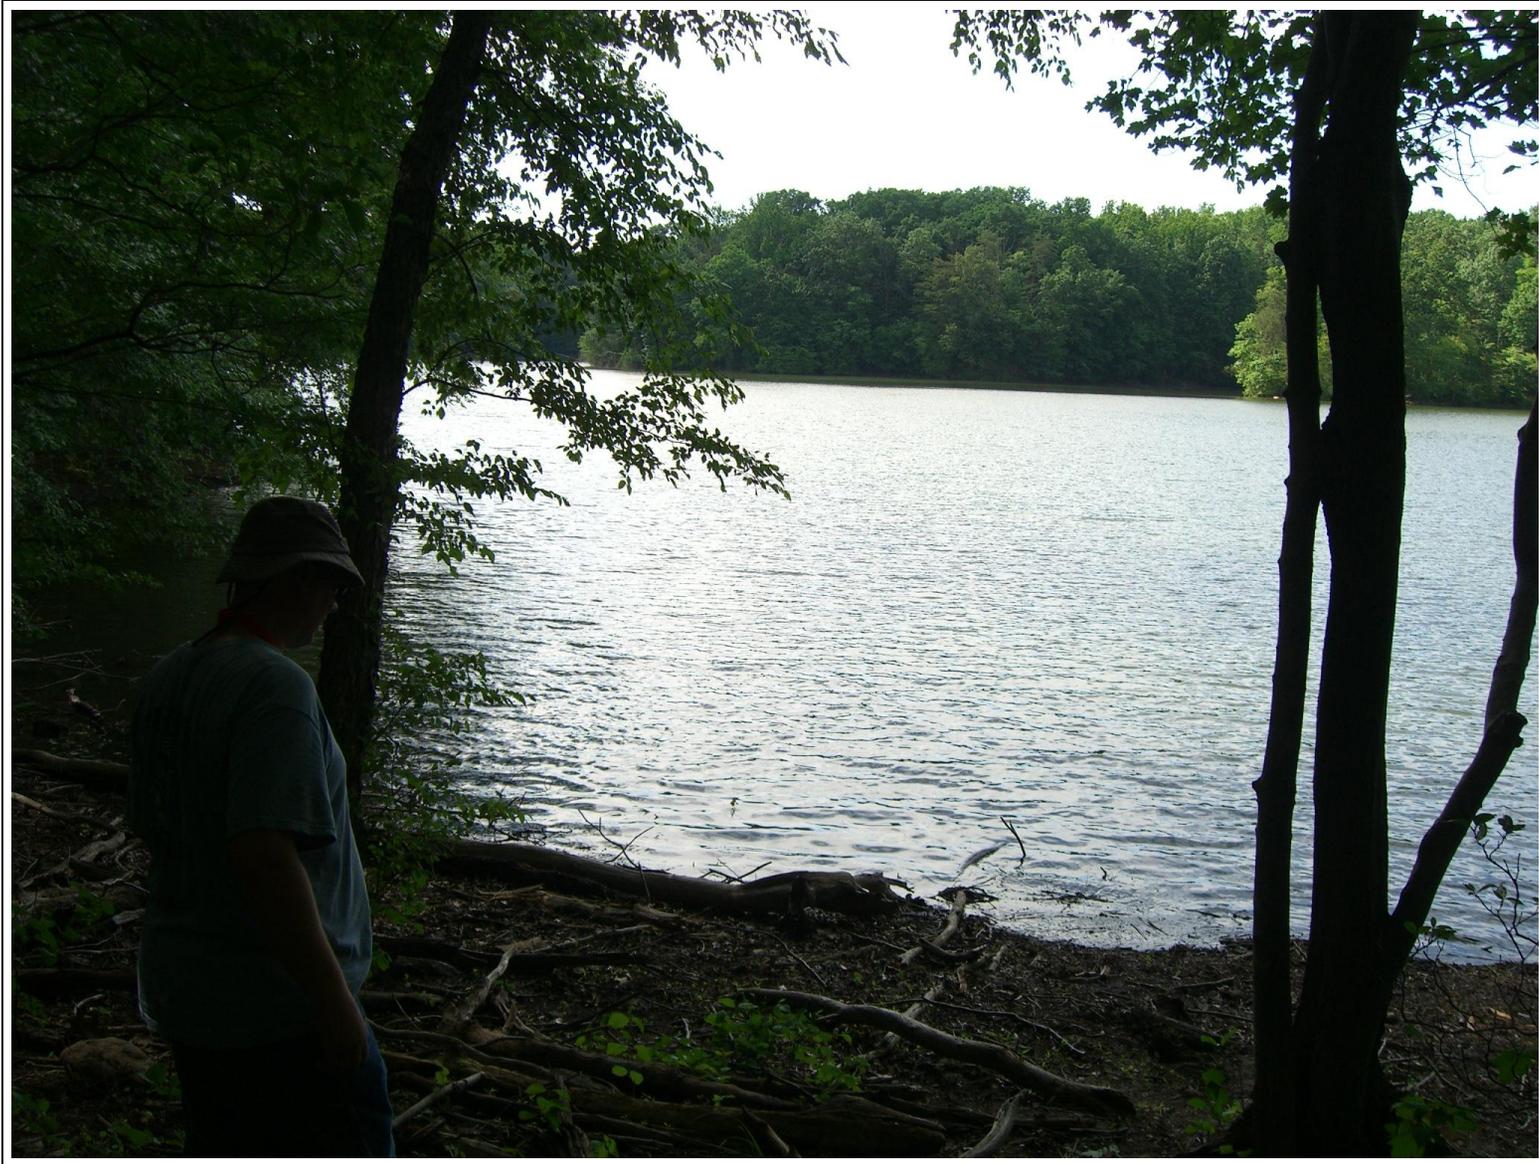
Photo 20: Terry Ledley Equestrian Trail reservoir from closest trail point.
