Study Results, Observations, and Recommendations

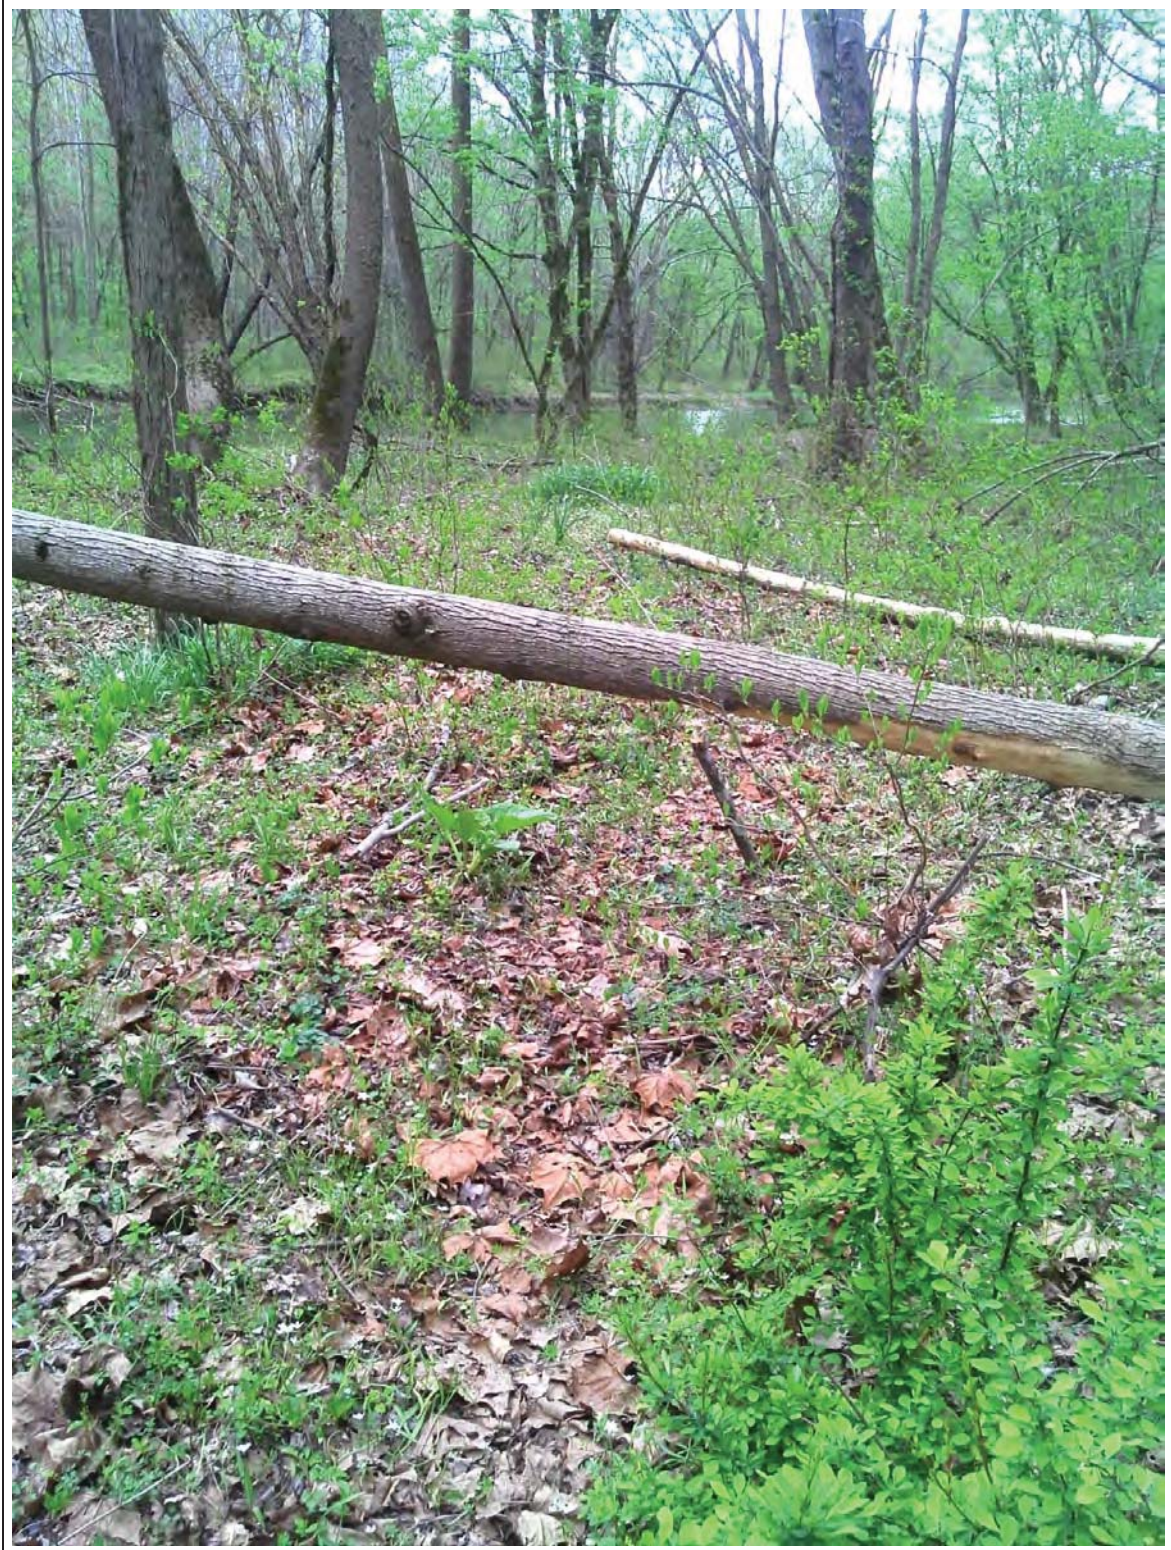
Photo 5-1: Tucker Lane fallen trees

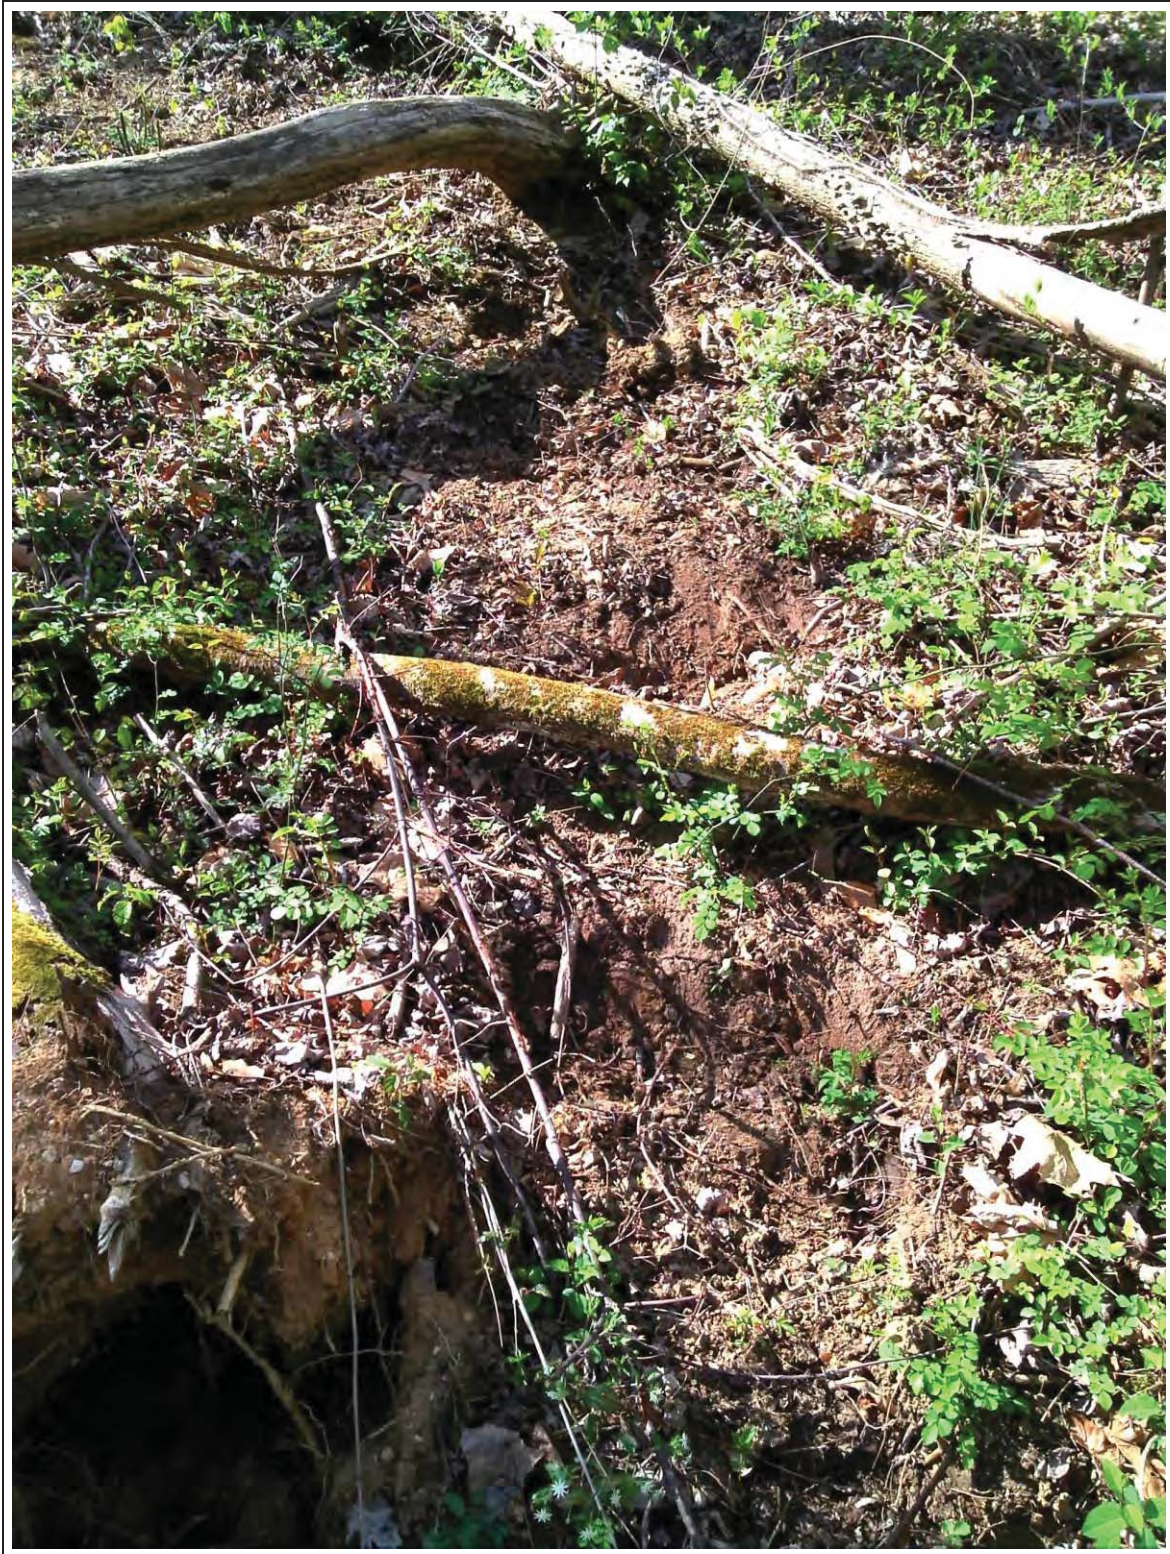
Photo 5-3: Ednor Lane slope and channelized erosion

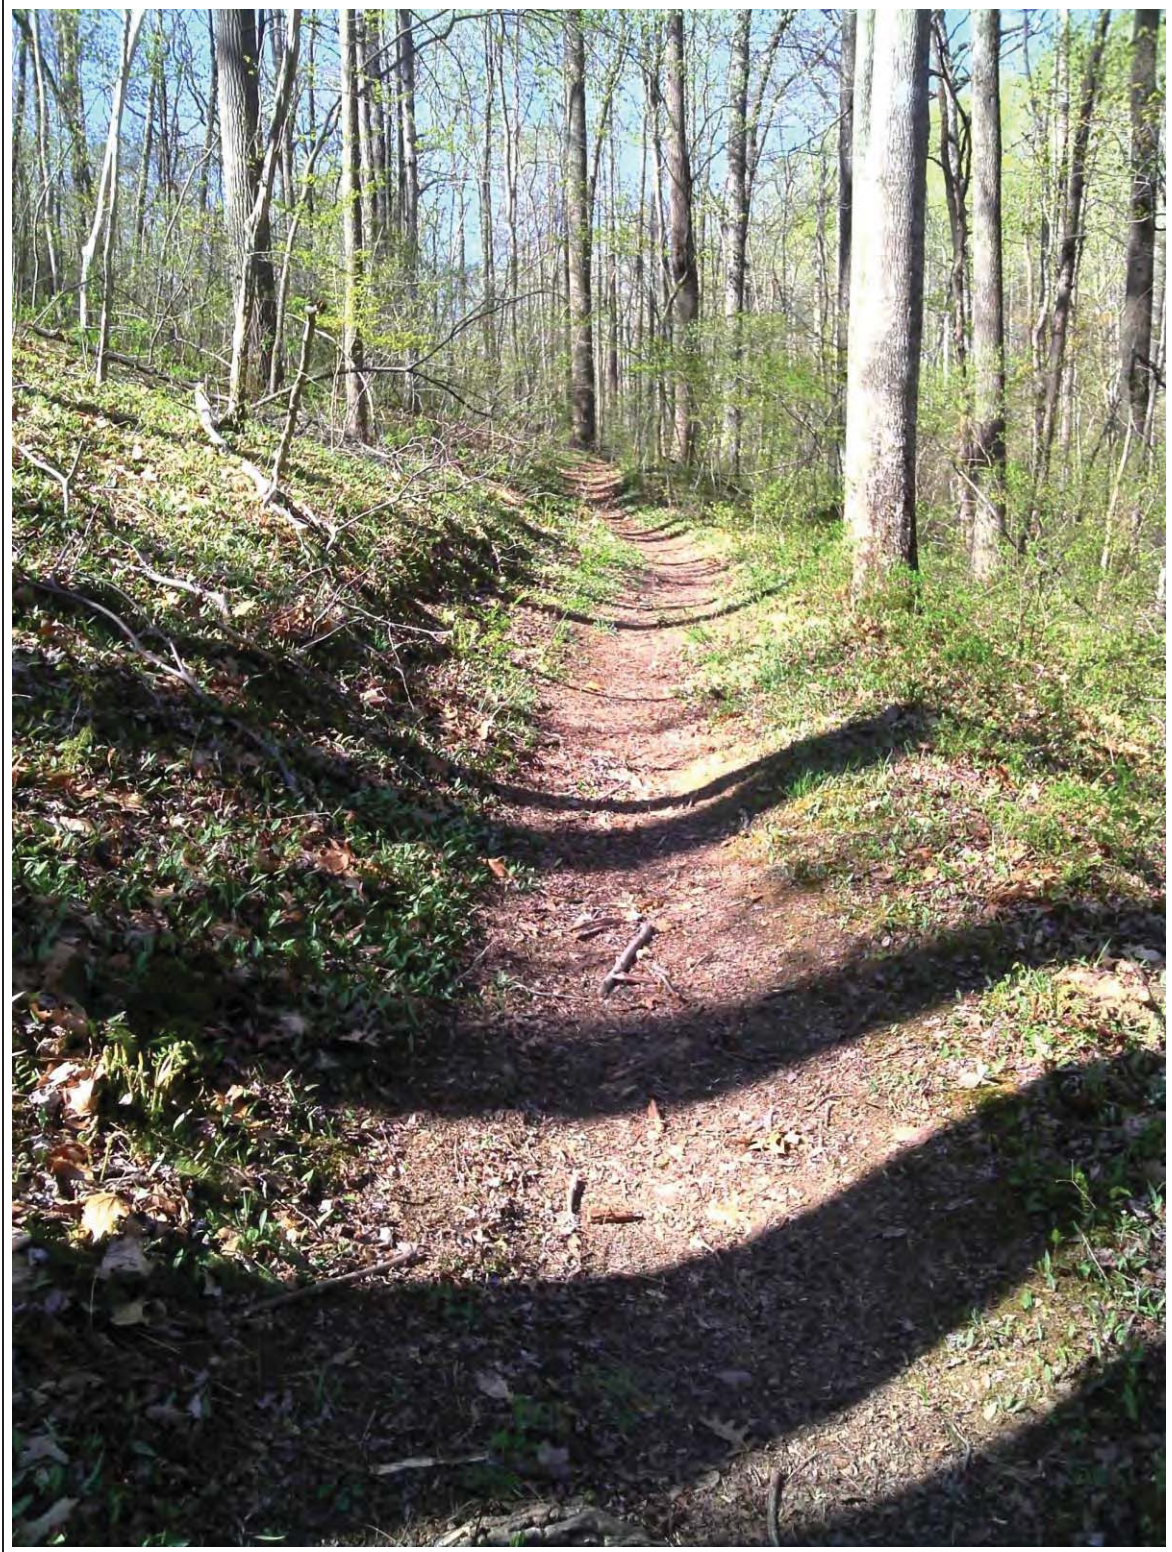
Photo 5-4: Ednor Lane slope and channelized erosion

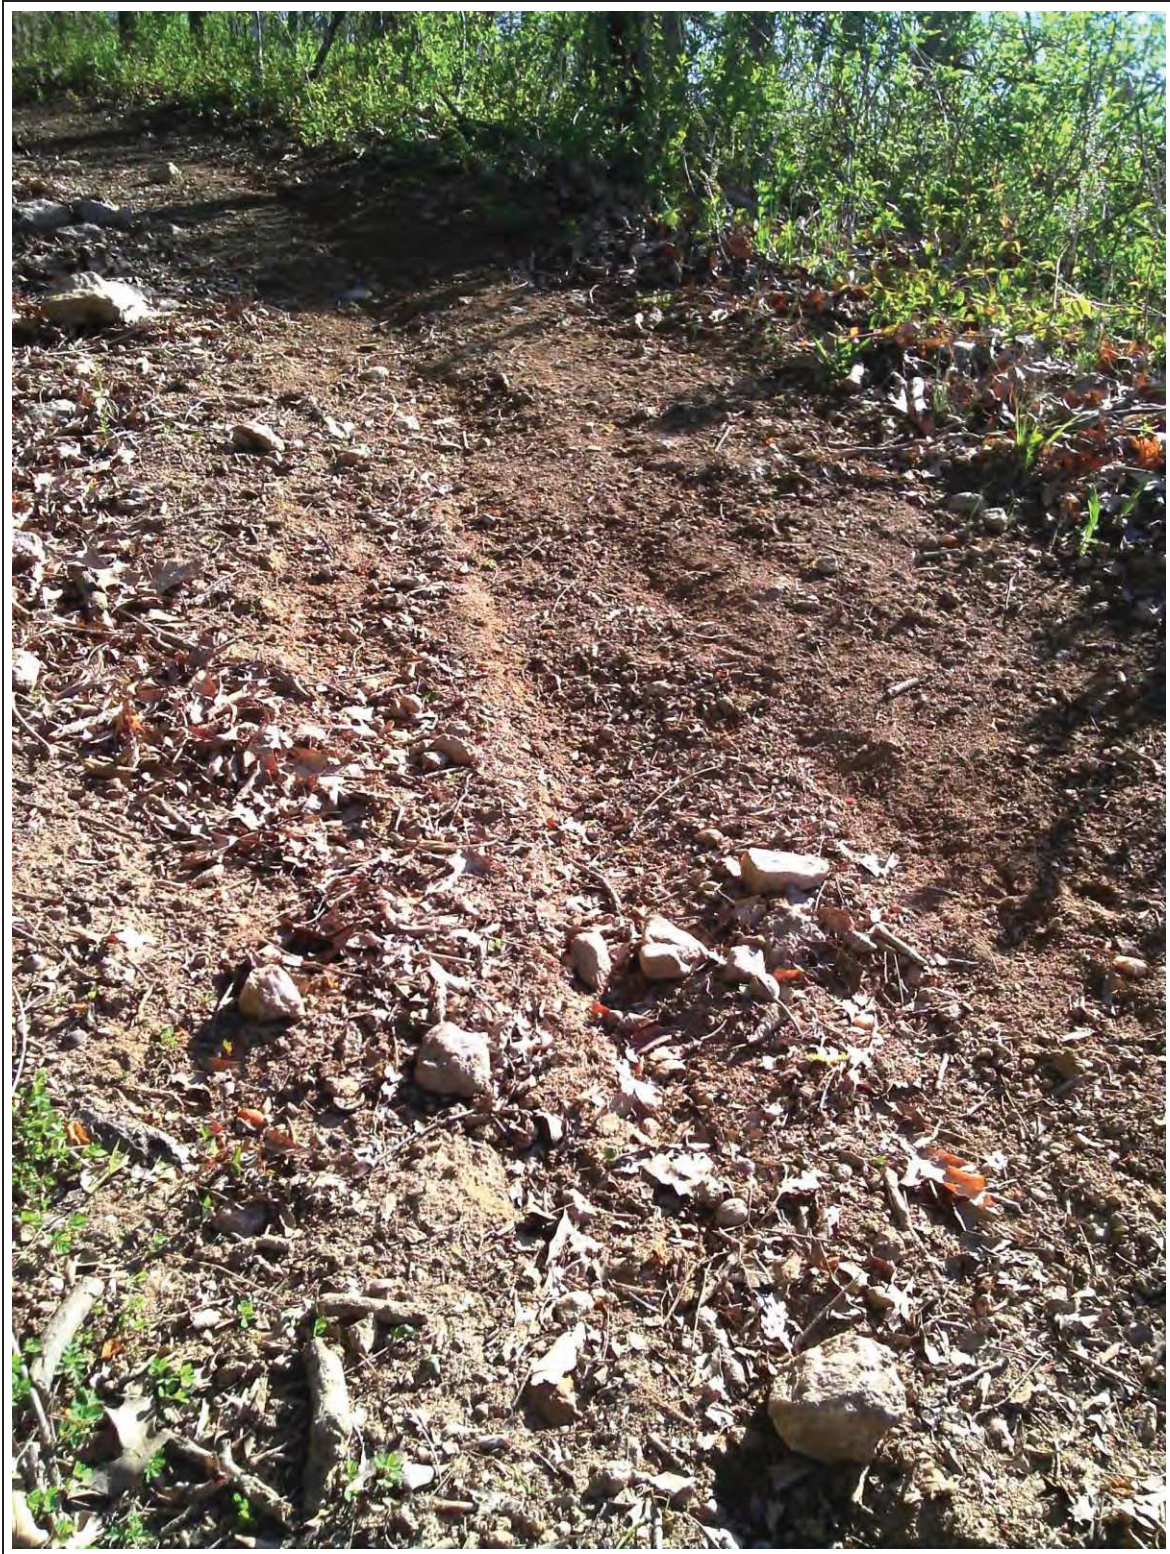
Photo 5-7: Brown's Bridge Recreation Area - North Bank motorcycle tracks caused rutting on the fairly steep slope

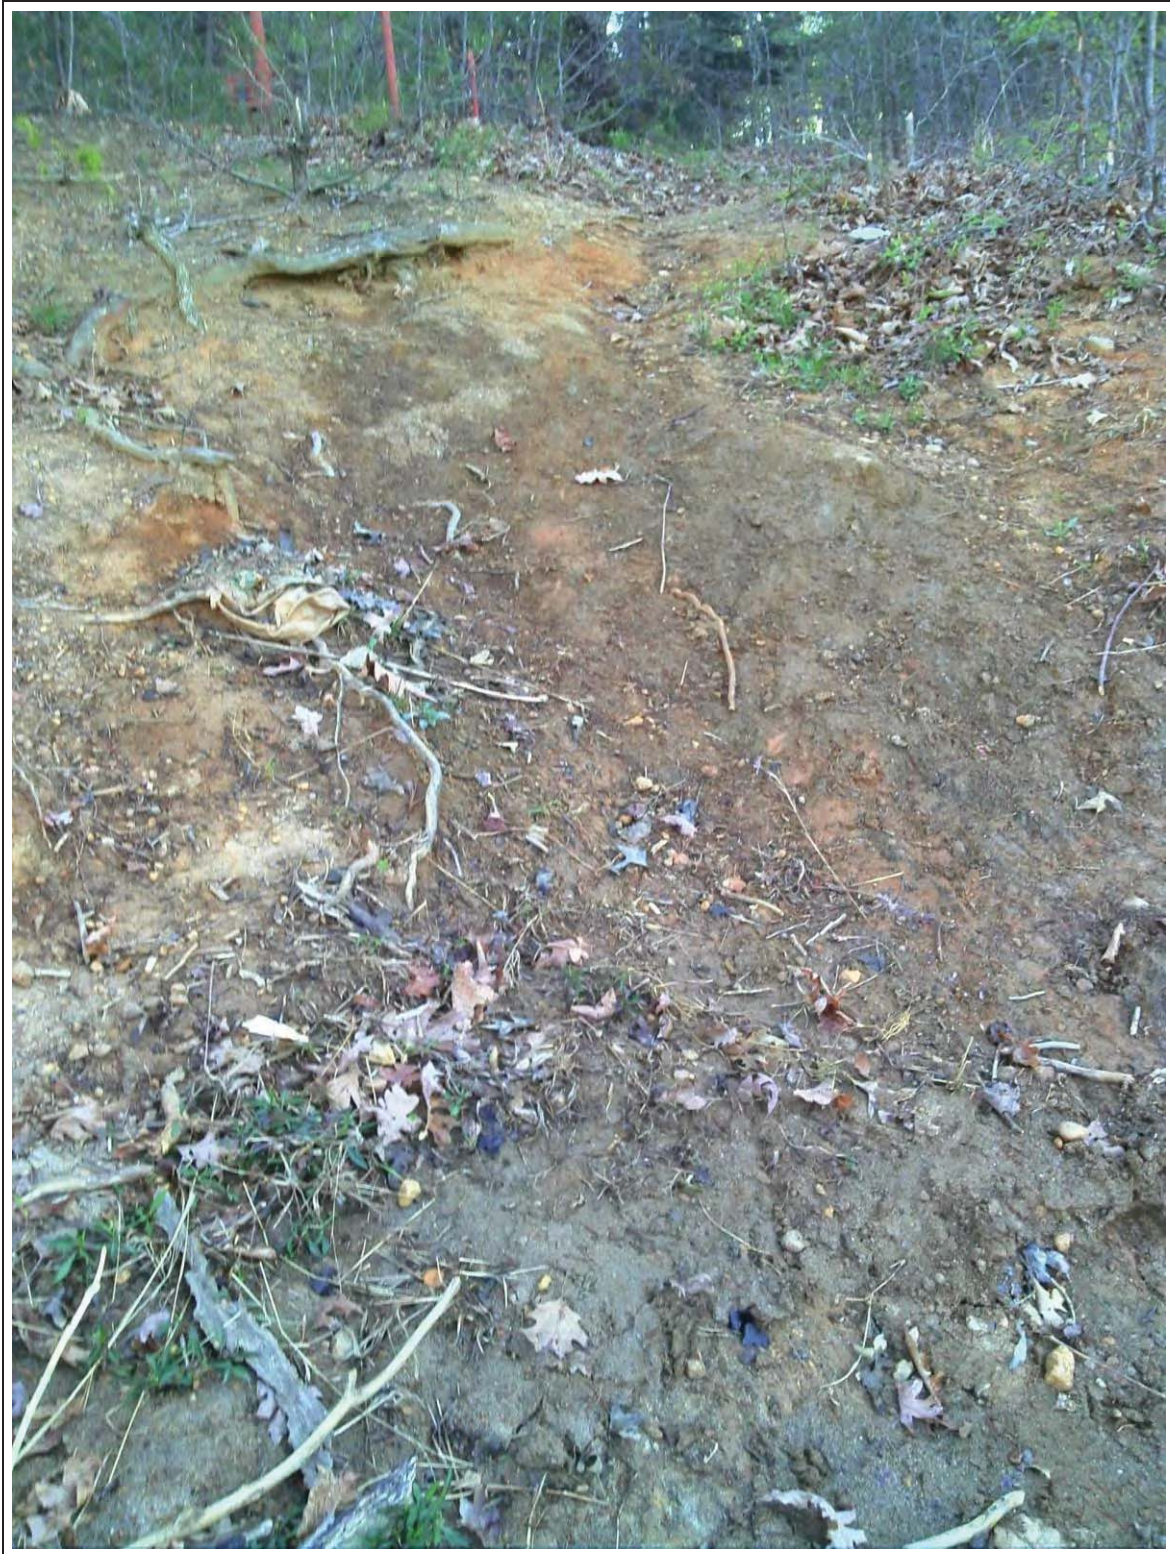
Photo 5-8: Brown's Bridge Recreation Area - North Bank exposed roots

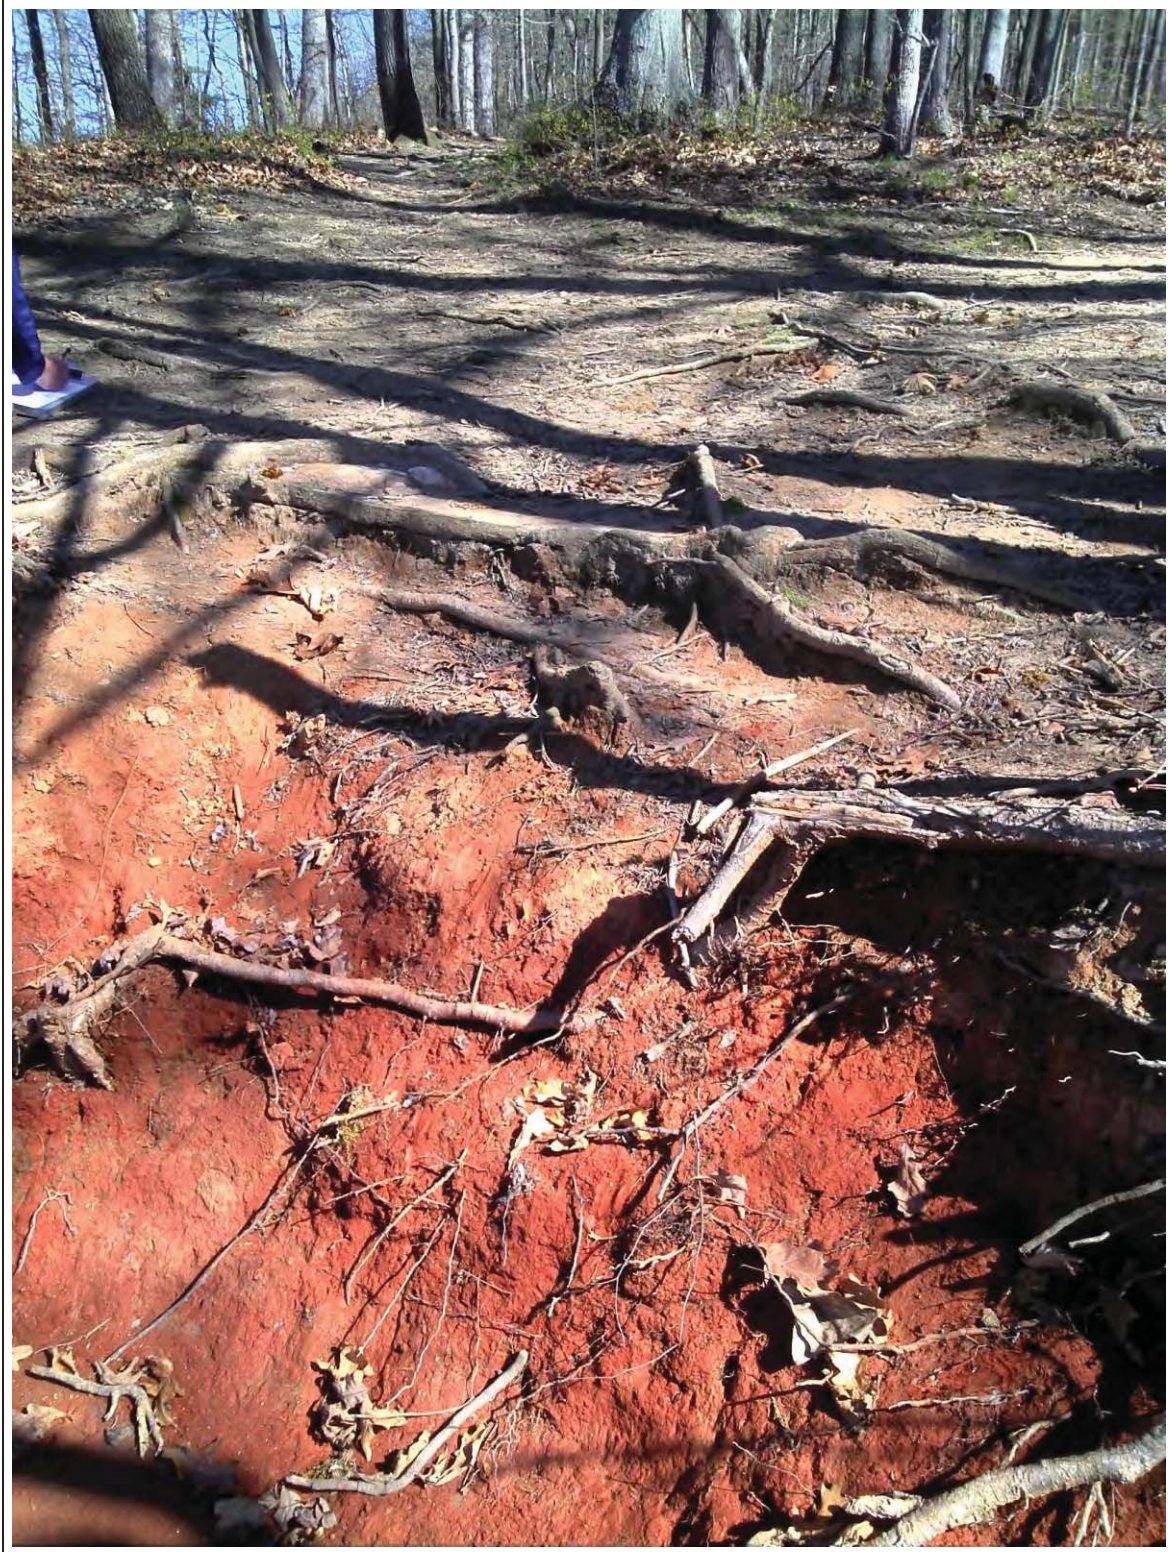
Photo 5-9: Brown's Bridge Recreation Area - North Bank shoreline collapsed area of red soil

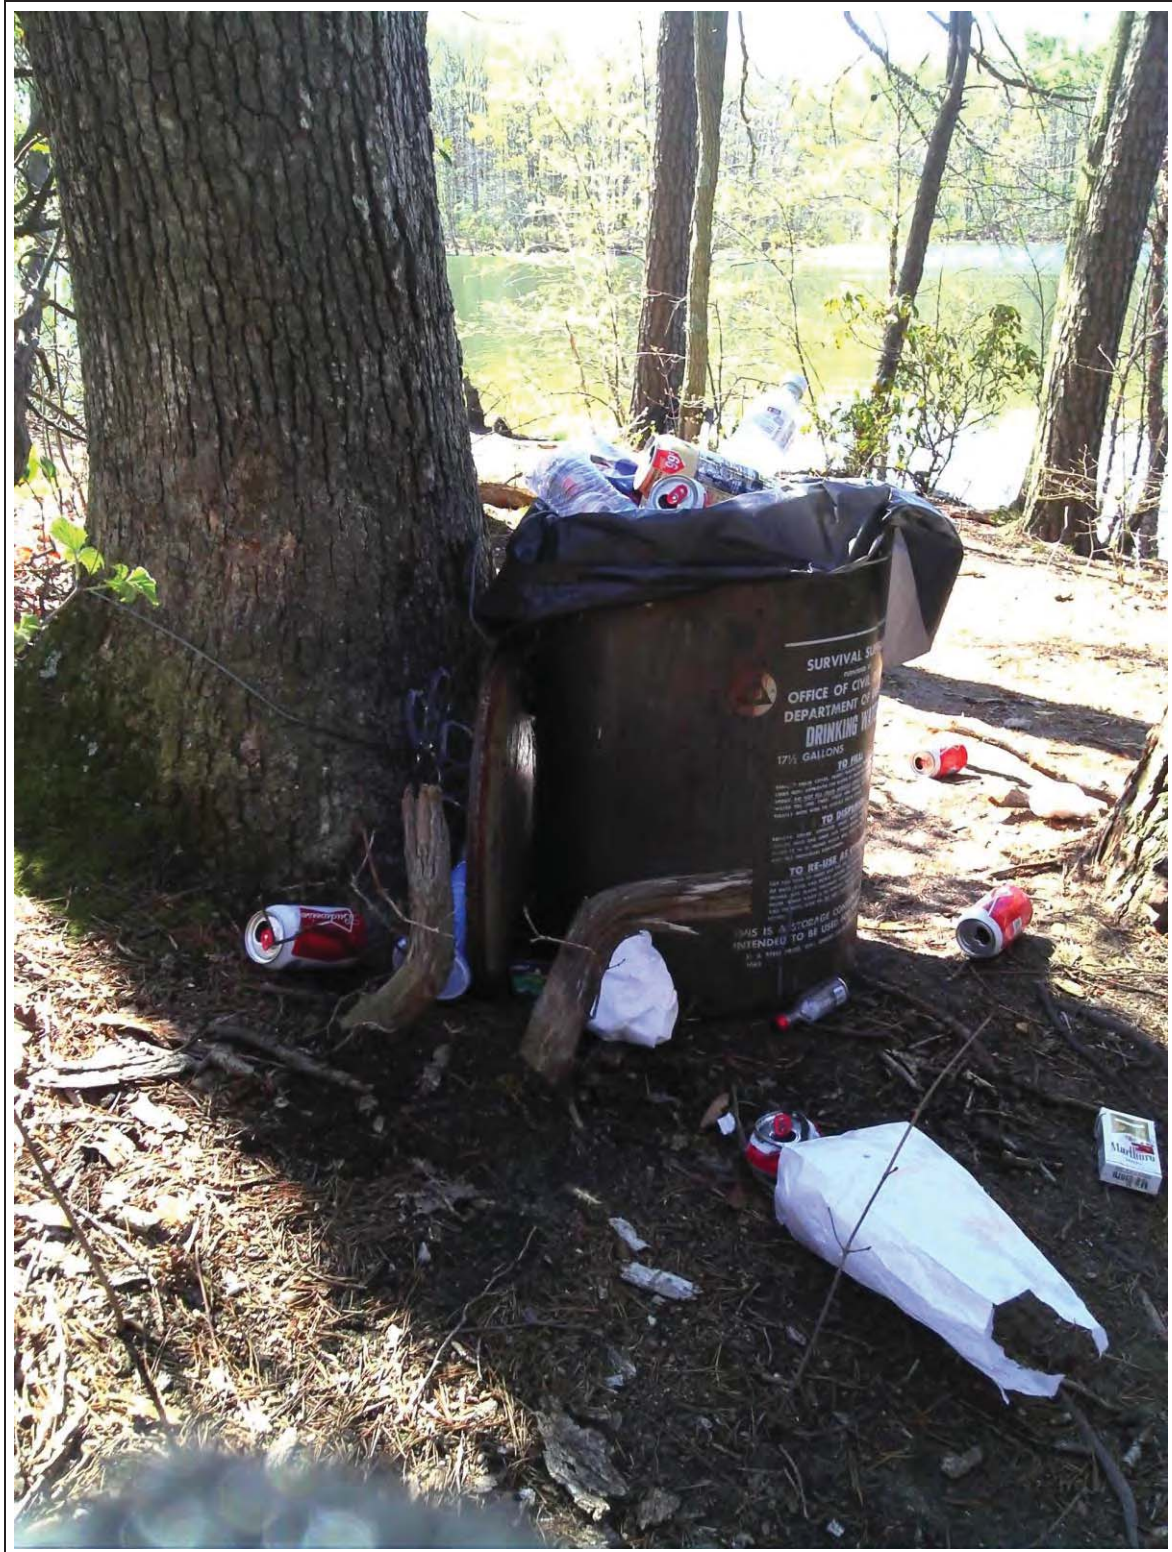
Photo 5-10: Brown's Bridge Recreation Area - North Bank overflowing trashcan

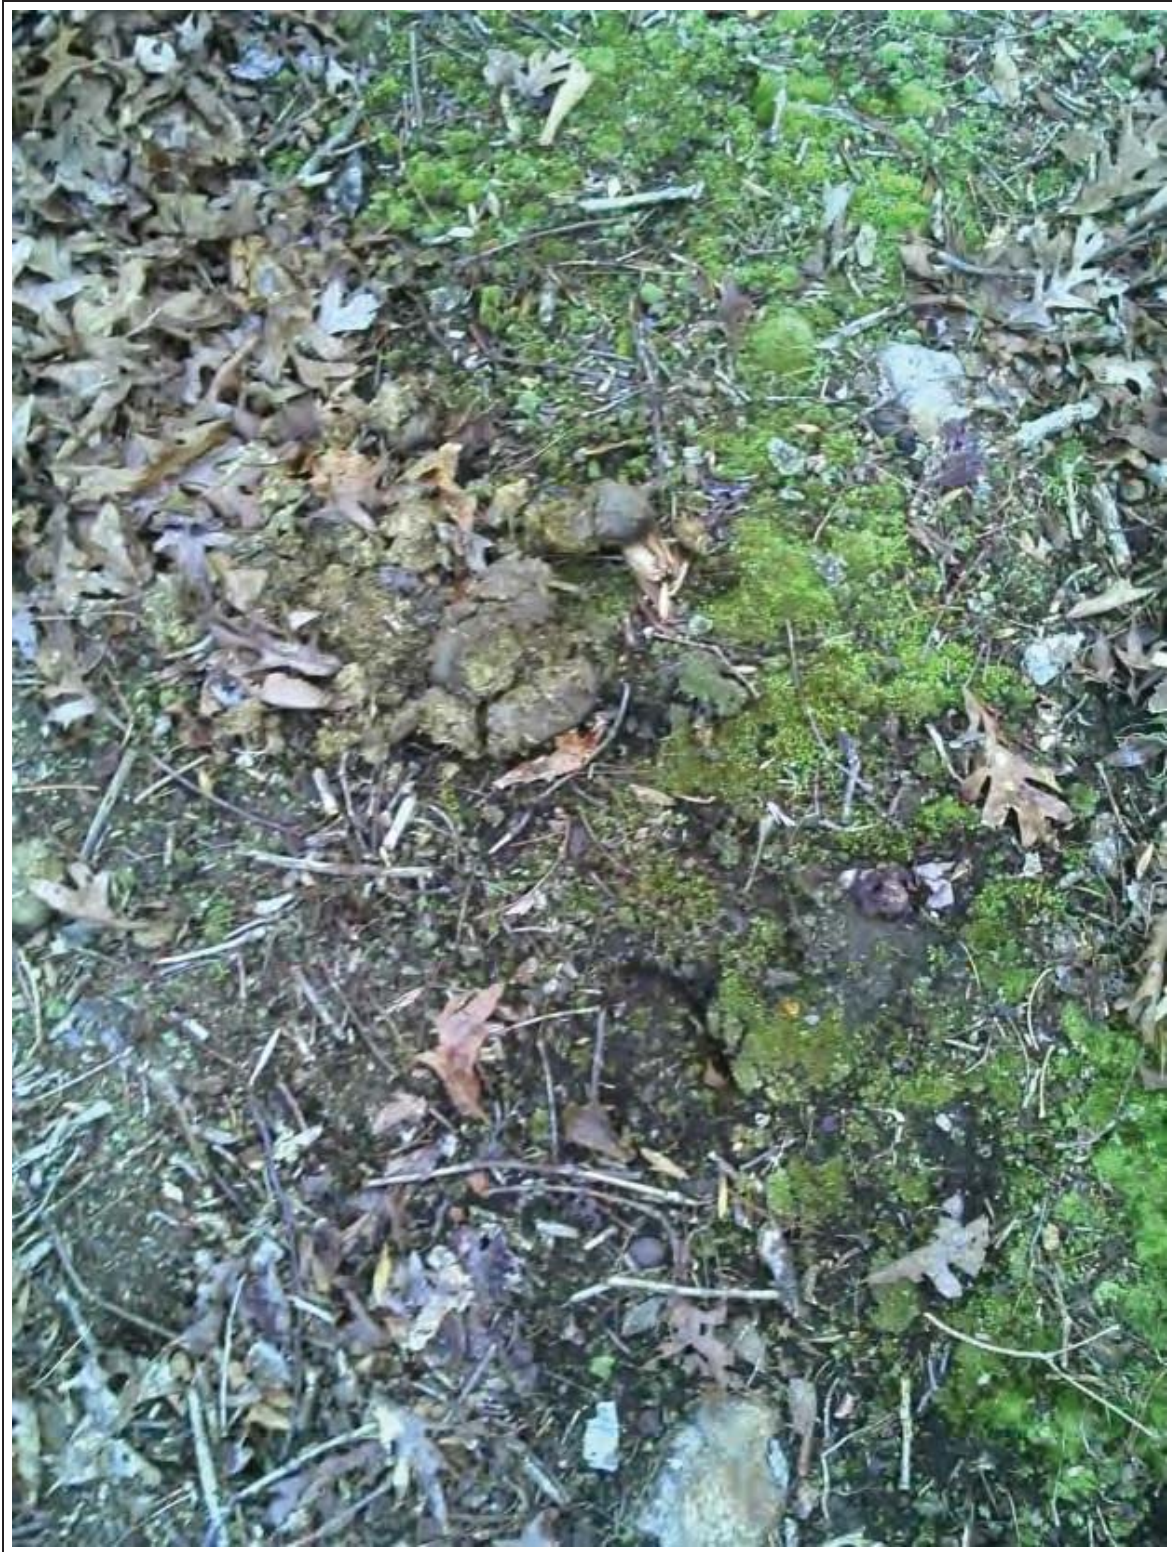
Photo 5-12: Scotts Cove West Shoreline Trail manure on trail

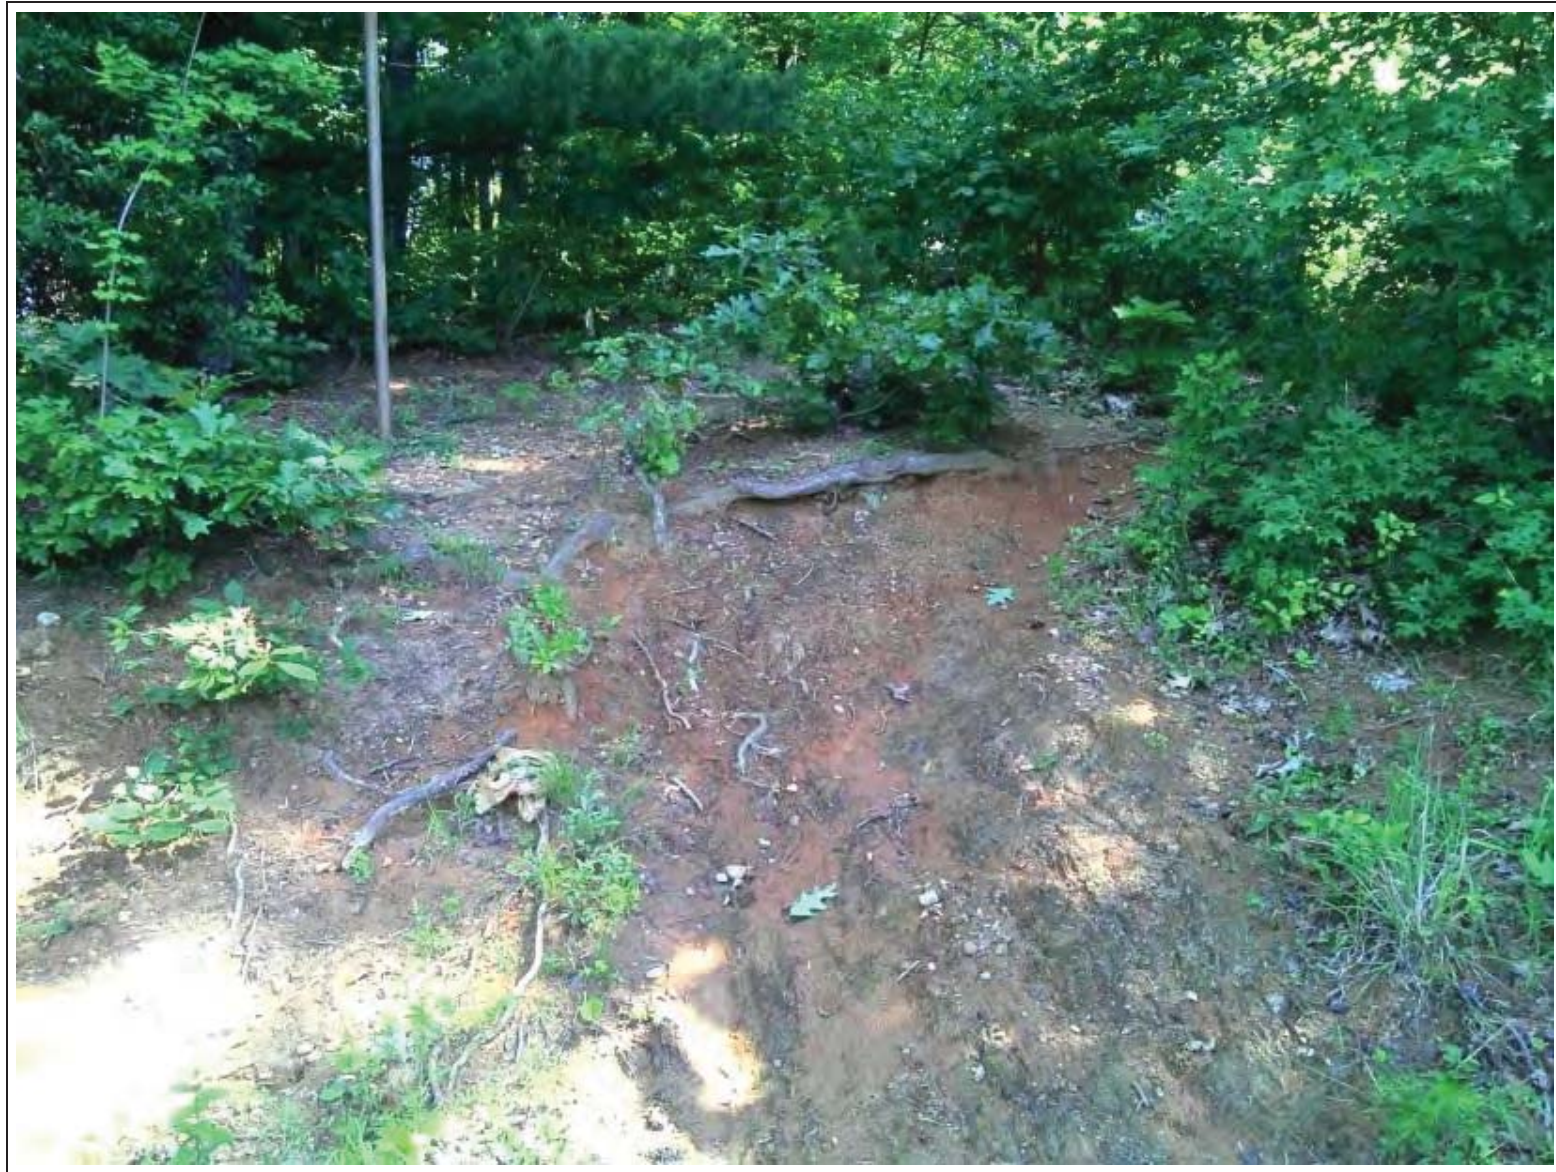
Photo 5-13: Scotts Cove West Utility Trail erosion

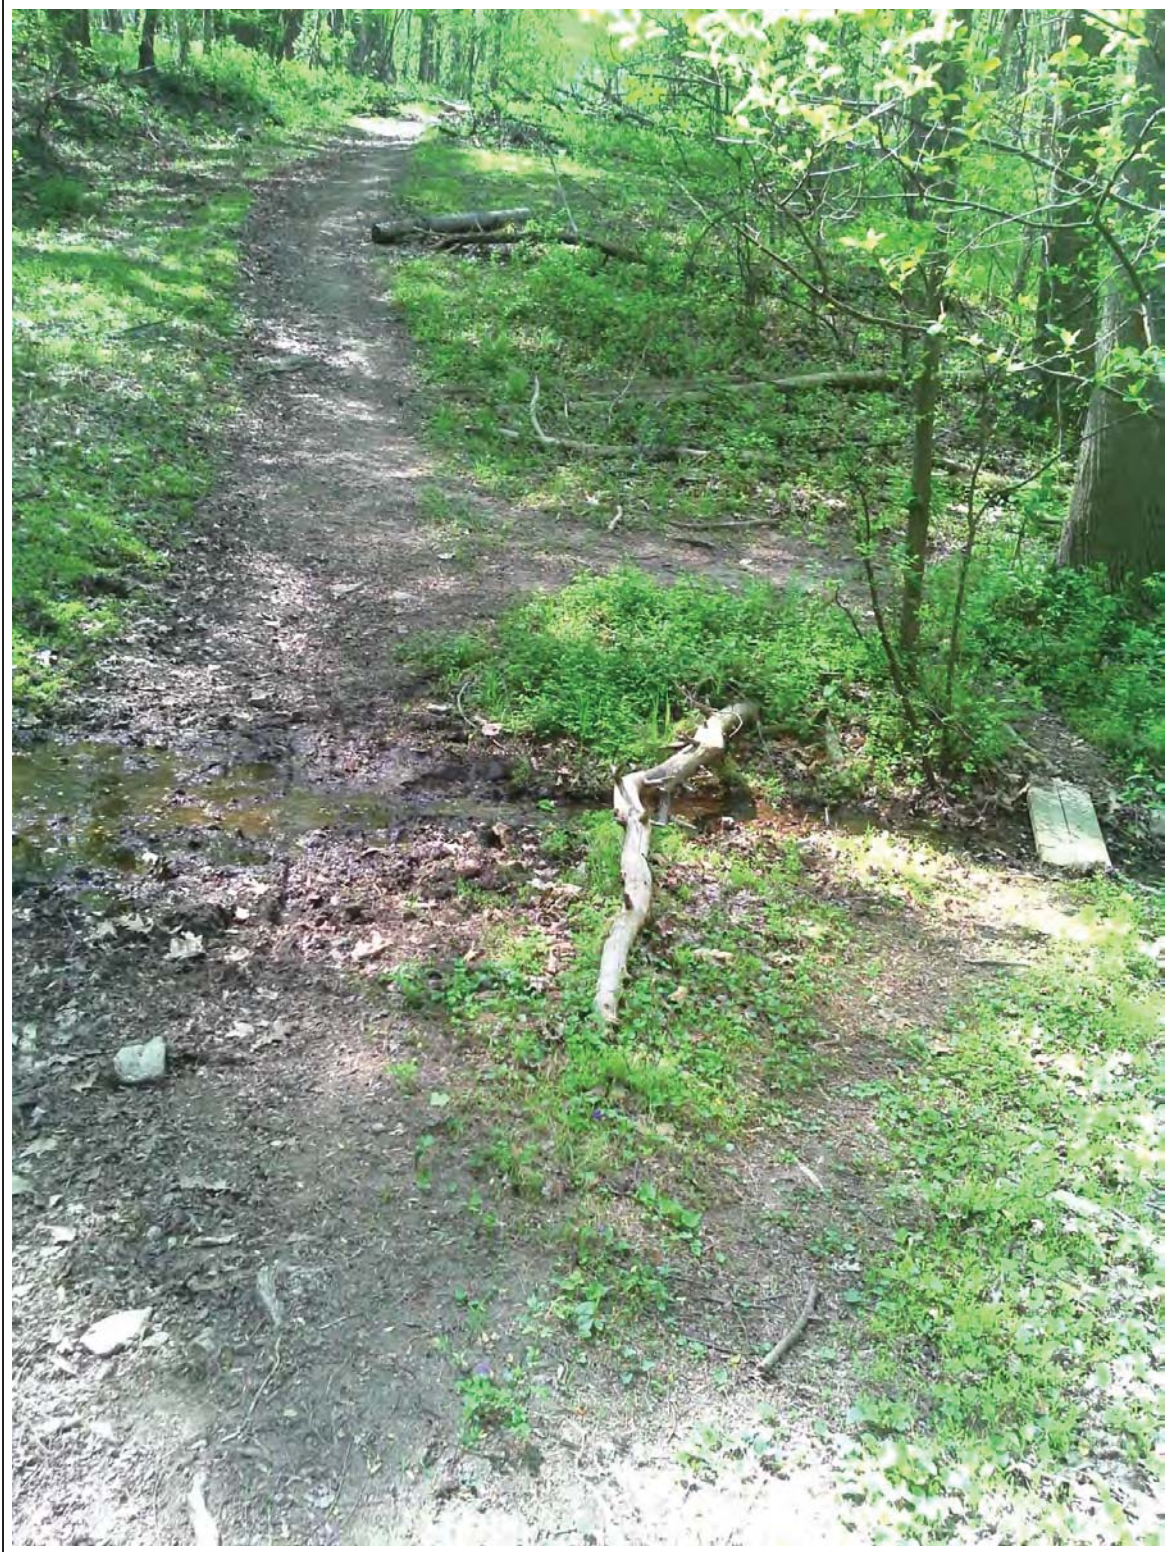
Photo 5-15: Terry Ledley Equestrian Trail stream crossing.

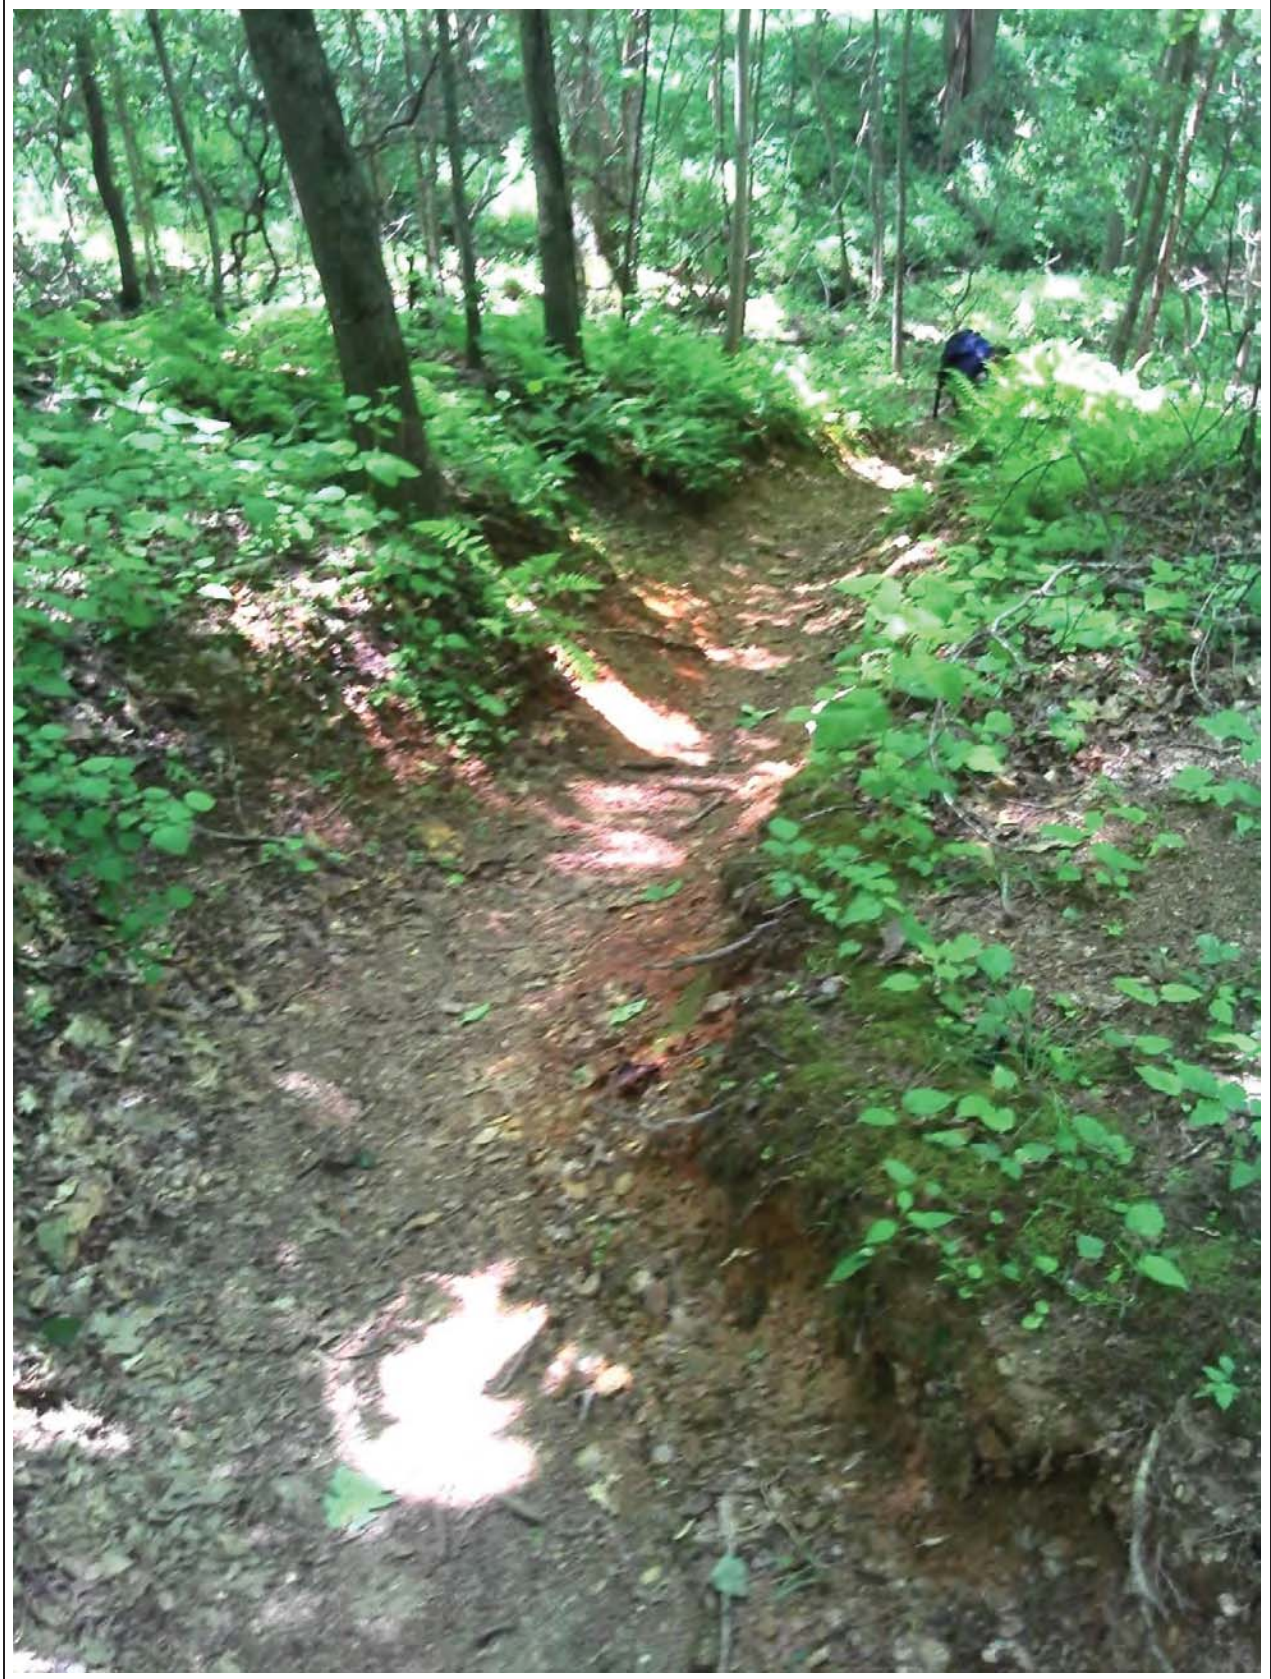
Photo 5-19: Pat Oliva Trail section eroded due to poor trail alignment

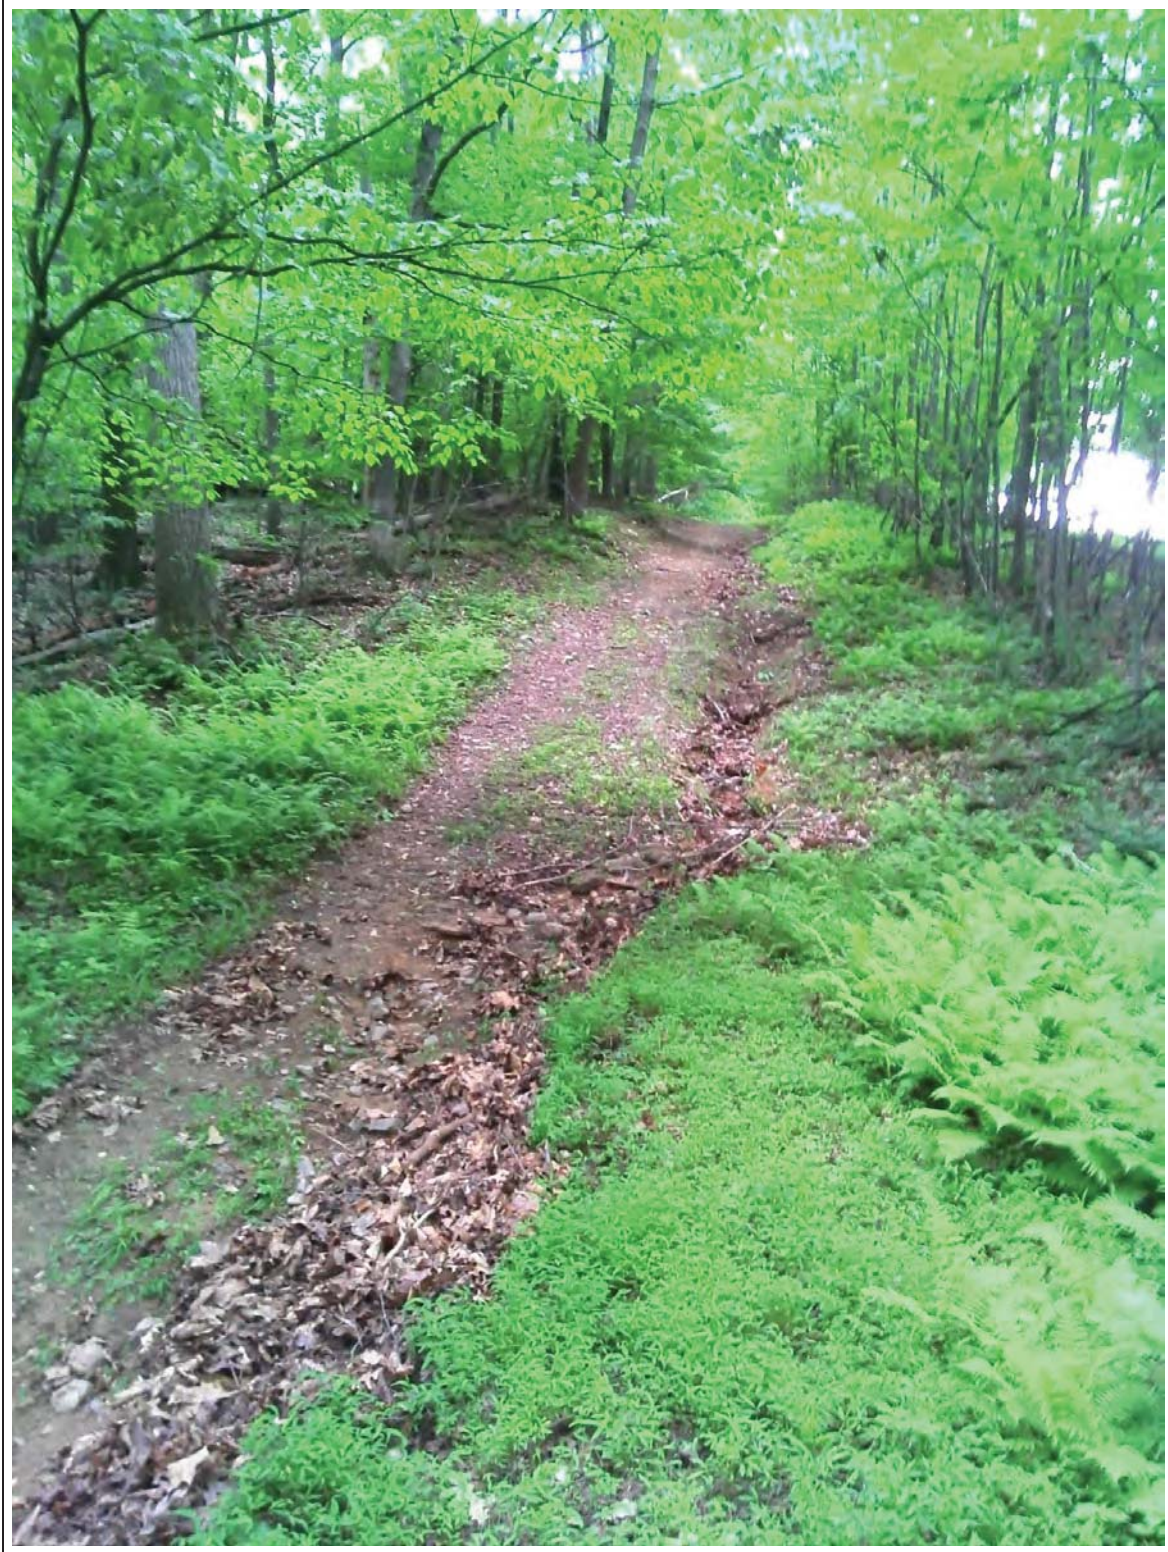
Photo 5-21: Pat Oliva Trail channelized erosion
