Study Results, Observations, and Recommendations

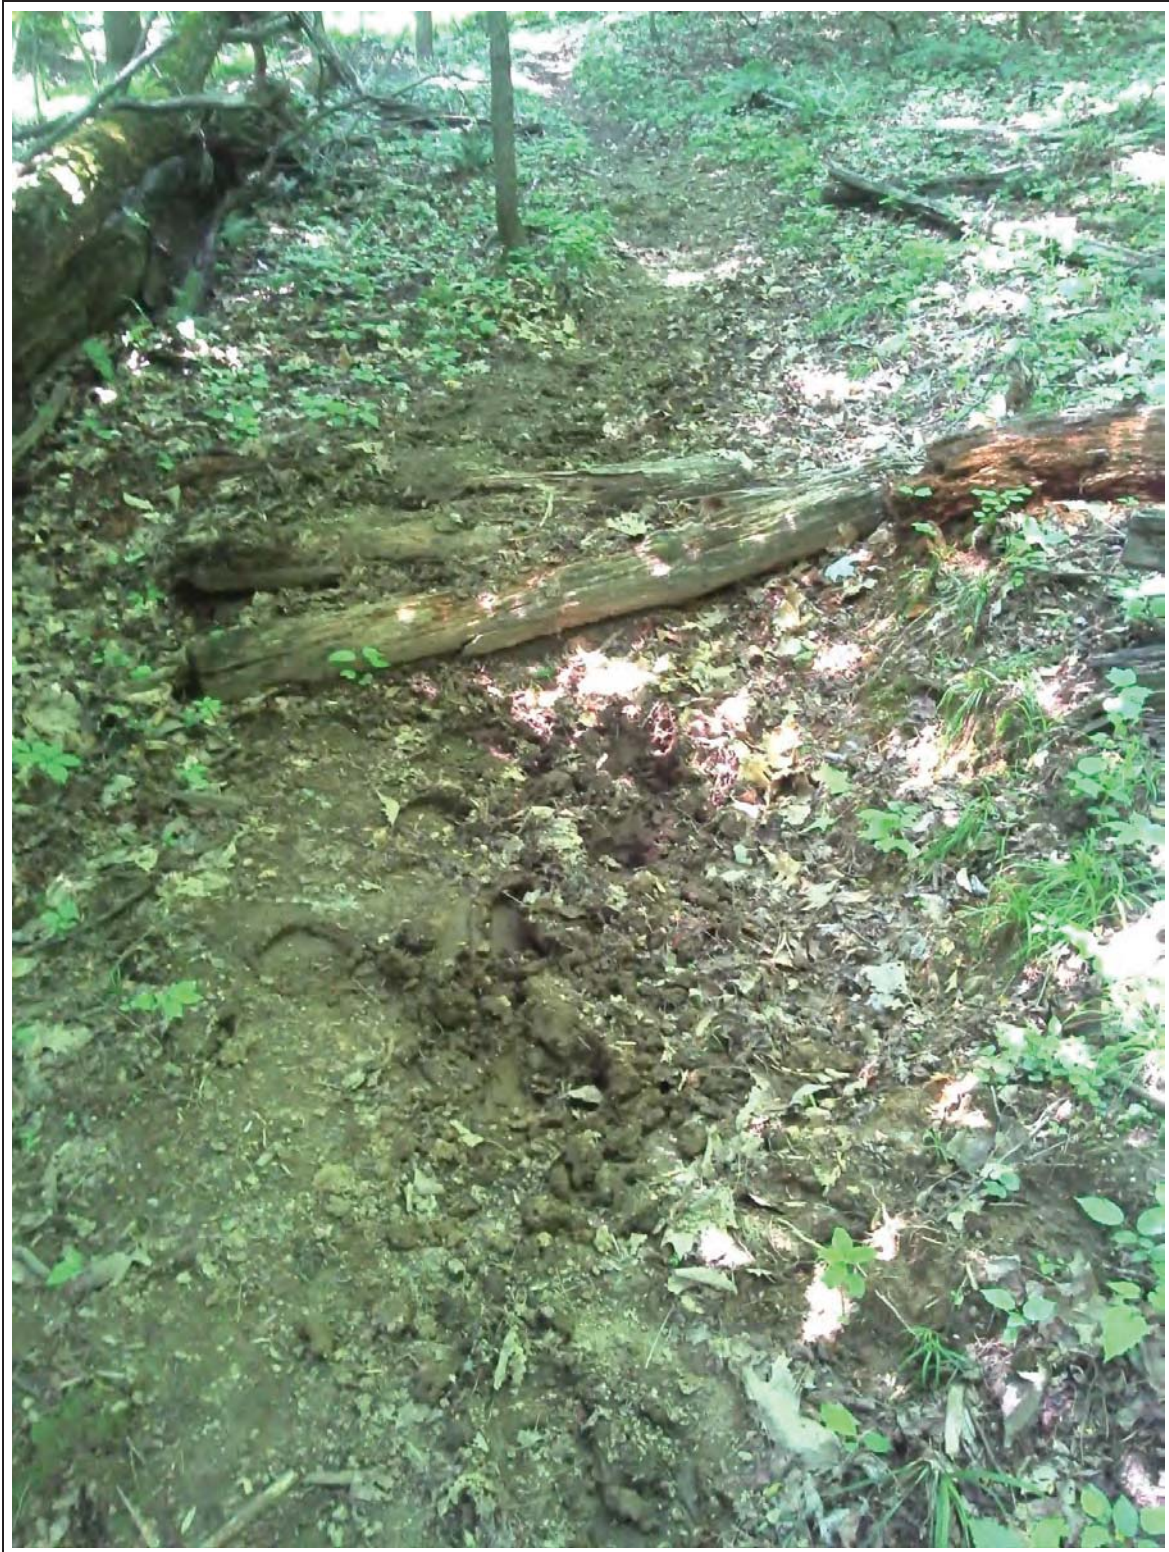
Photo 5-23: Pat Oliva Trail horse tracks and disturbed soil

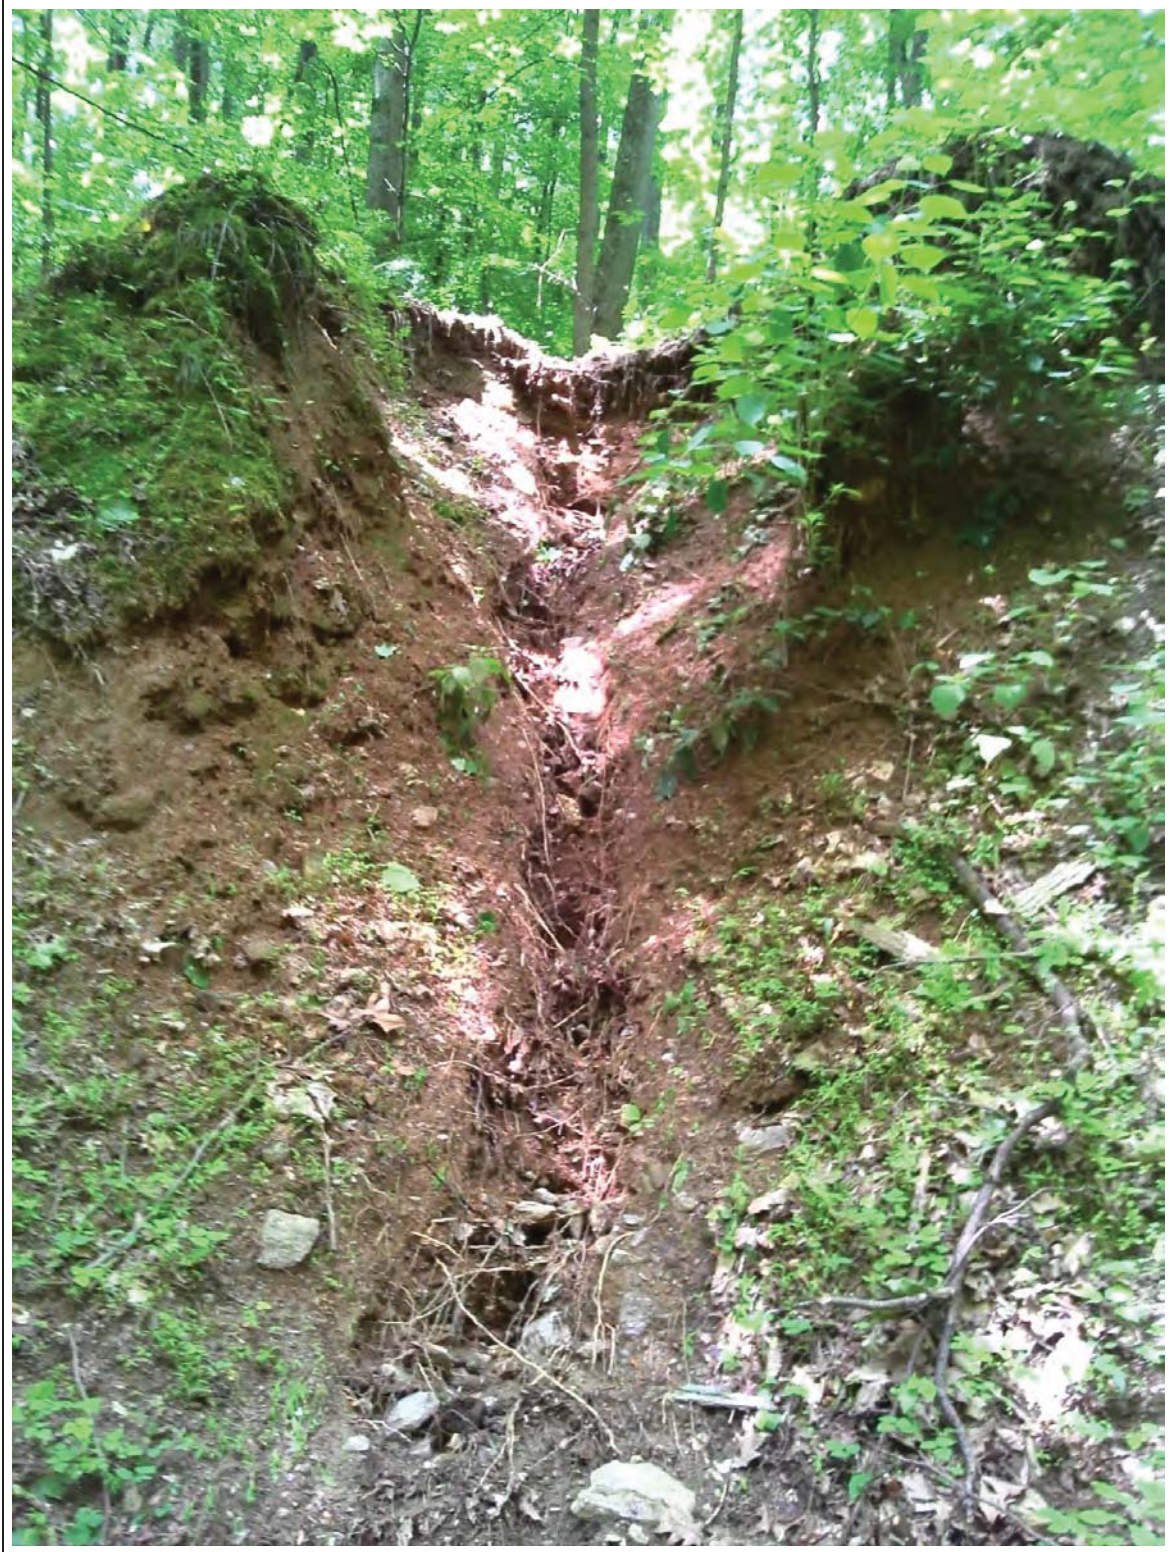
Photo 5-25: Washout area within Section 5 of the Access Road

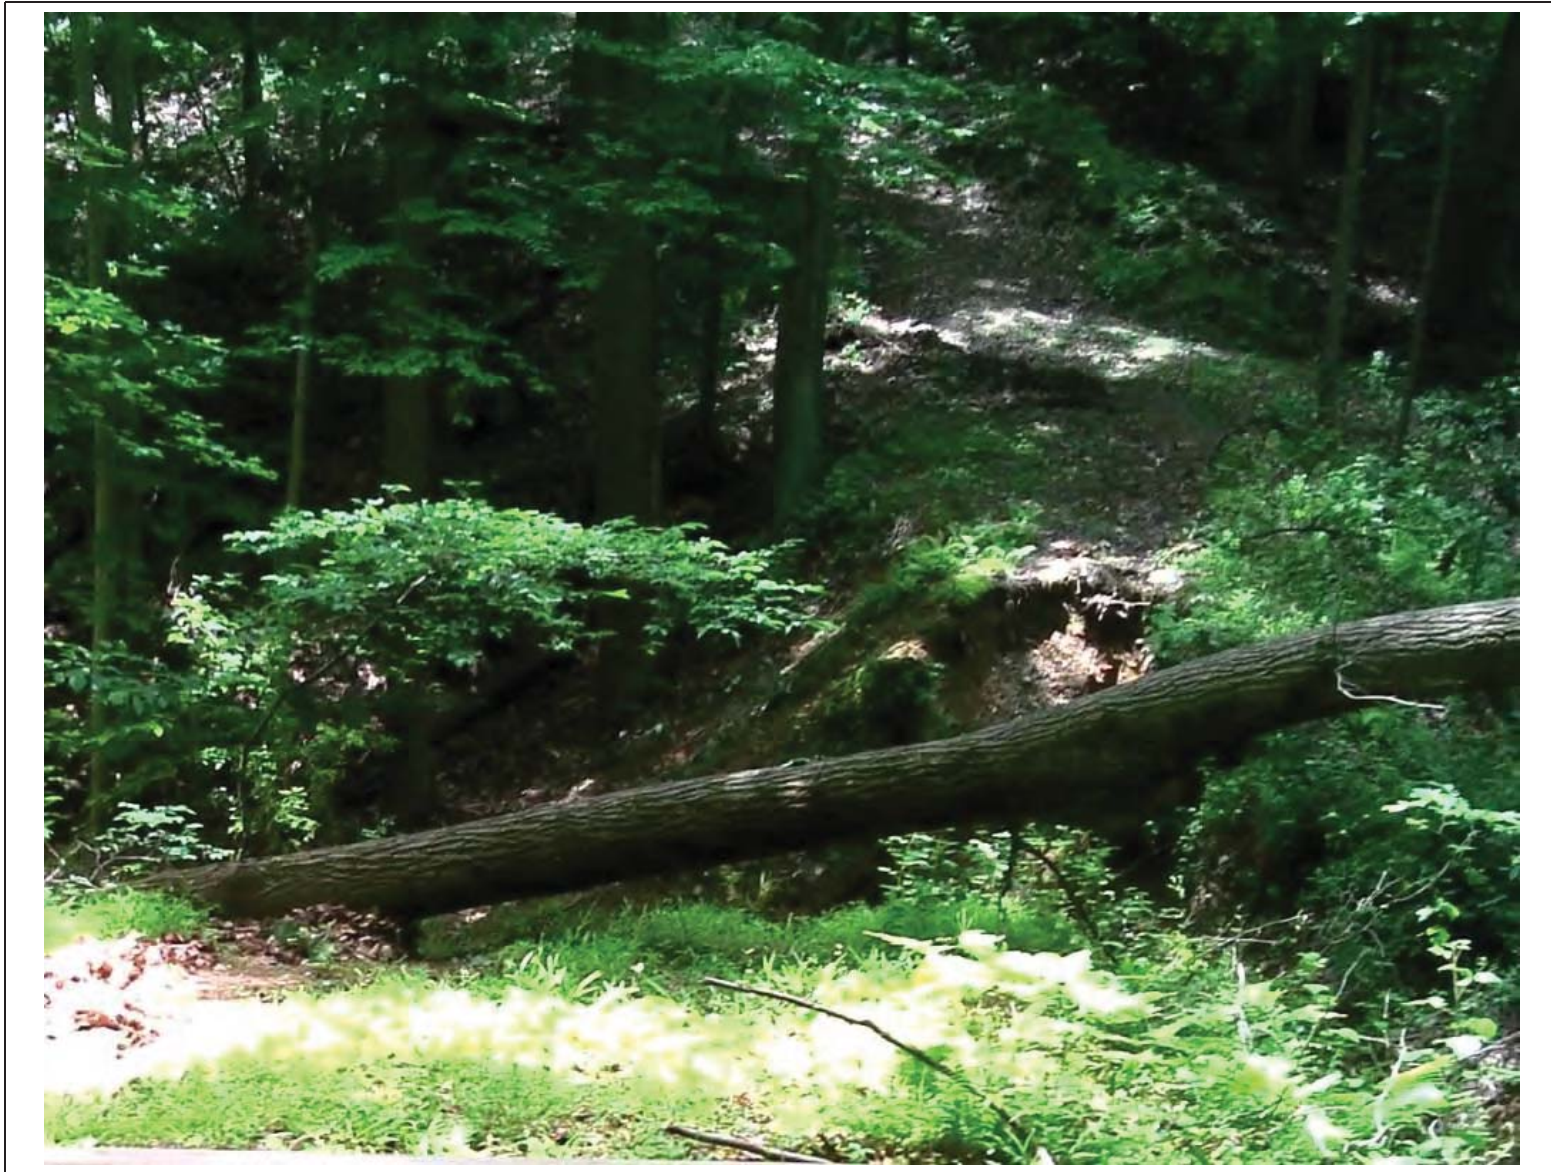
Photo 5-26: Washout area within Section 5 of the Access Road

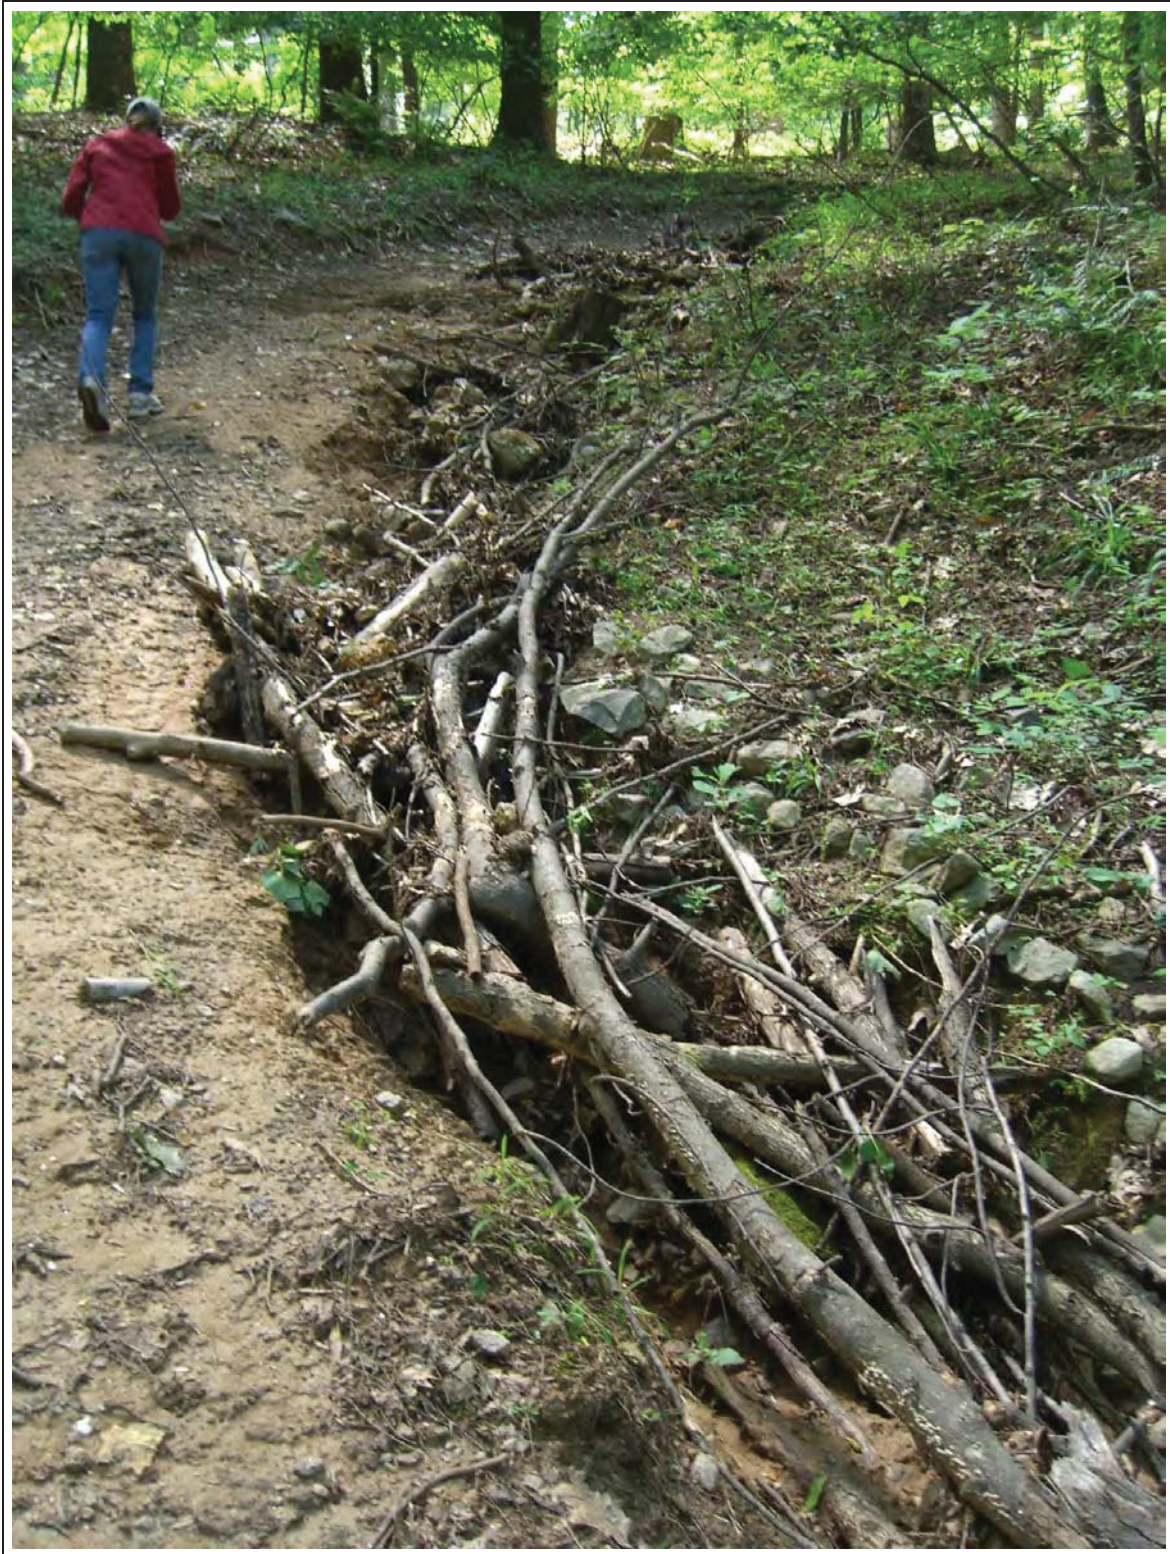
Photo 5-27: Section 6 steep hill with deep erosion/gully.

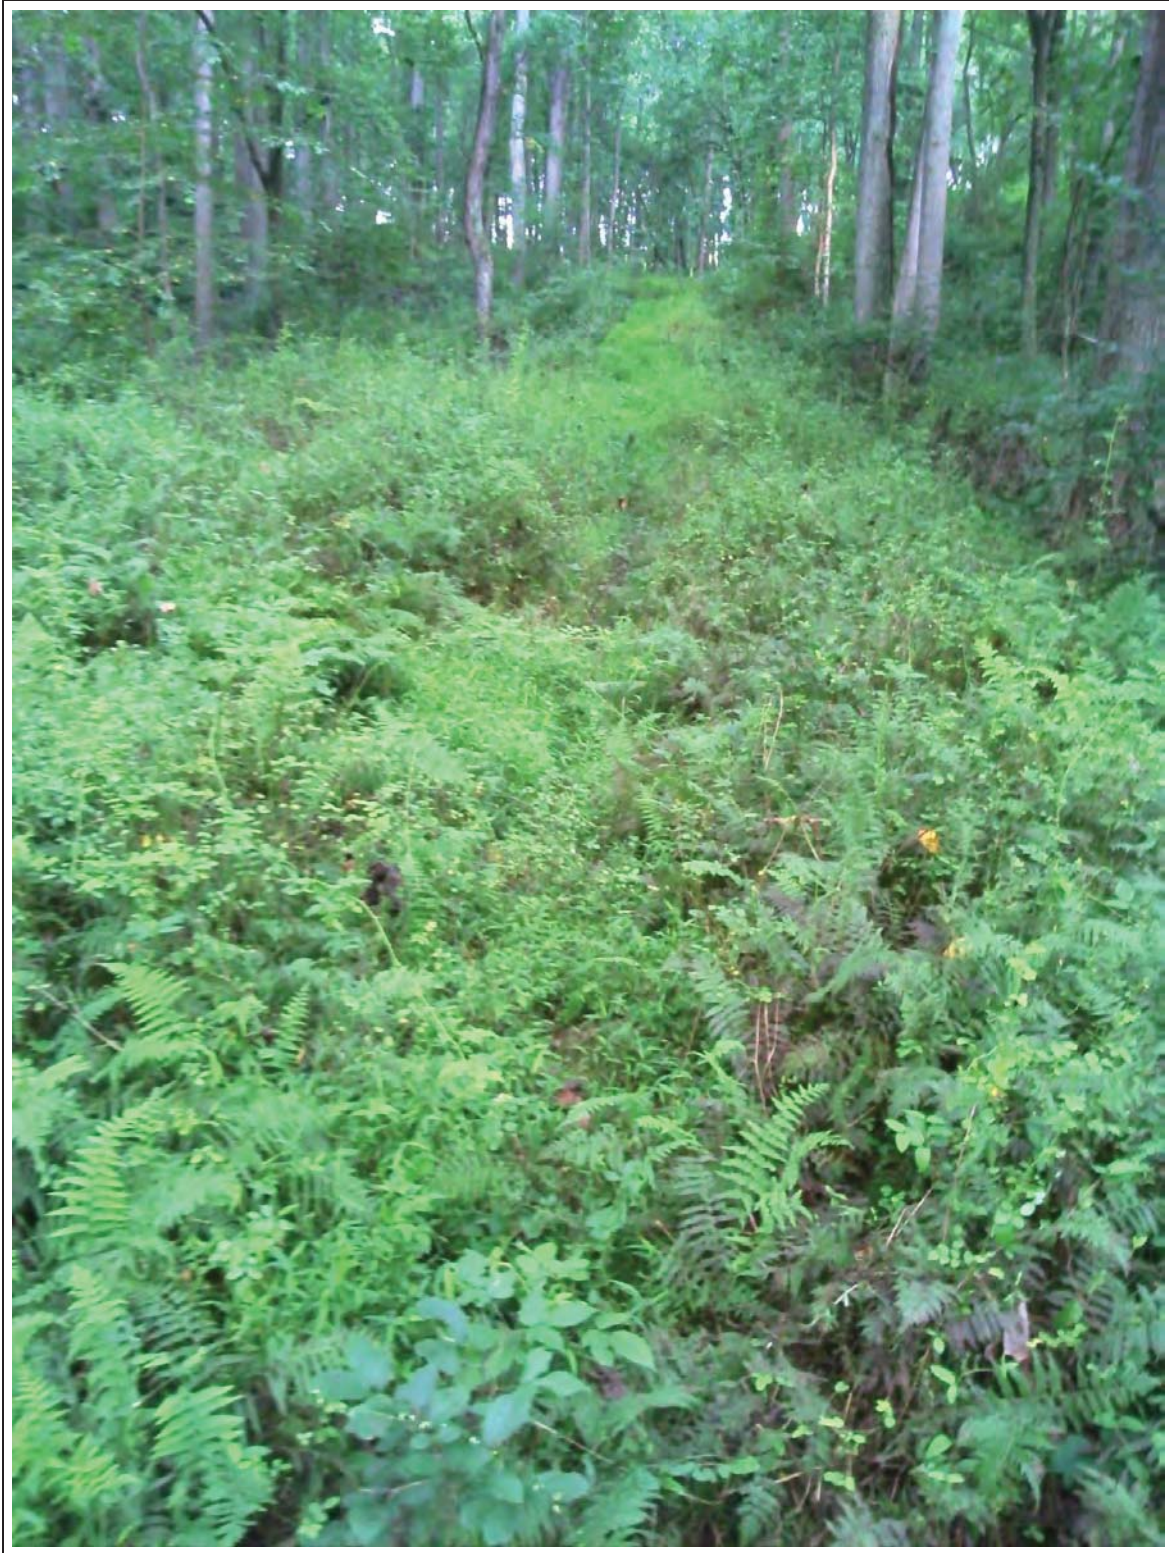
Photo 5-28: Harding Road Section with heavy vegetation

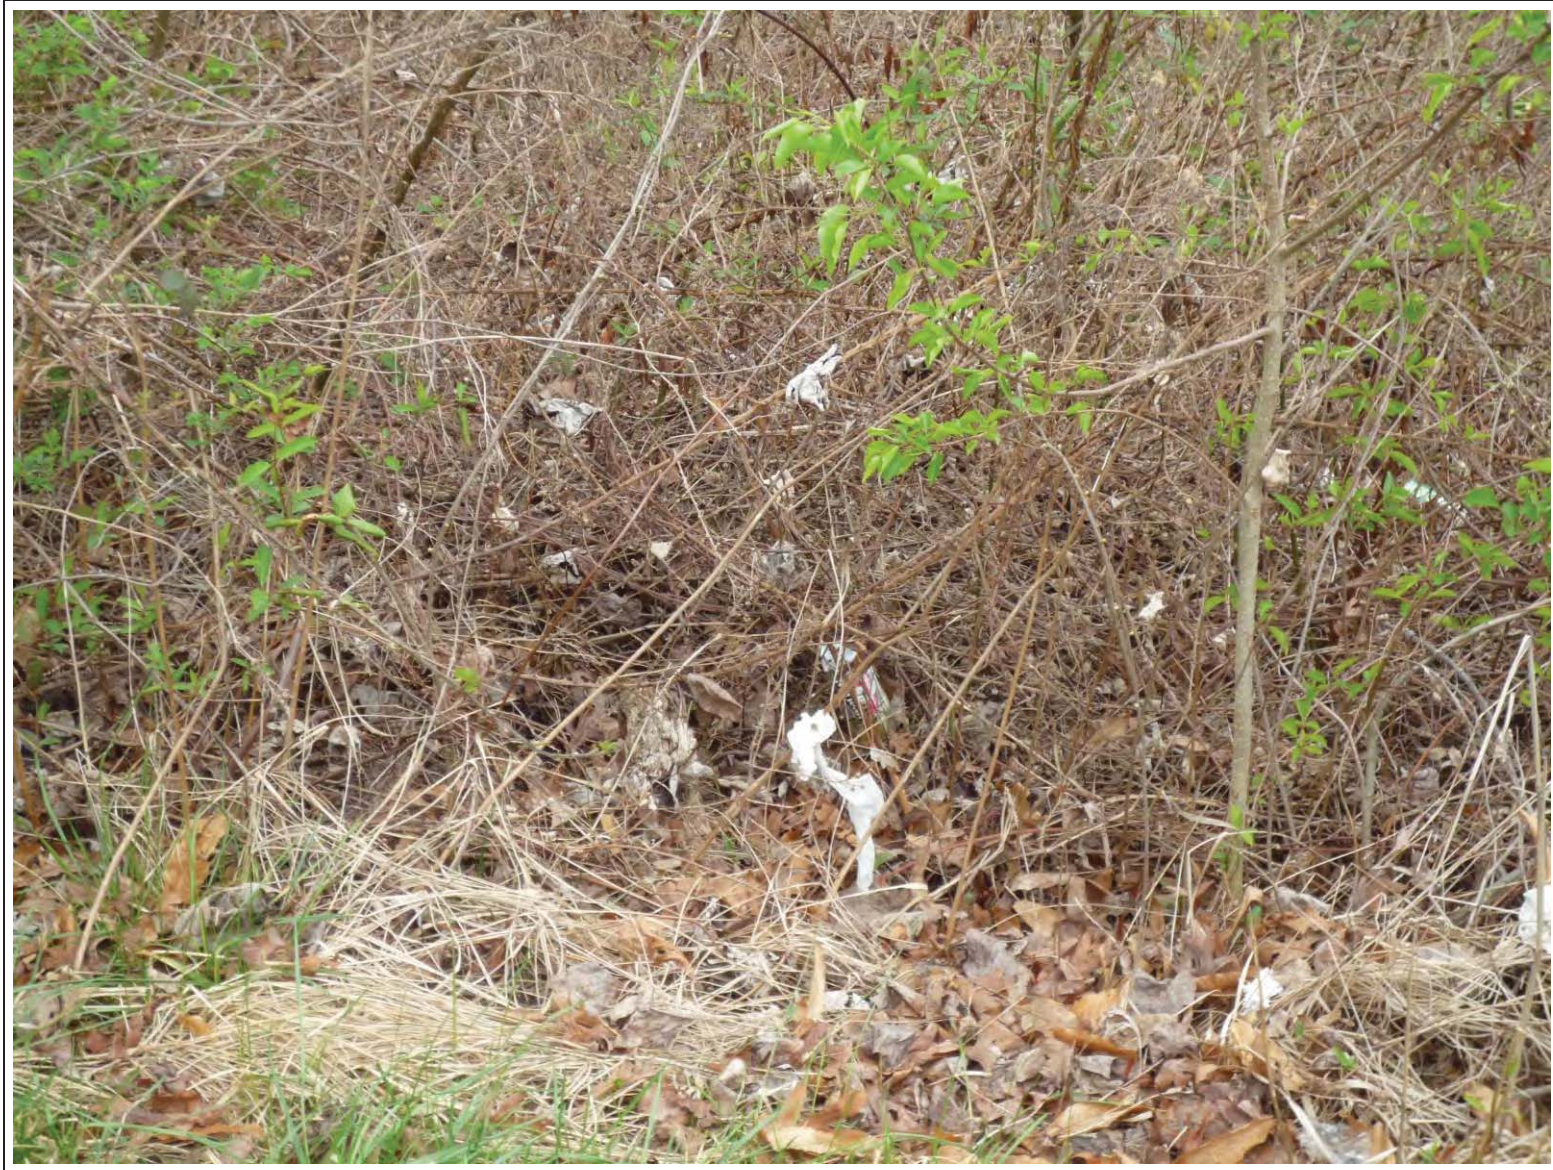
Photo 5-32: Triadelphia Recreational Area Shoreline and Interior Trails trash found along trail

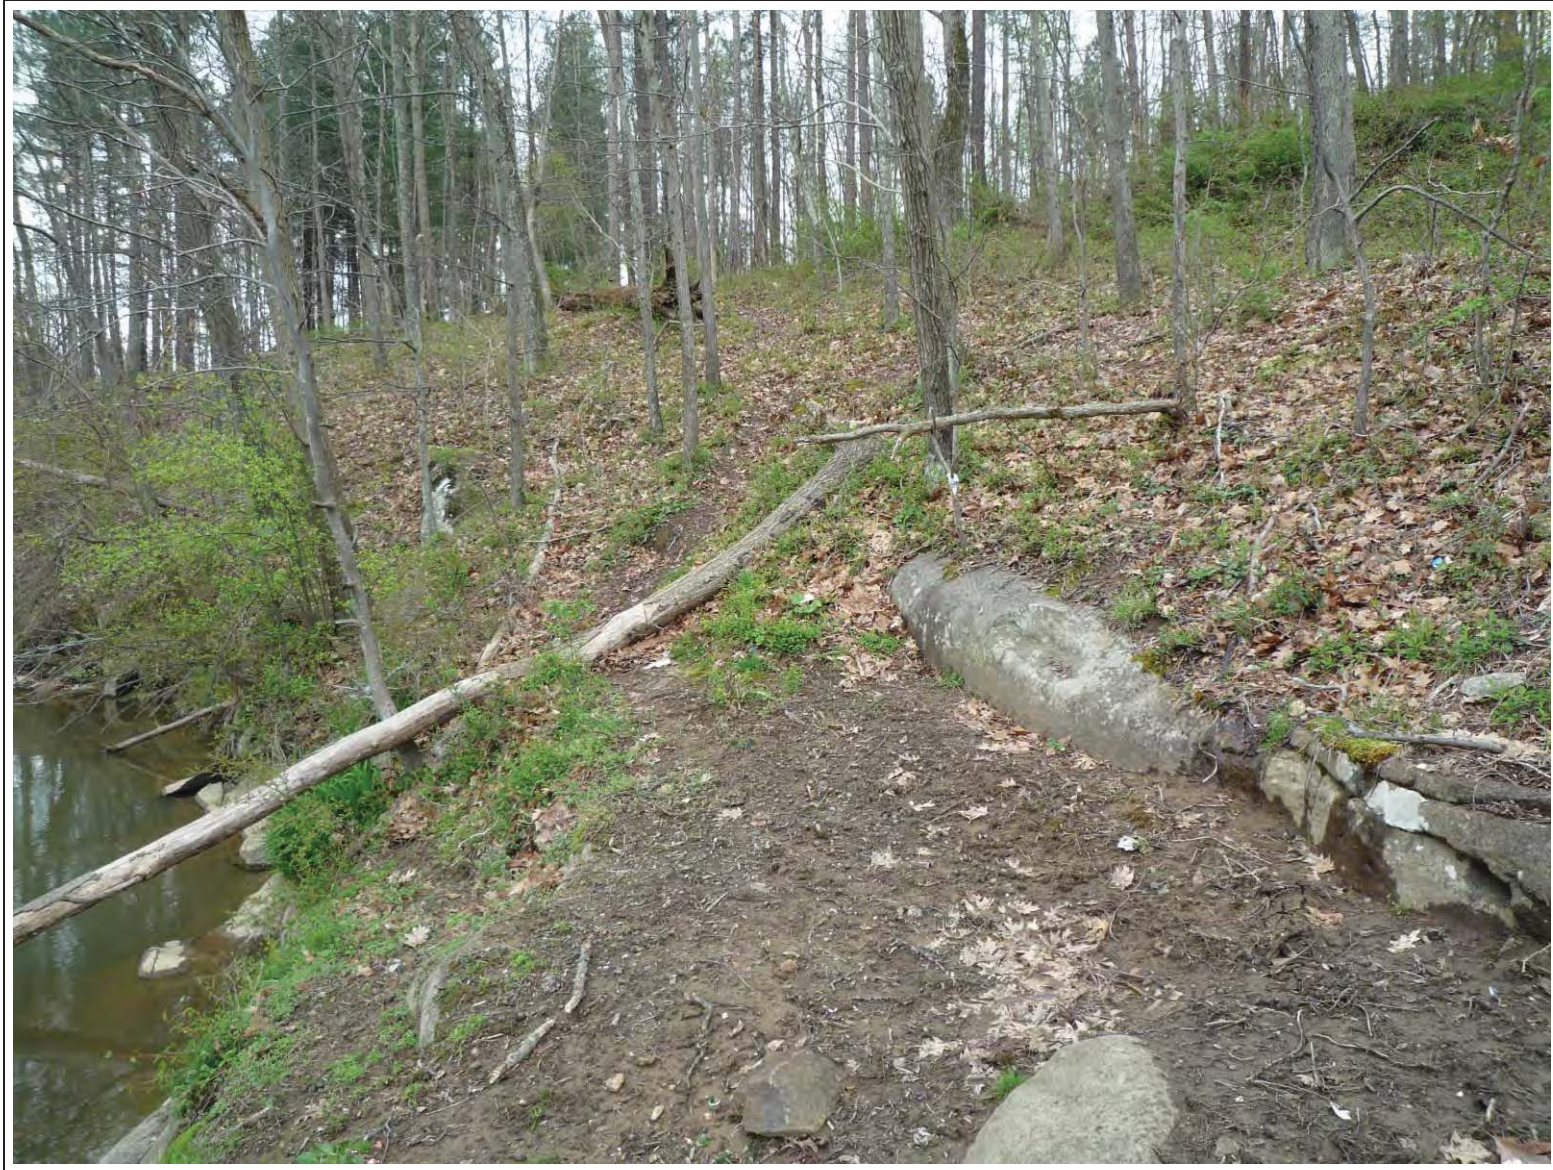
Photo 5-33: Triadelphia Recreational Area Shoreline and Interior Trails bank erosion

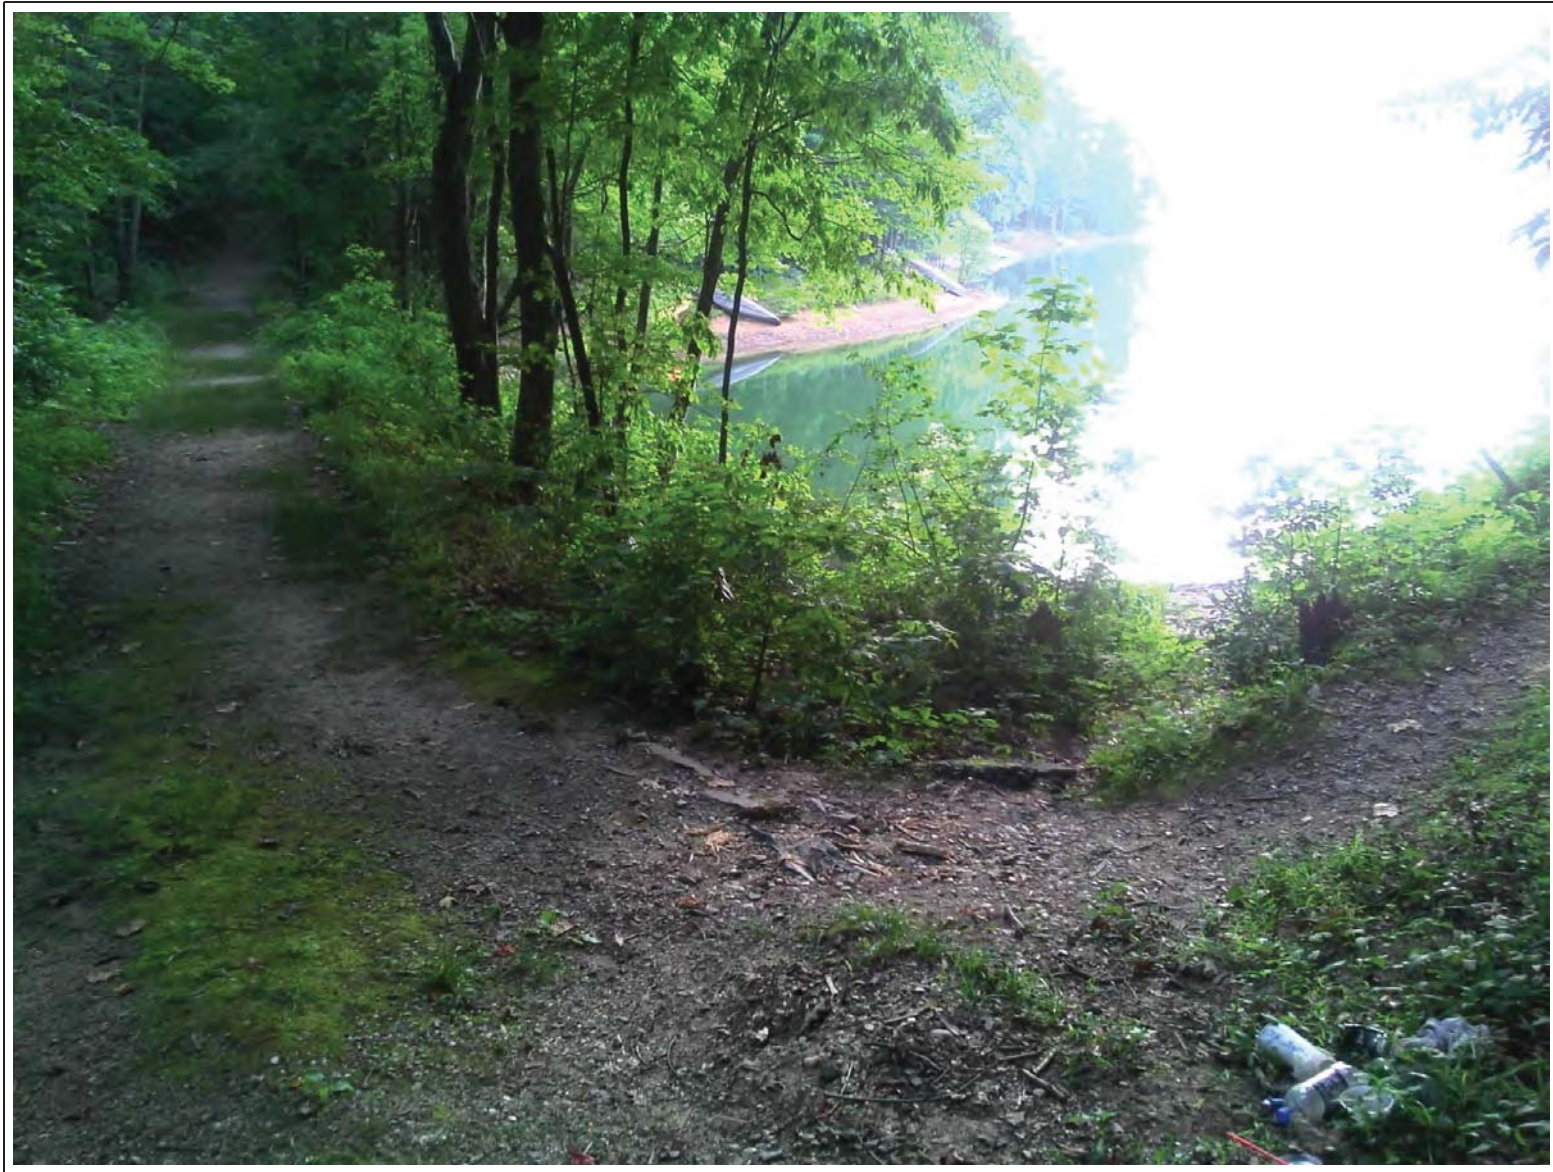
Photo 5-34: Greenbridge Recreation Area bank erosion

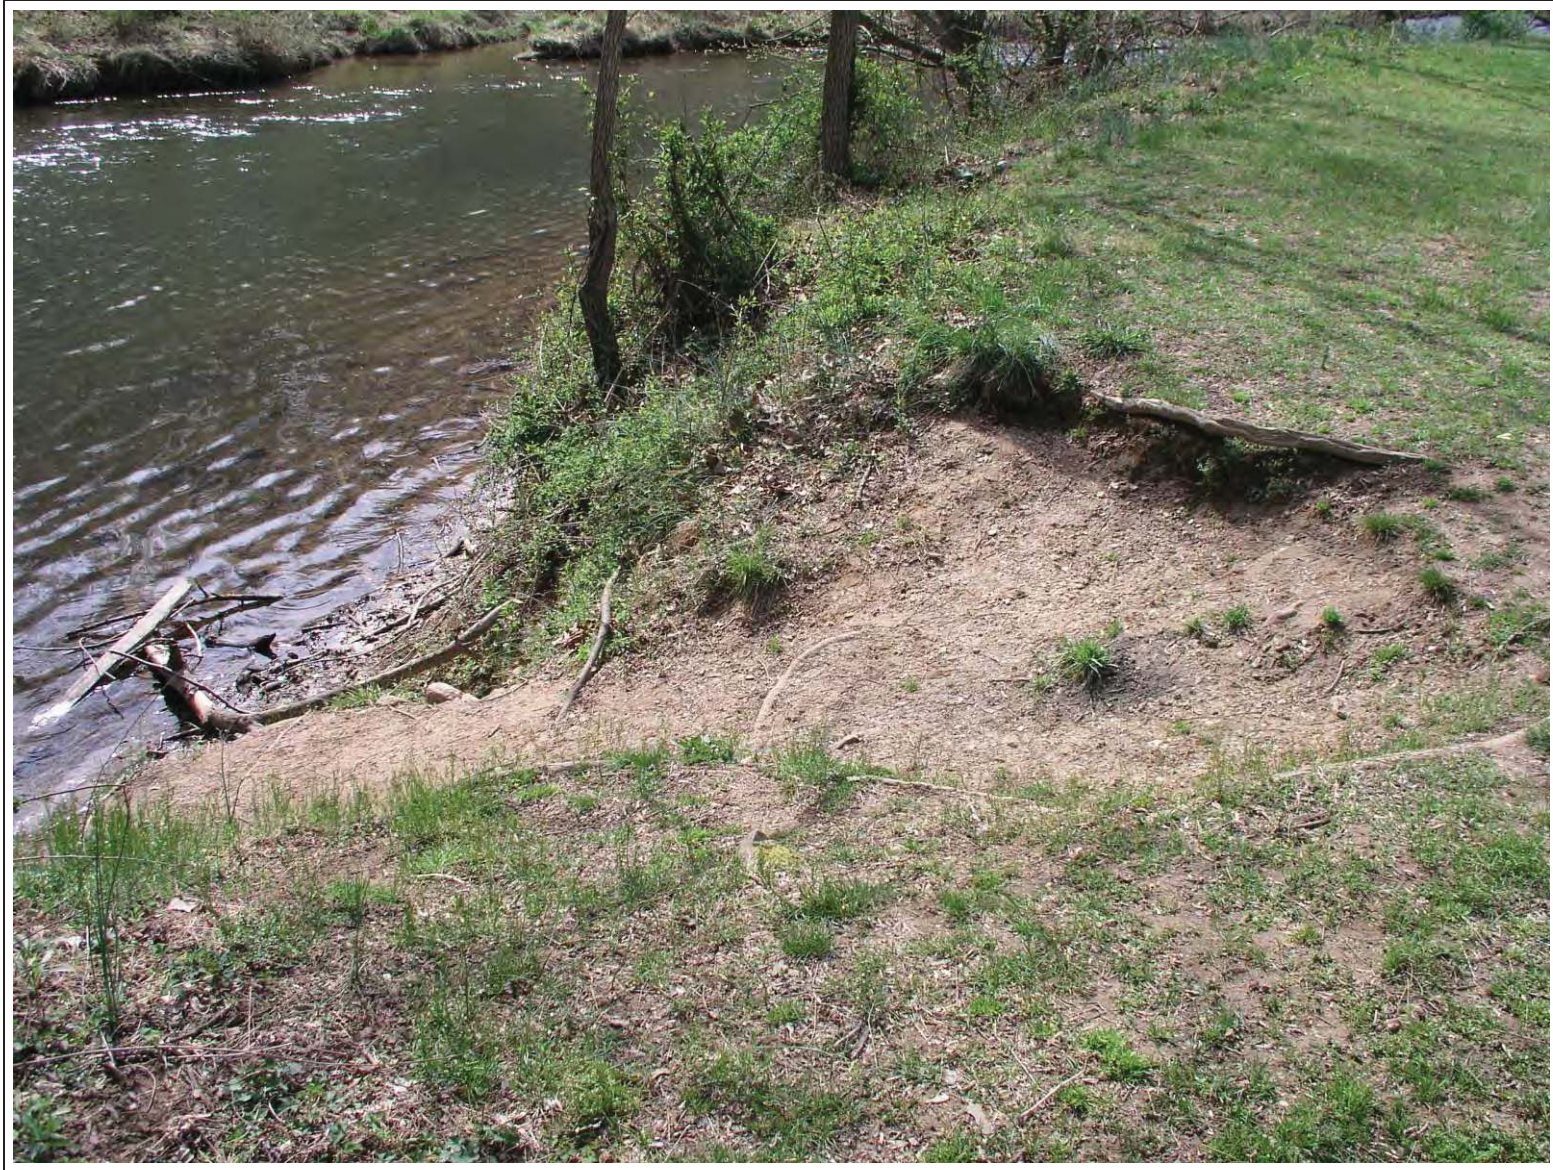
Photo 5-35: Brighton Dam Recreational Area bank erosion

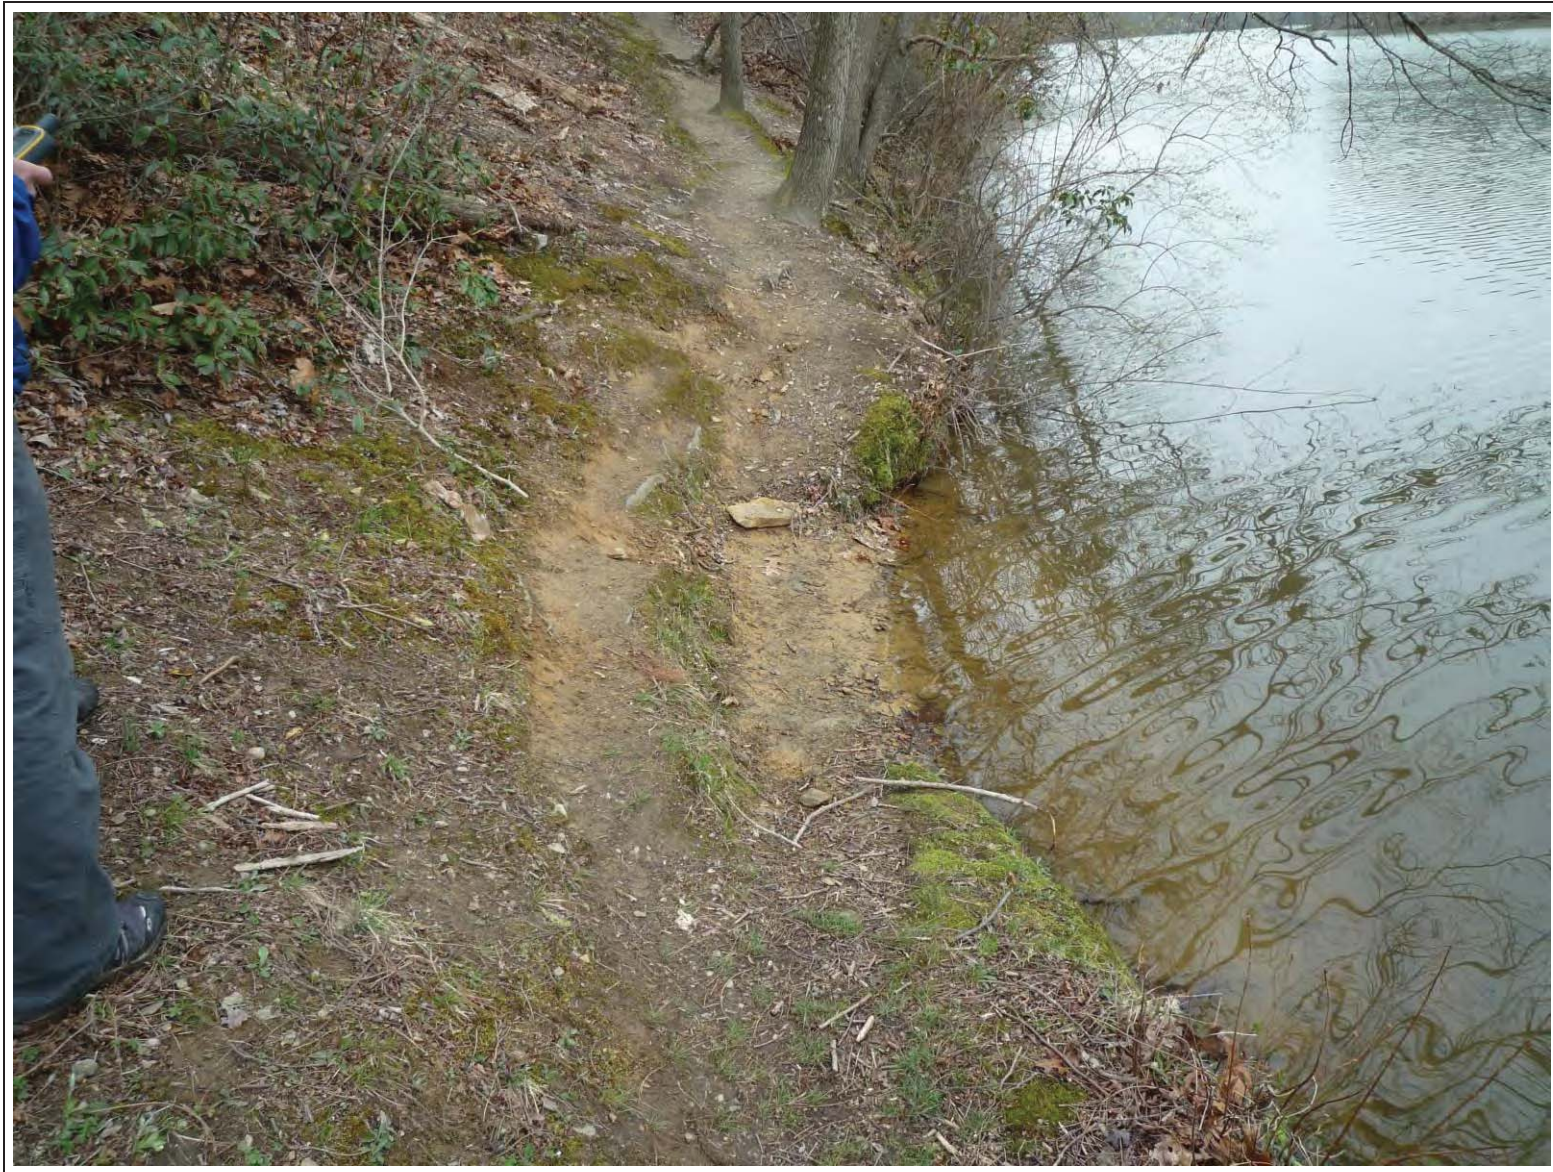
Photo 5-36: Big Branch shoreline trail high slope alignment

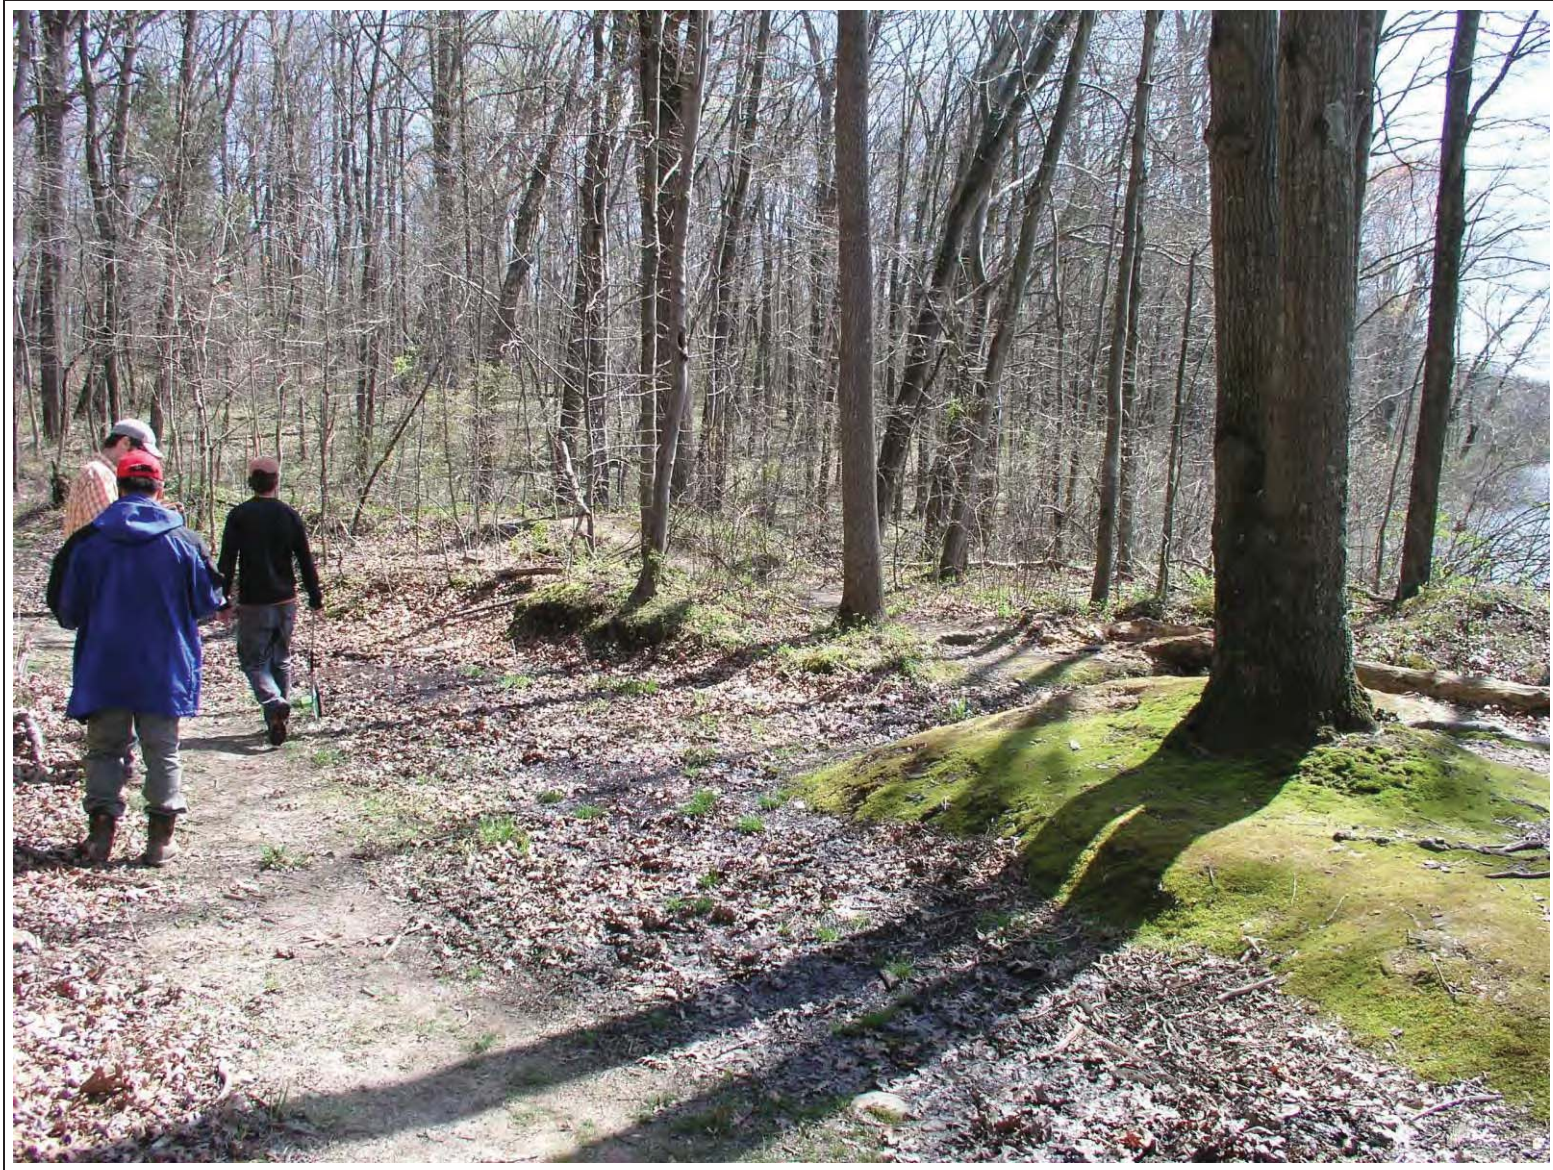
Photo 5-37: Pig Tail Recreational Area trail erosion

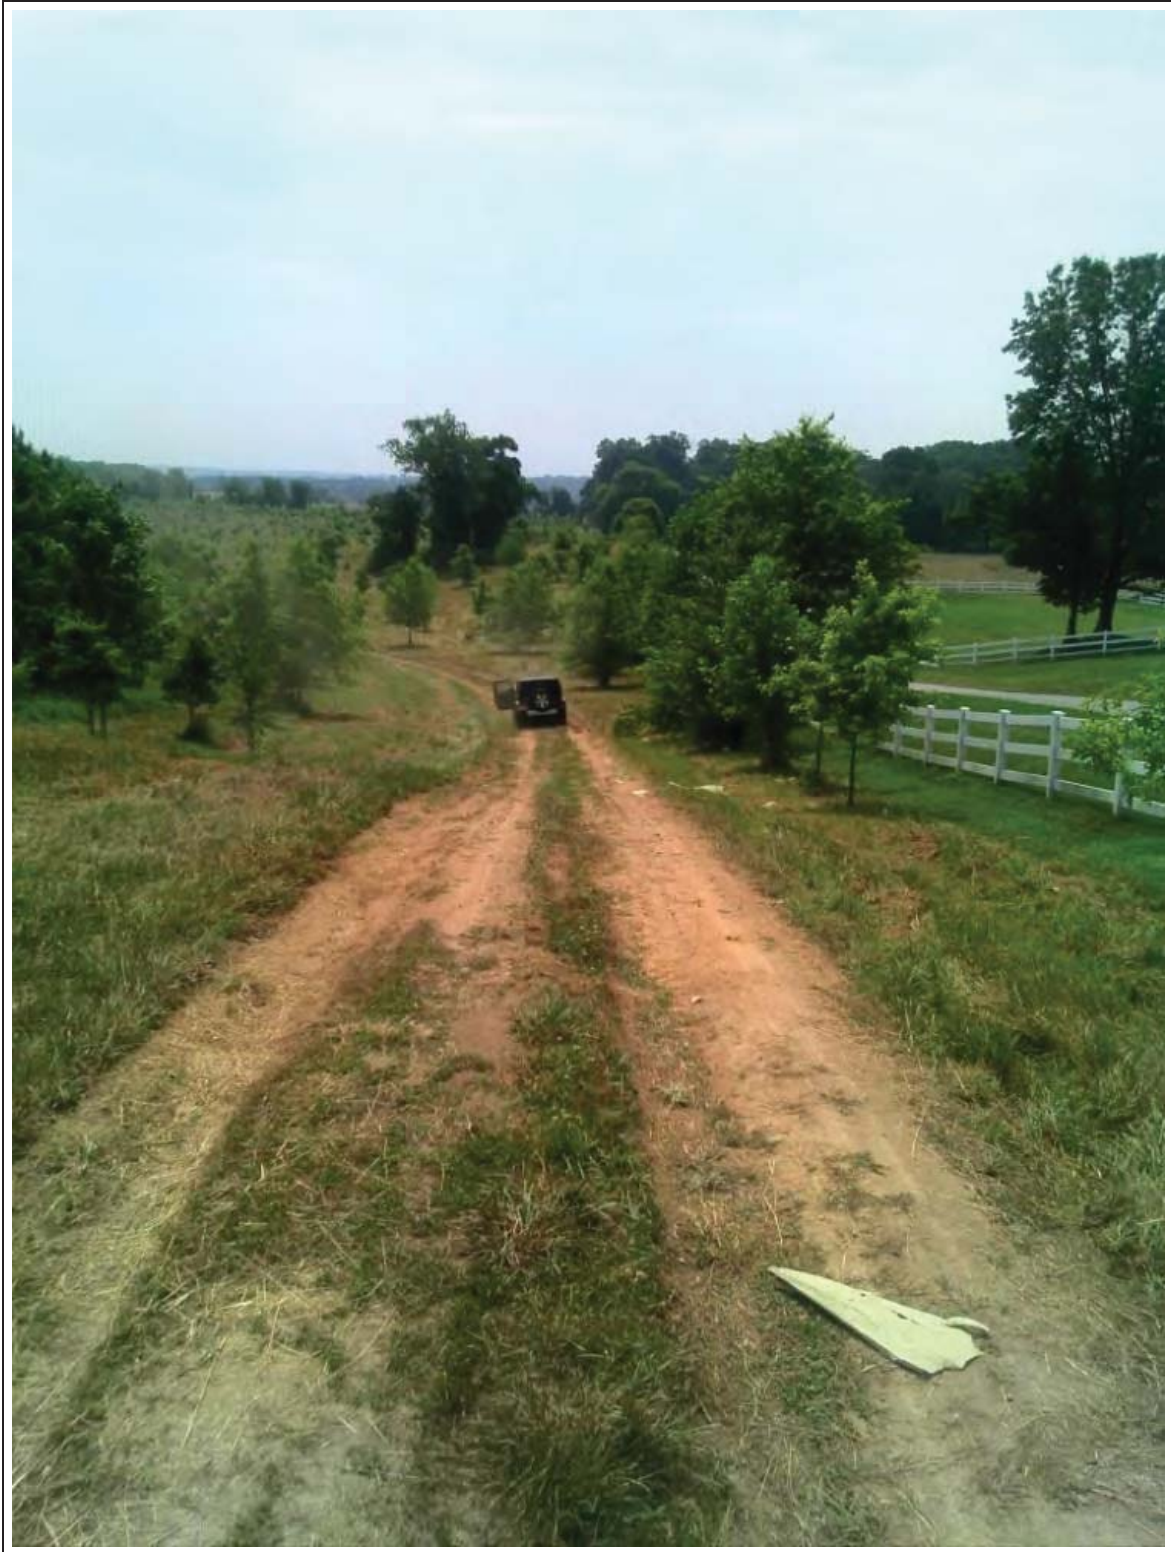
Photo 5-39: Triadelphia Lake Road rutting from vehicles
