Study Results, Observations, and Recommendations

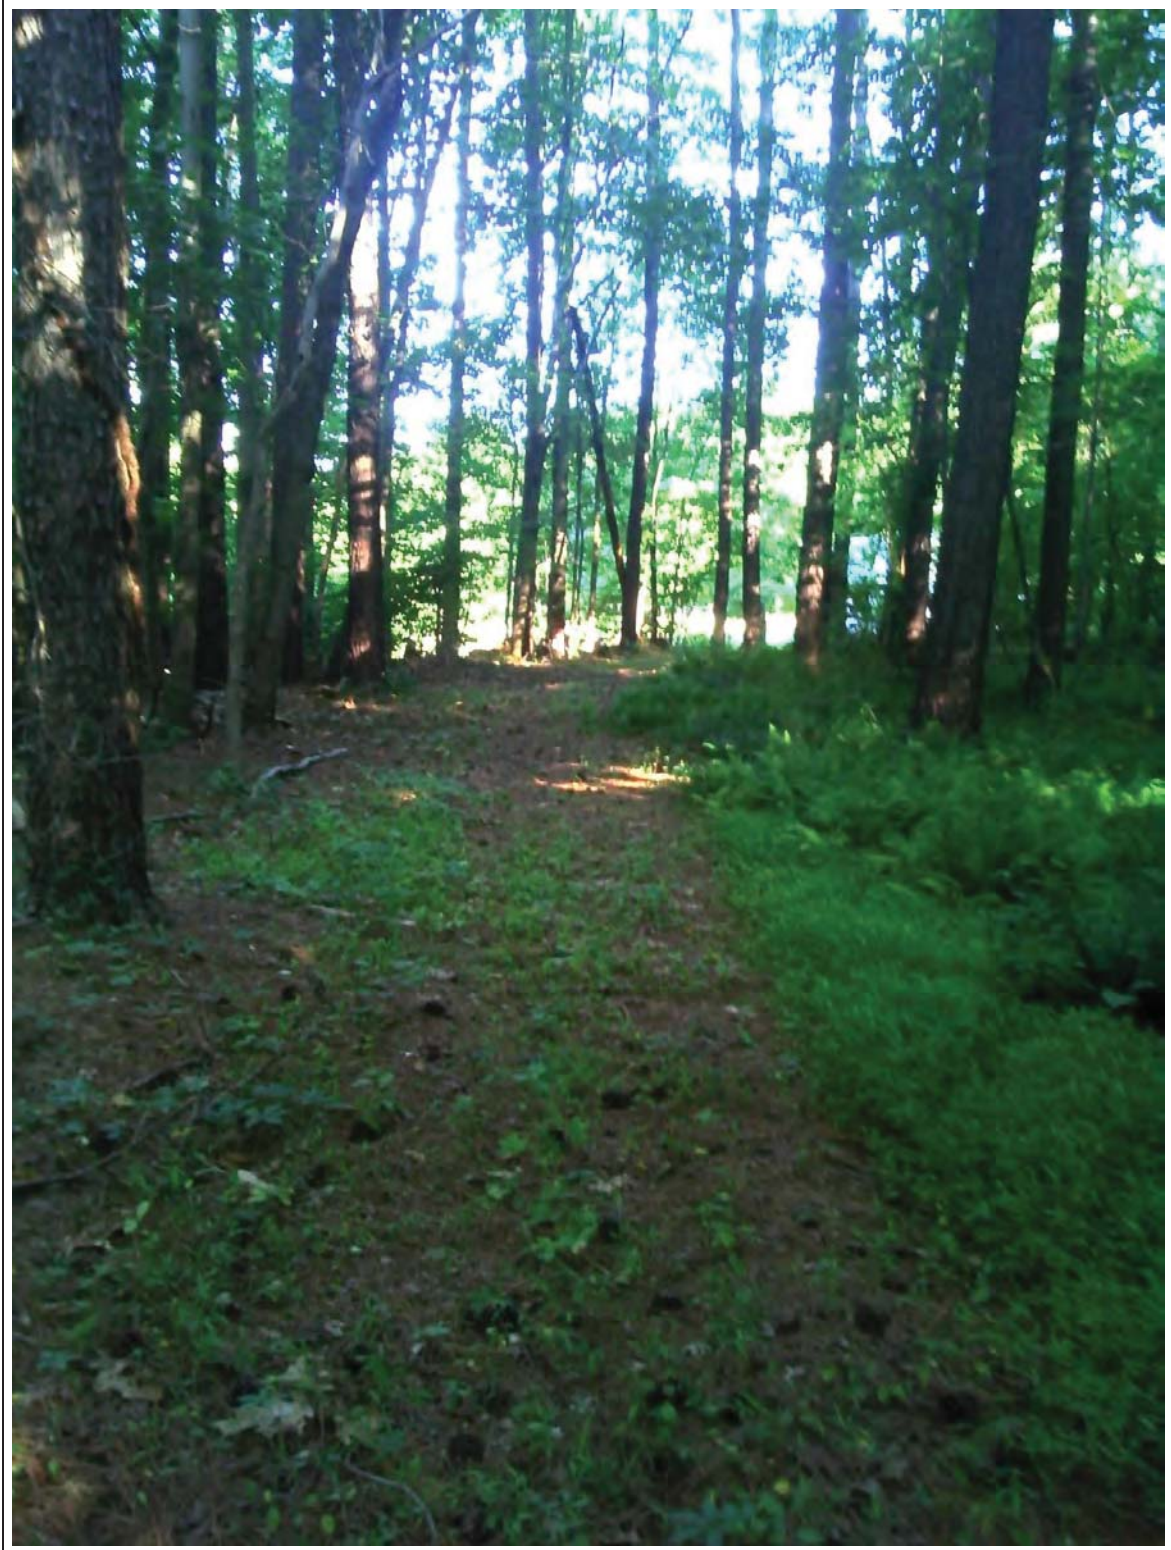
Photo 5-43: Greenbridge East unauthorized trail spur to shoreline

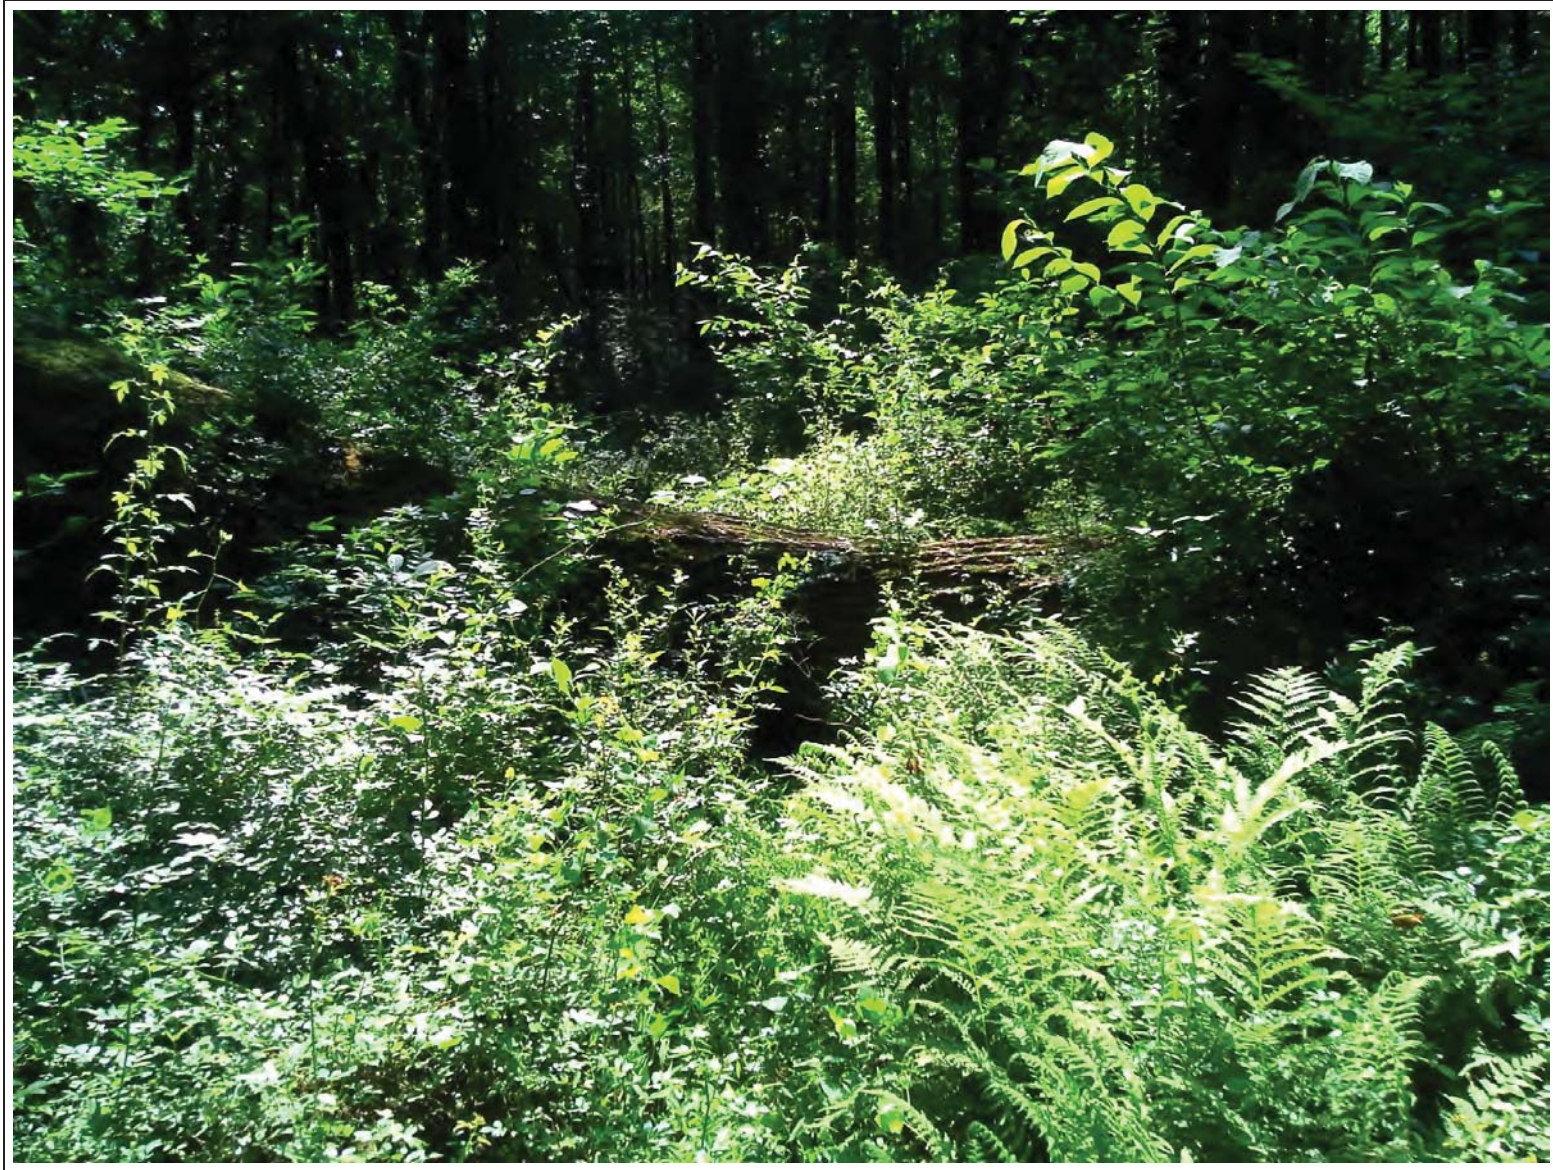
Photo 5-45: West Big Branch Access Road covered with overgrown vegetation

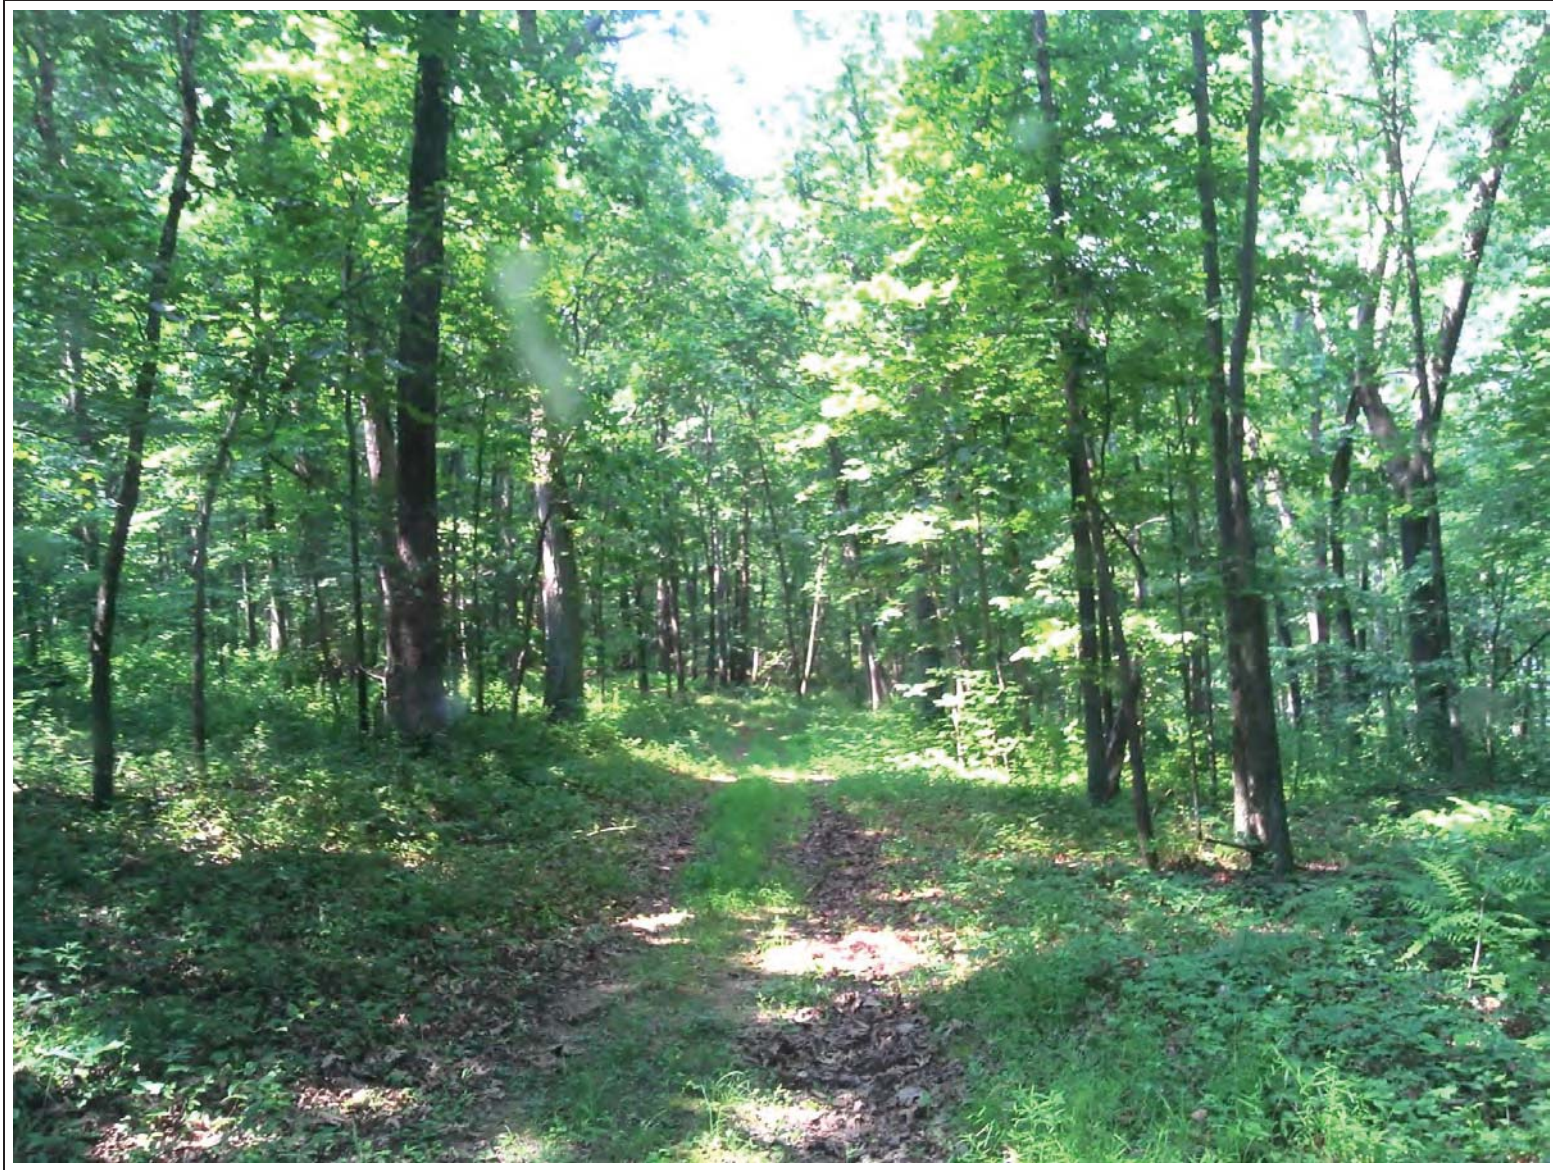
Photo 5-46: West Big Branch Access Road vehicle induced rutting

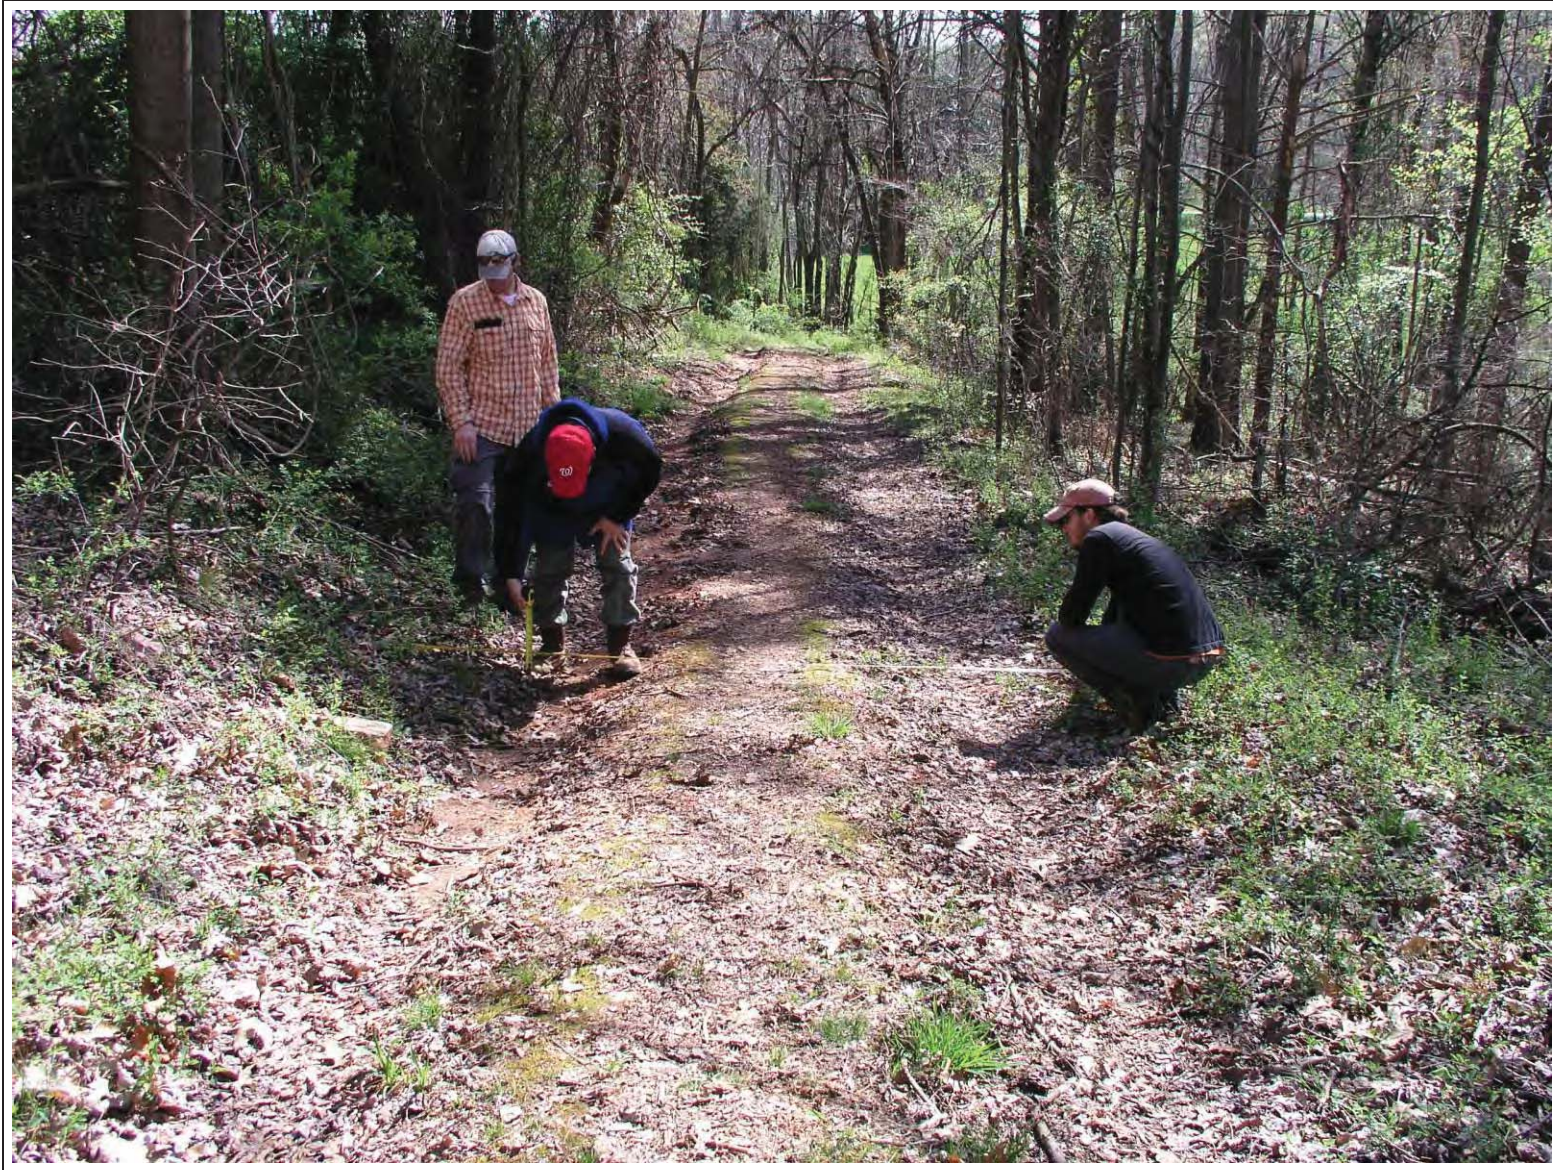
Photo 5-47: Pig Tail vehicle rutting

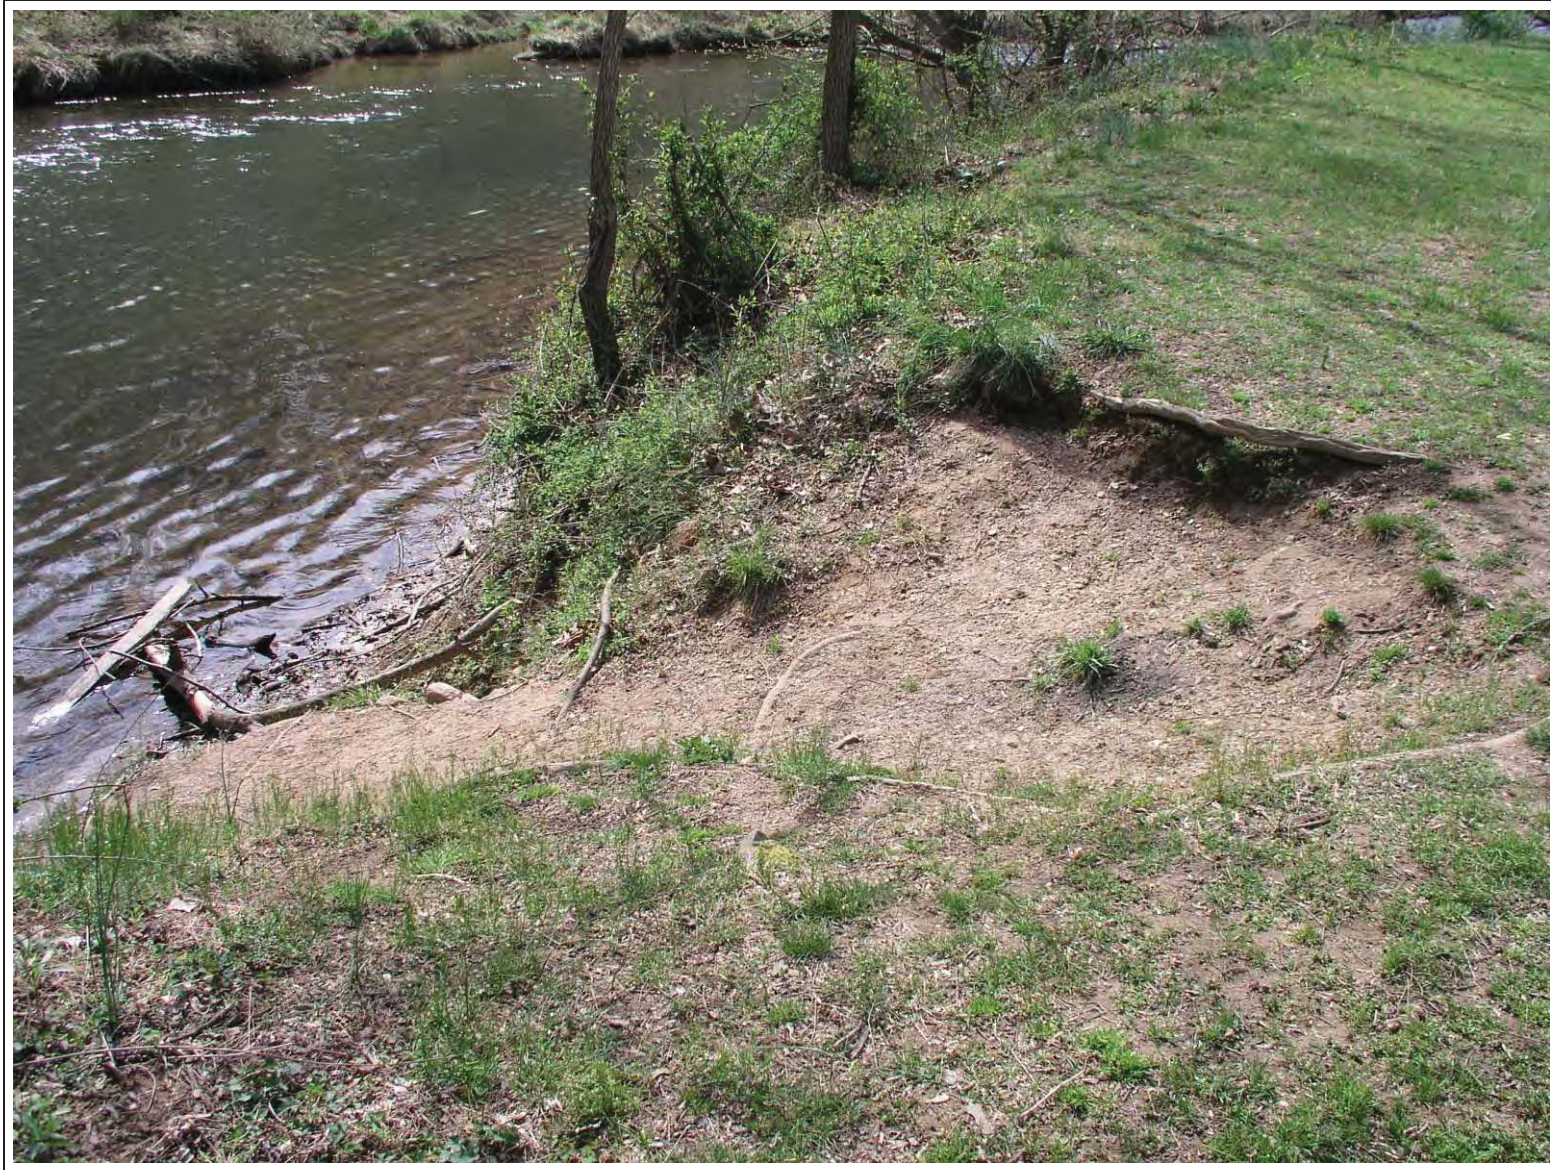
Photo 5-66: Brighton Dam localized bank erosion due to fishing access to edge of water

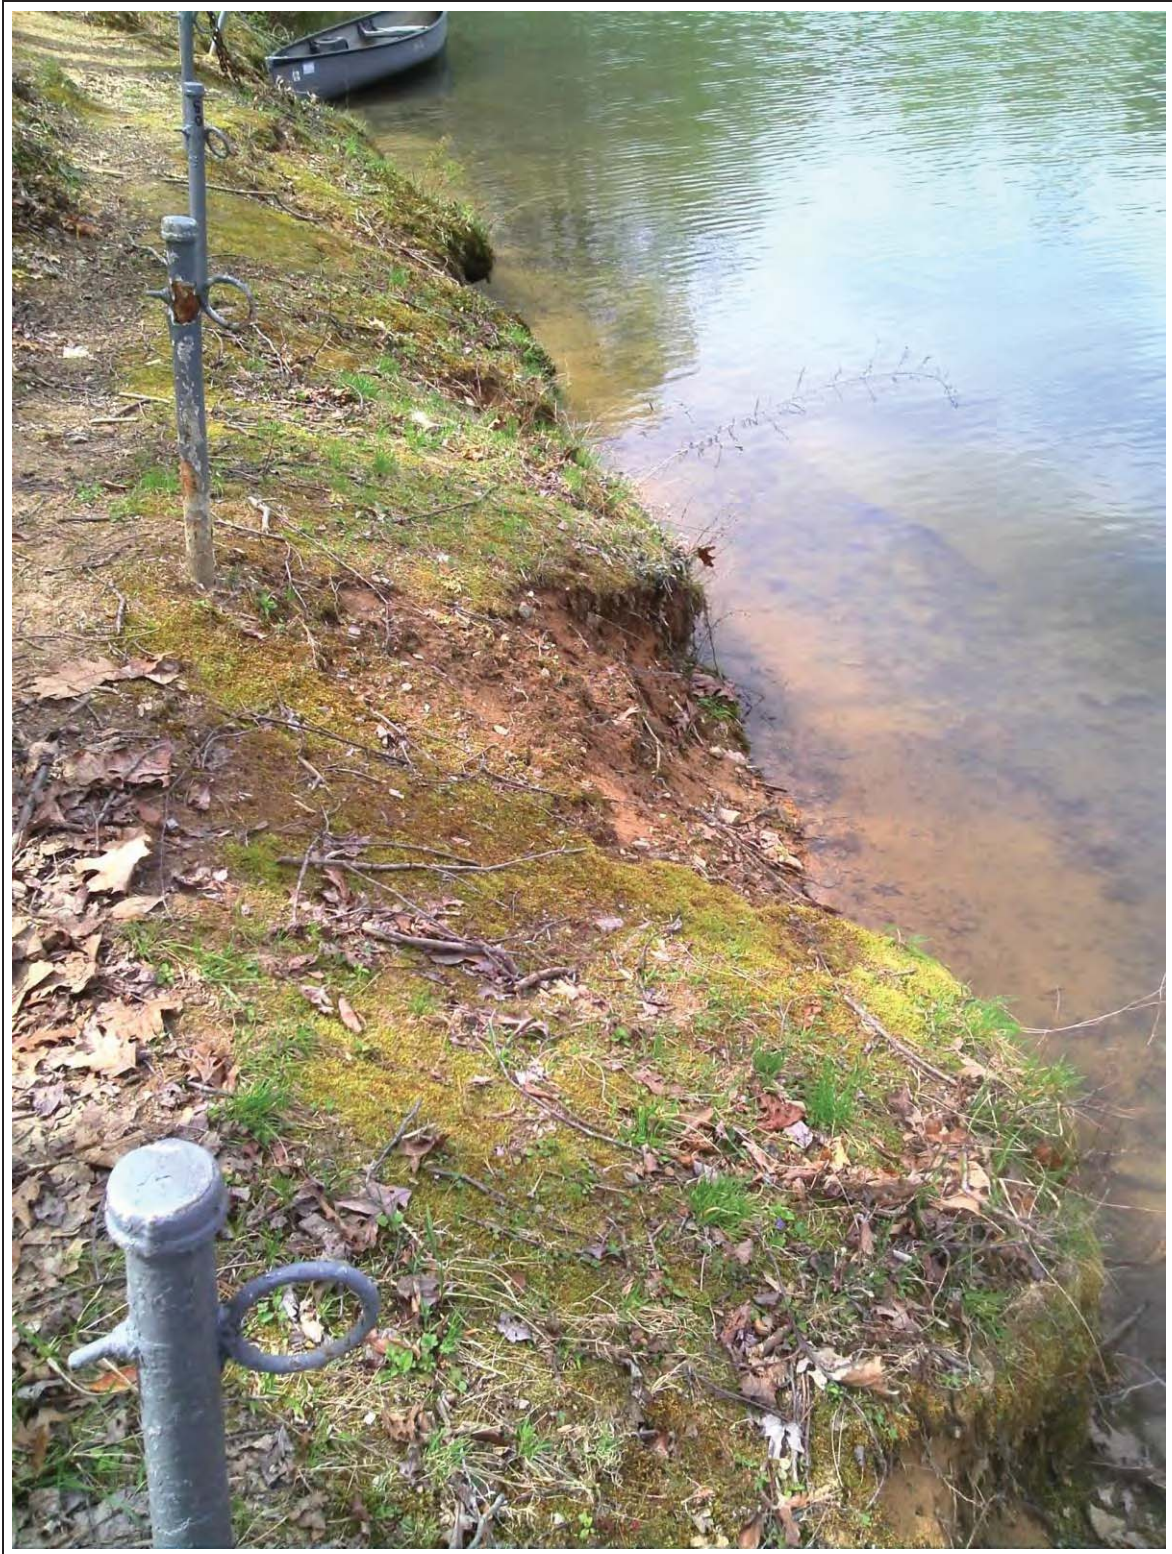
Photo 5-78: Greenbridge Recreational Area bank erosion with un-stabilized slopes

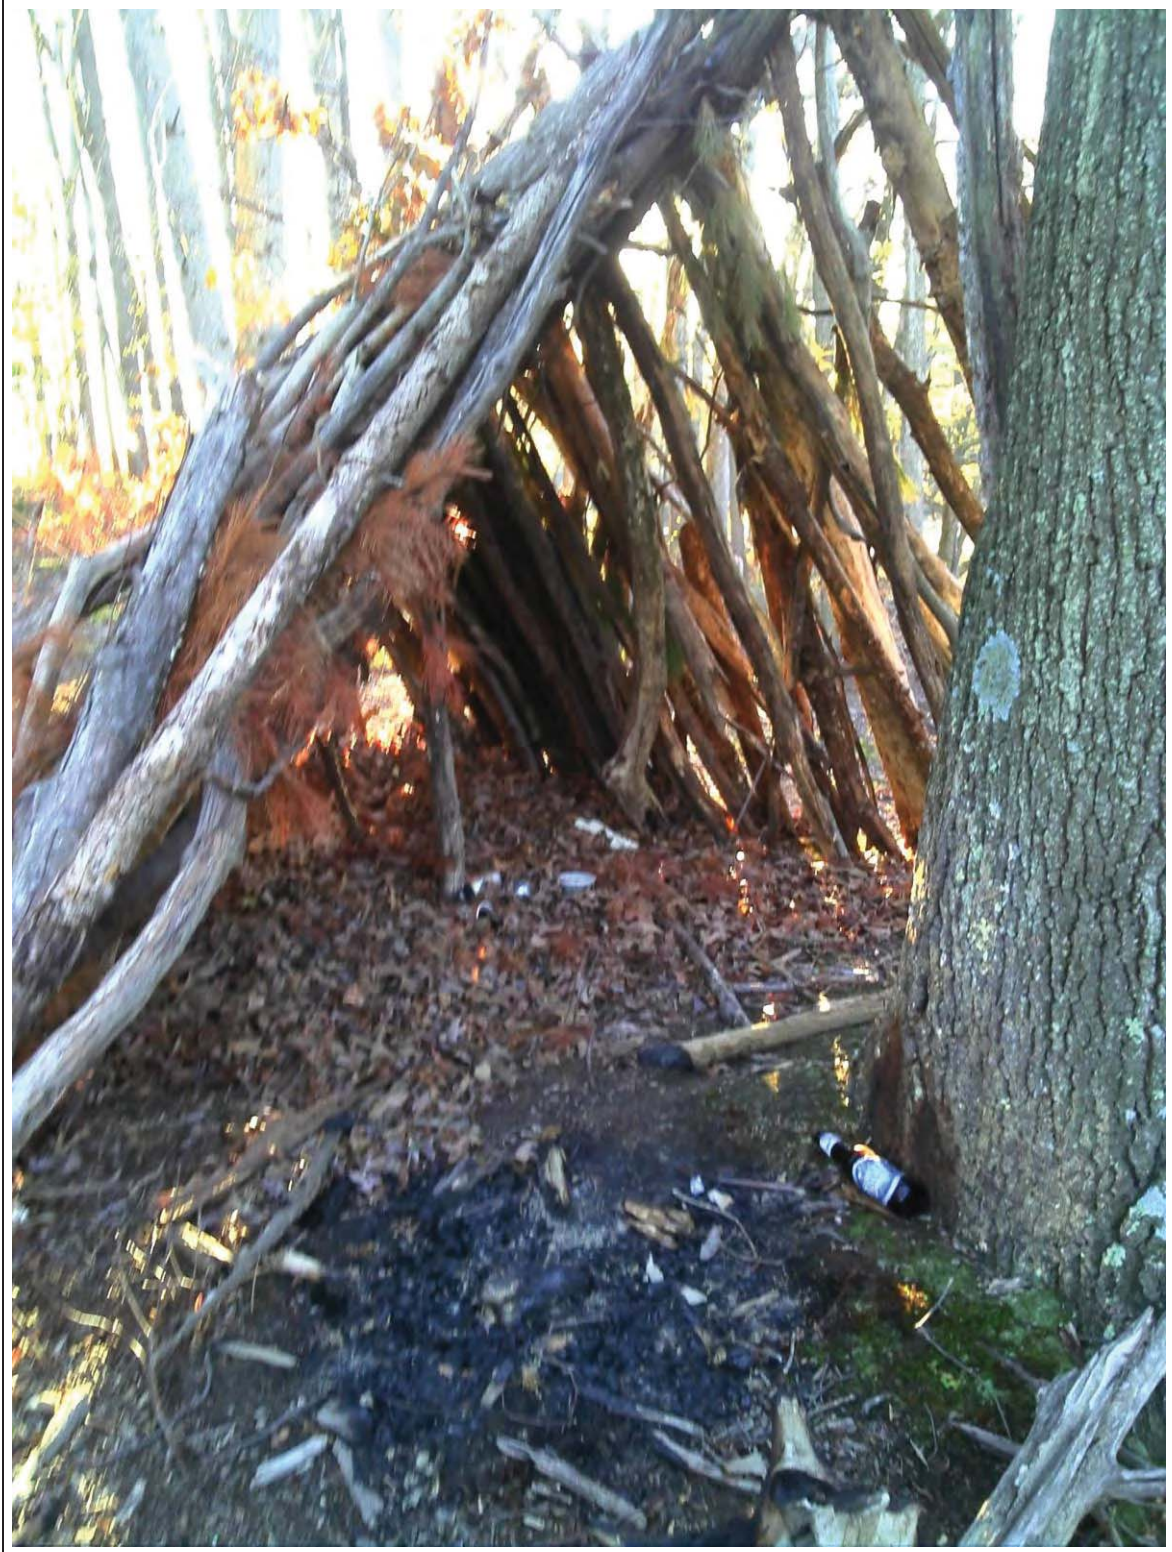
Photo 6-1: Apparent Homeless Activity

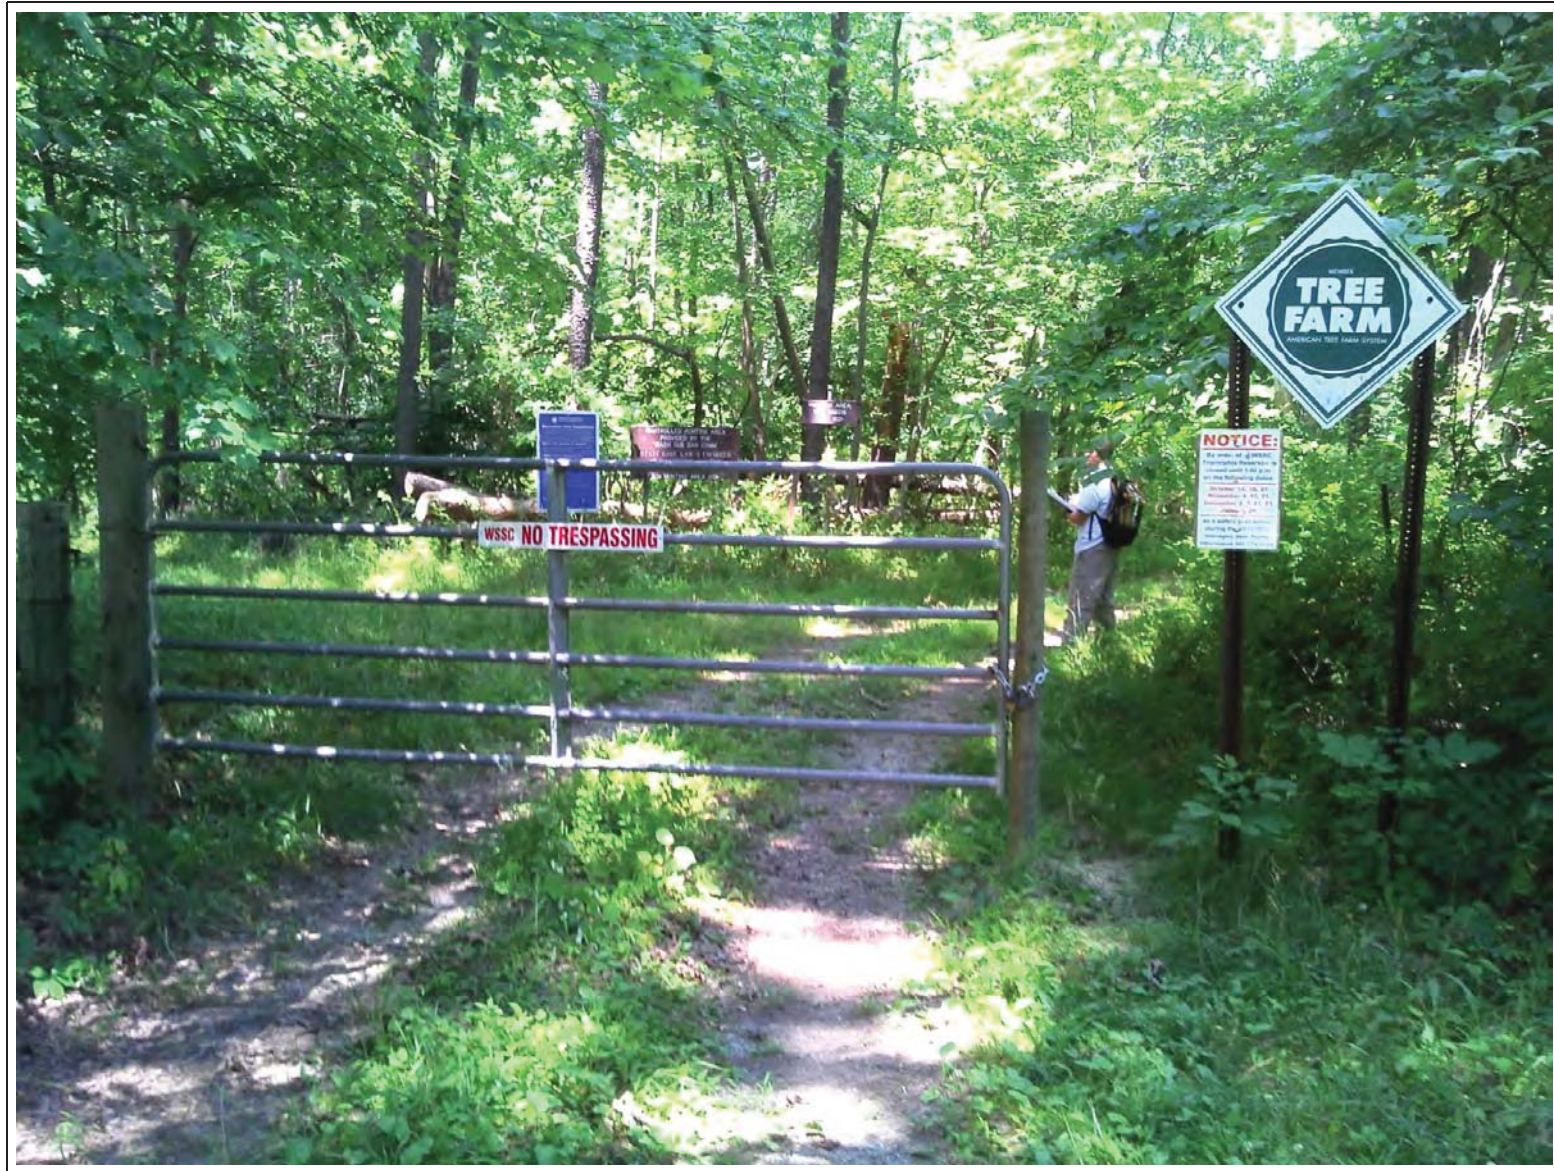
Photo 6-2: Example of confusing signage

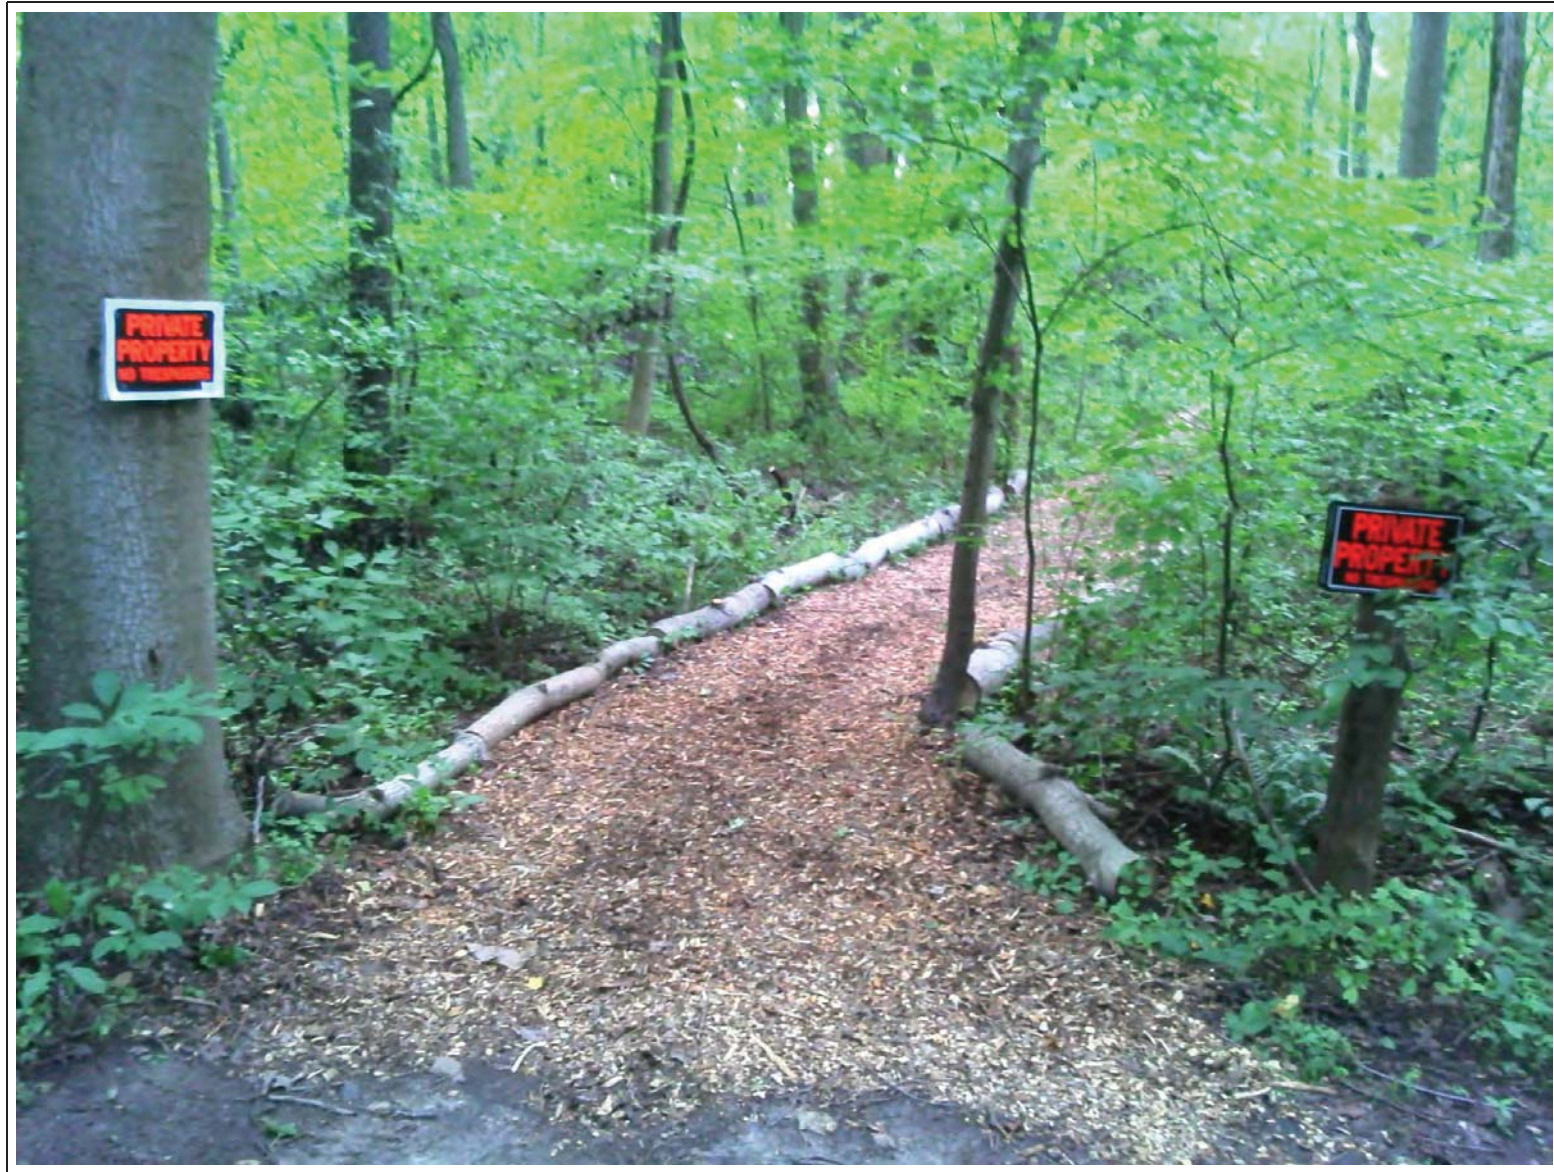
Photo 6-4: Example of unauthorized private access to WSSC property

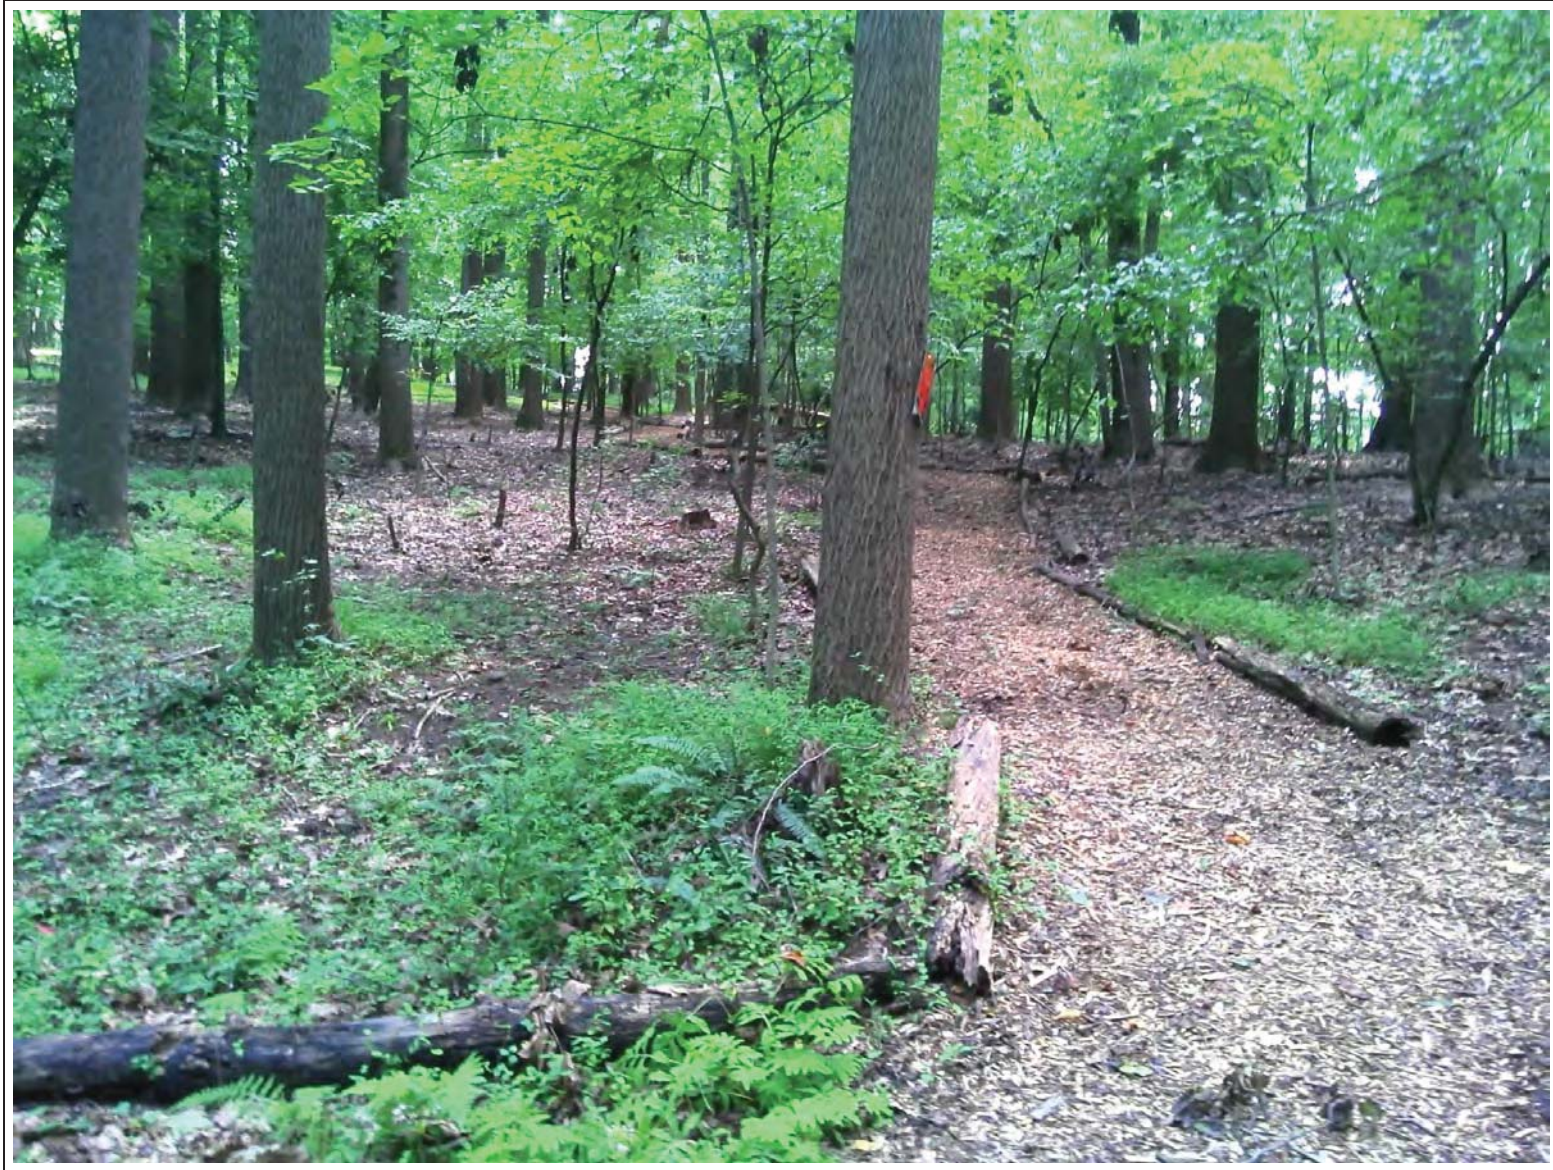
Photo 6-5: Example of unauthorized private access to WSSC property

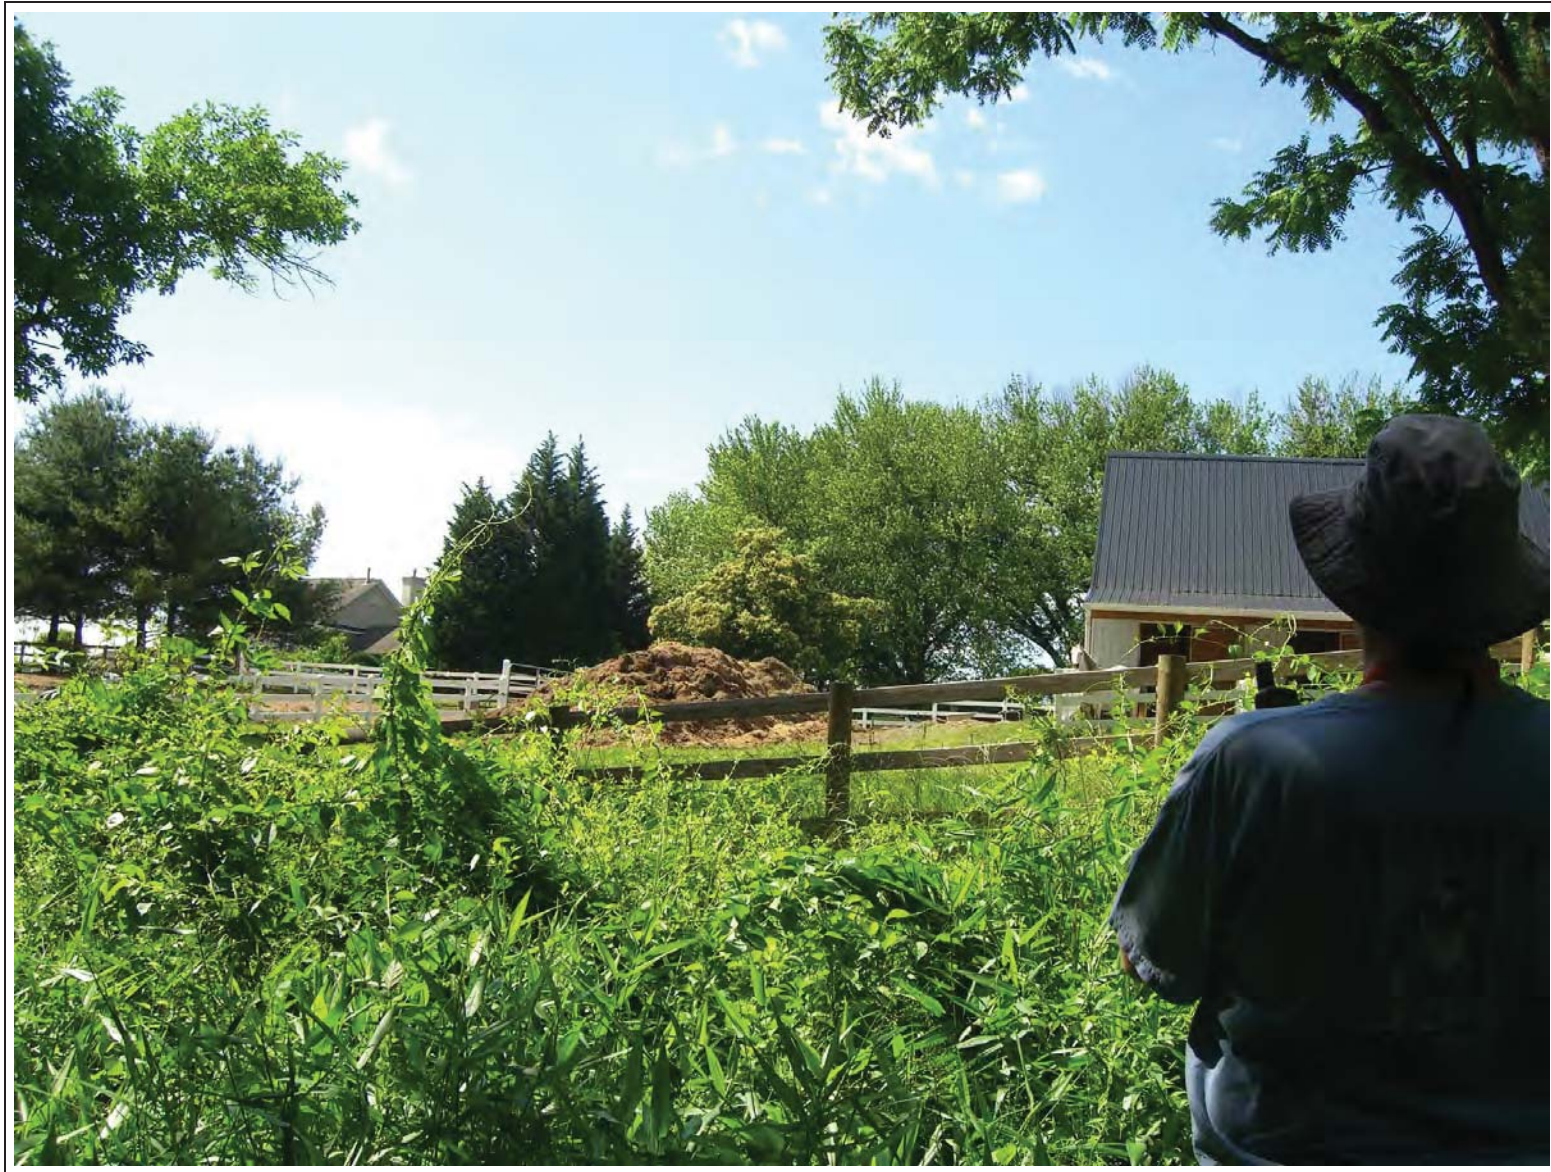
Photo 6-6: Horse farm with manure pile.

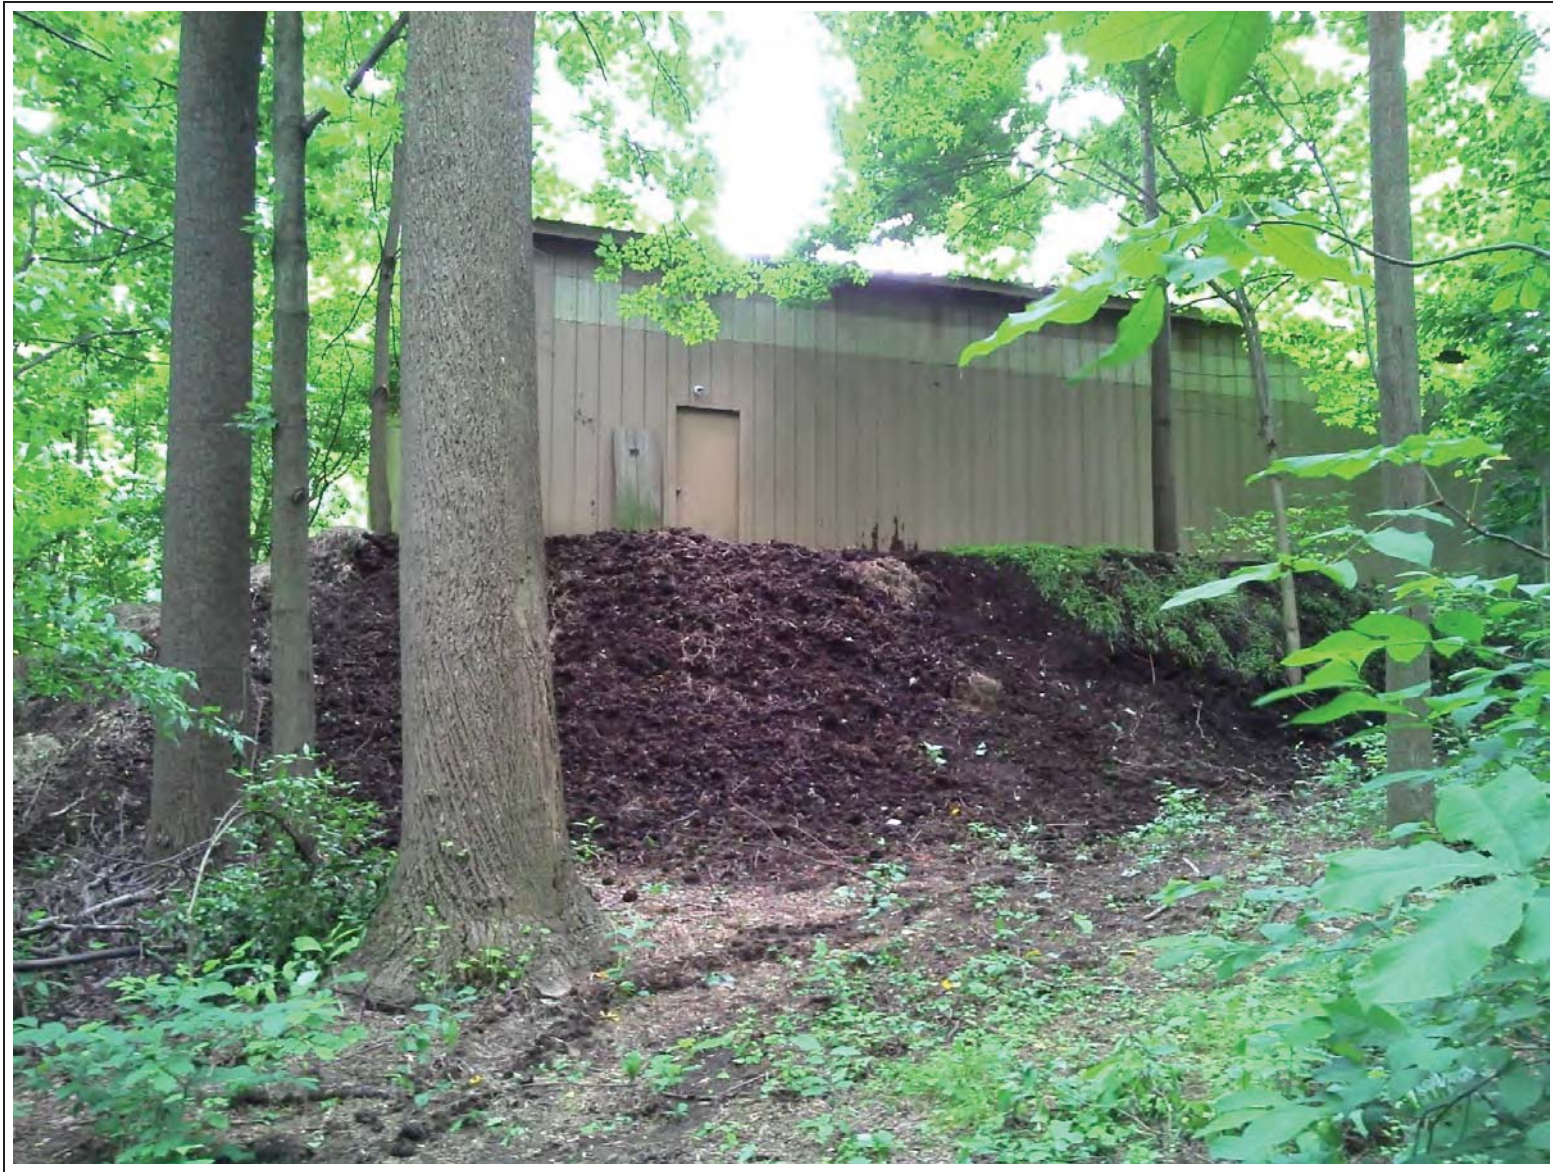
Photo 6-7: Horse farm with manure pile.
