Study Results, Observations, and Recommendations

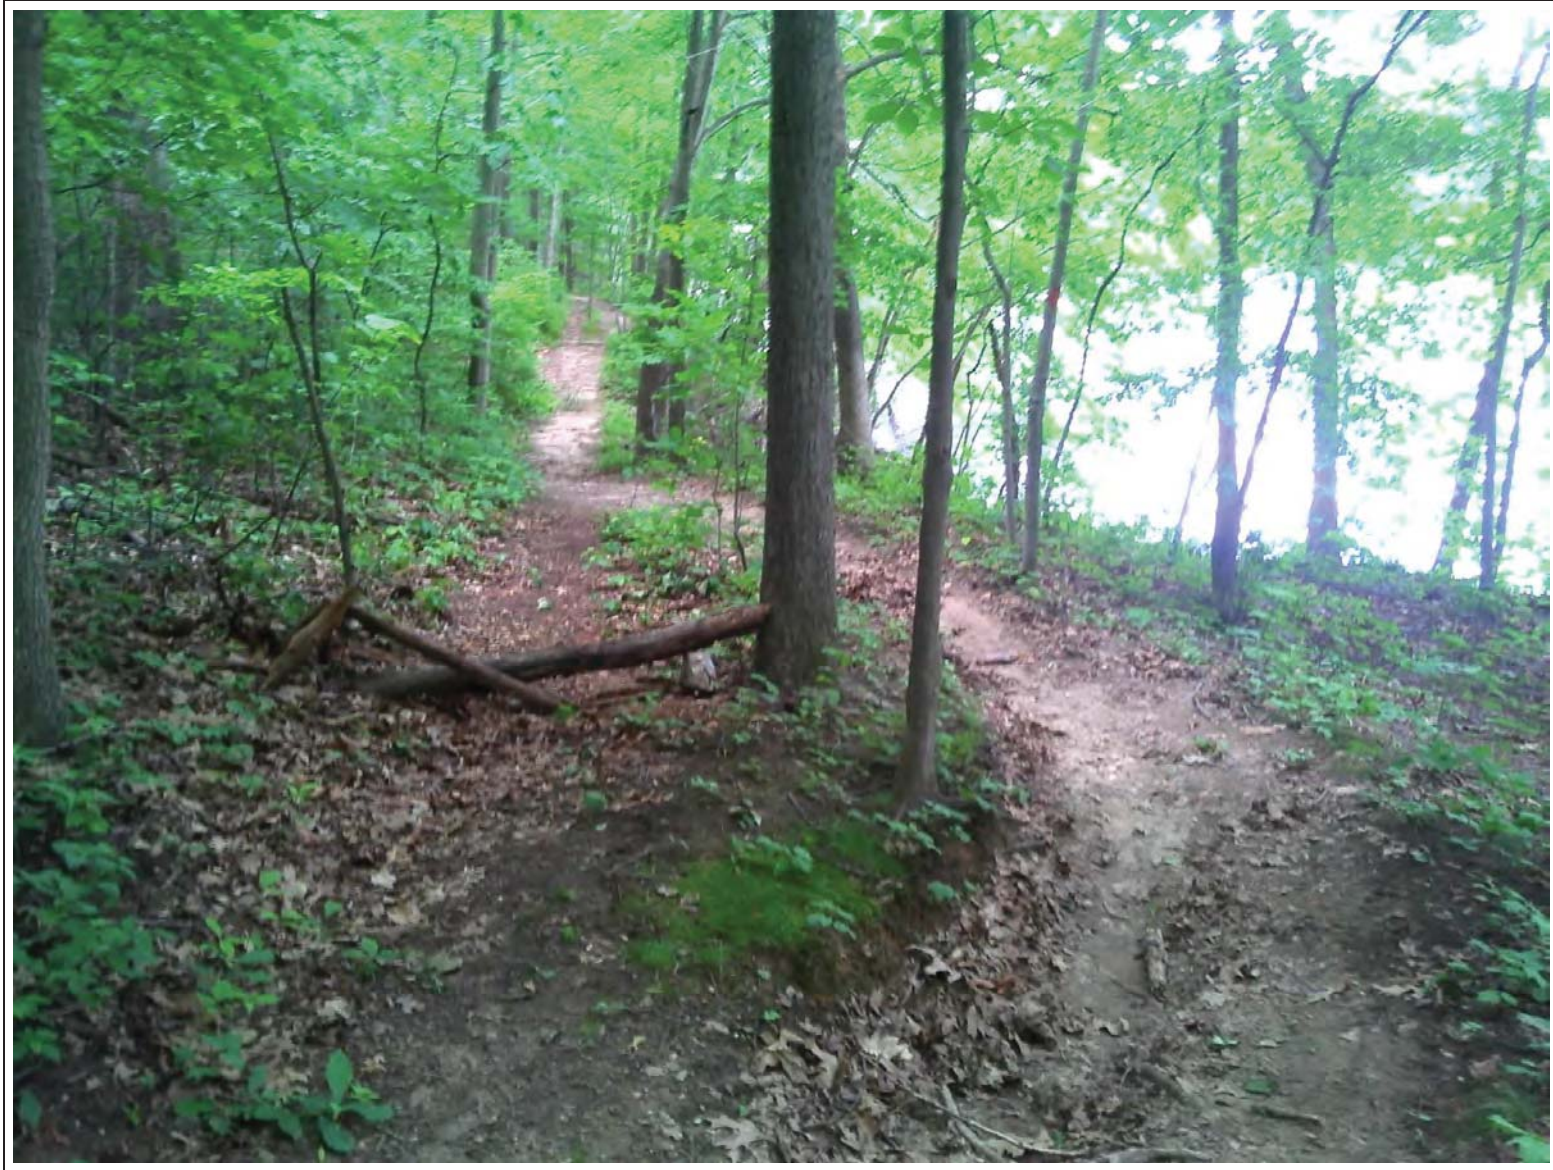
Photo 6-8: Example of human modification to WSSC property – horse jump

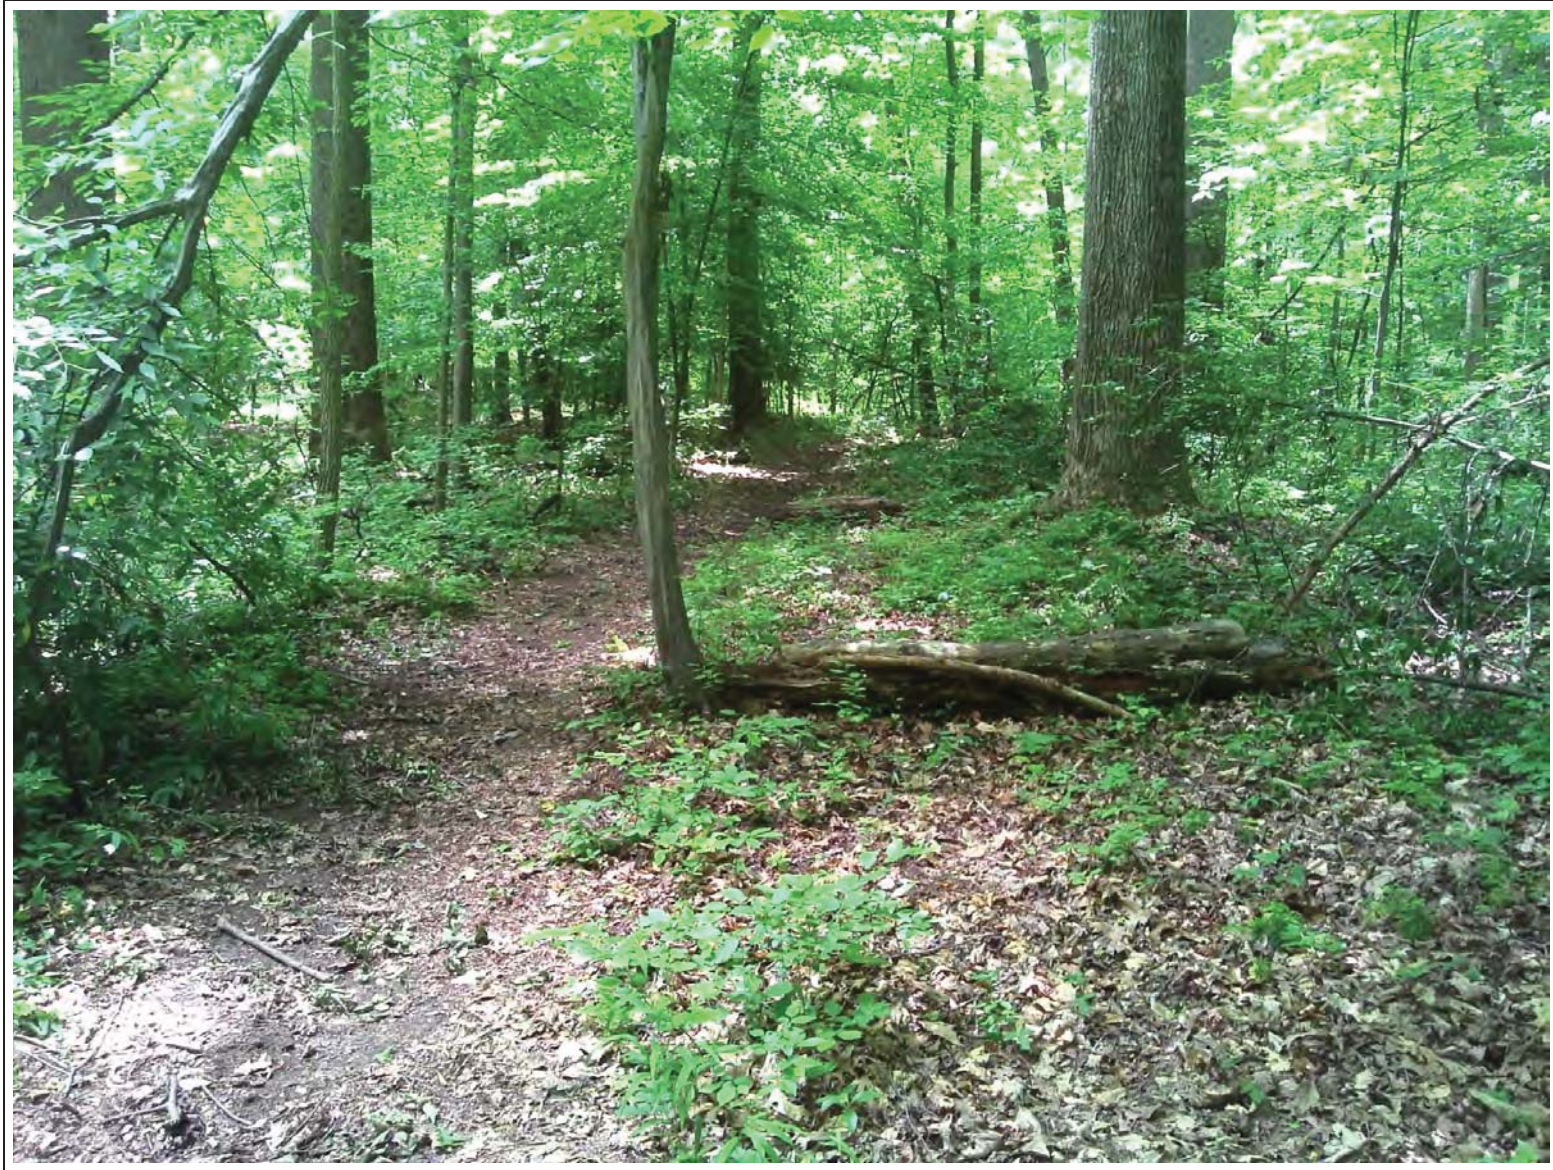
Photo 6-9: Example of human modification to WSSC property – horse jump
