5 Descriptions of Trails and Access Points

5.1 Results of GPS Trail Mapping

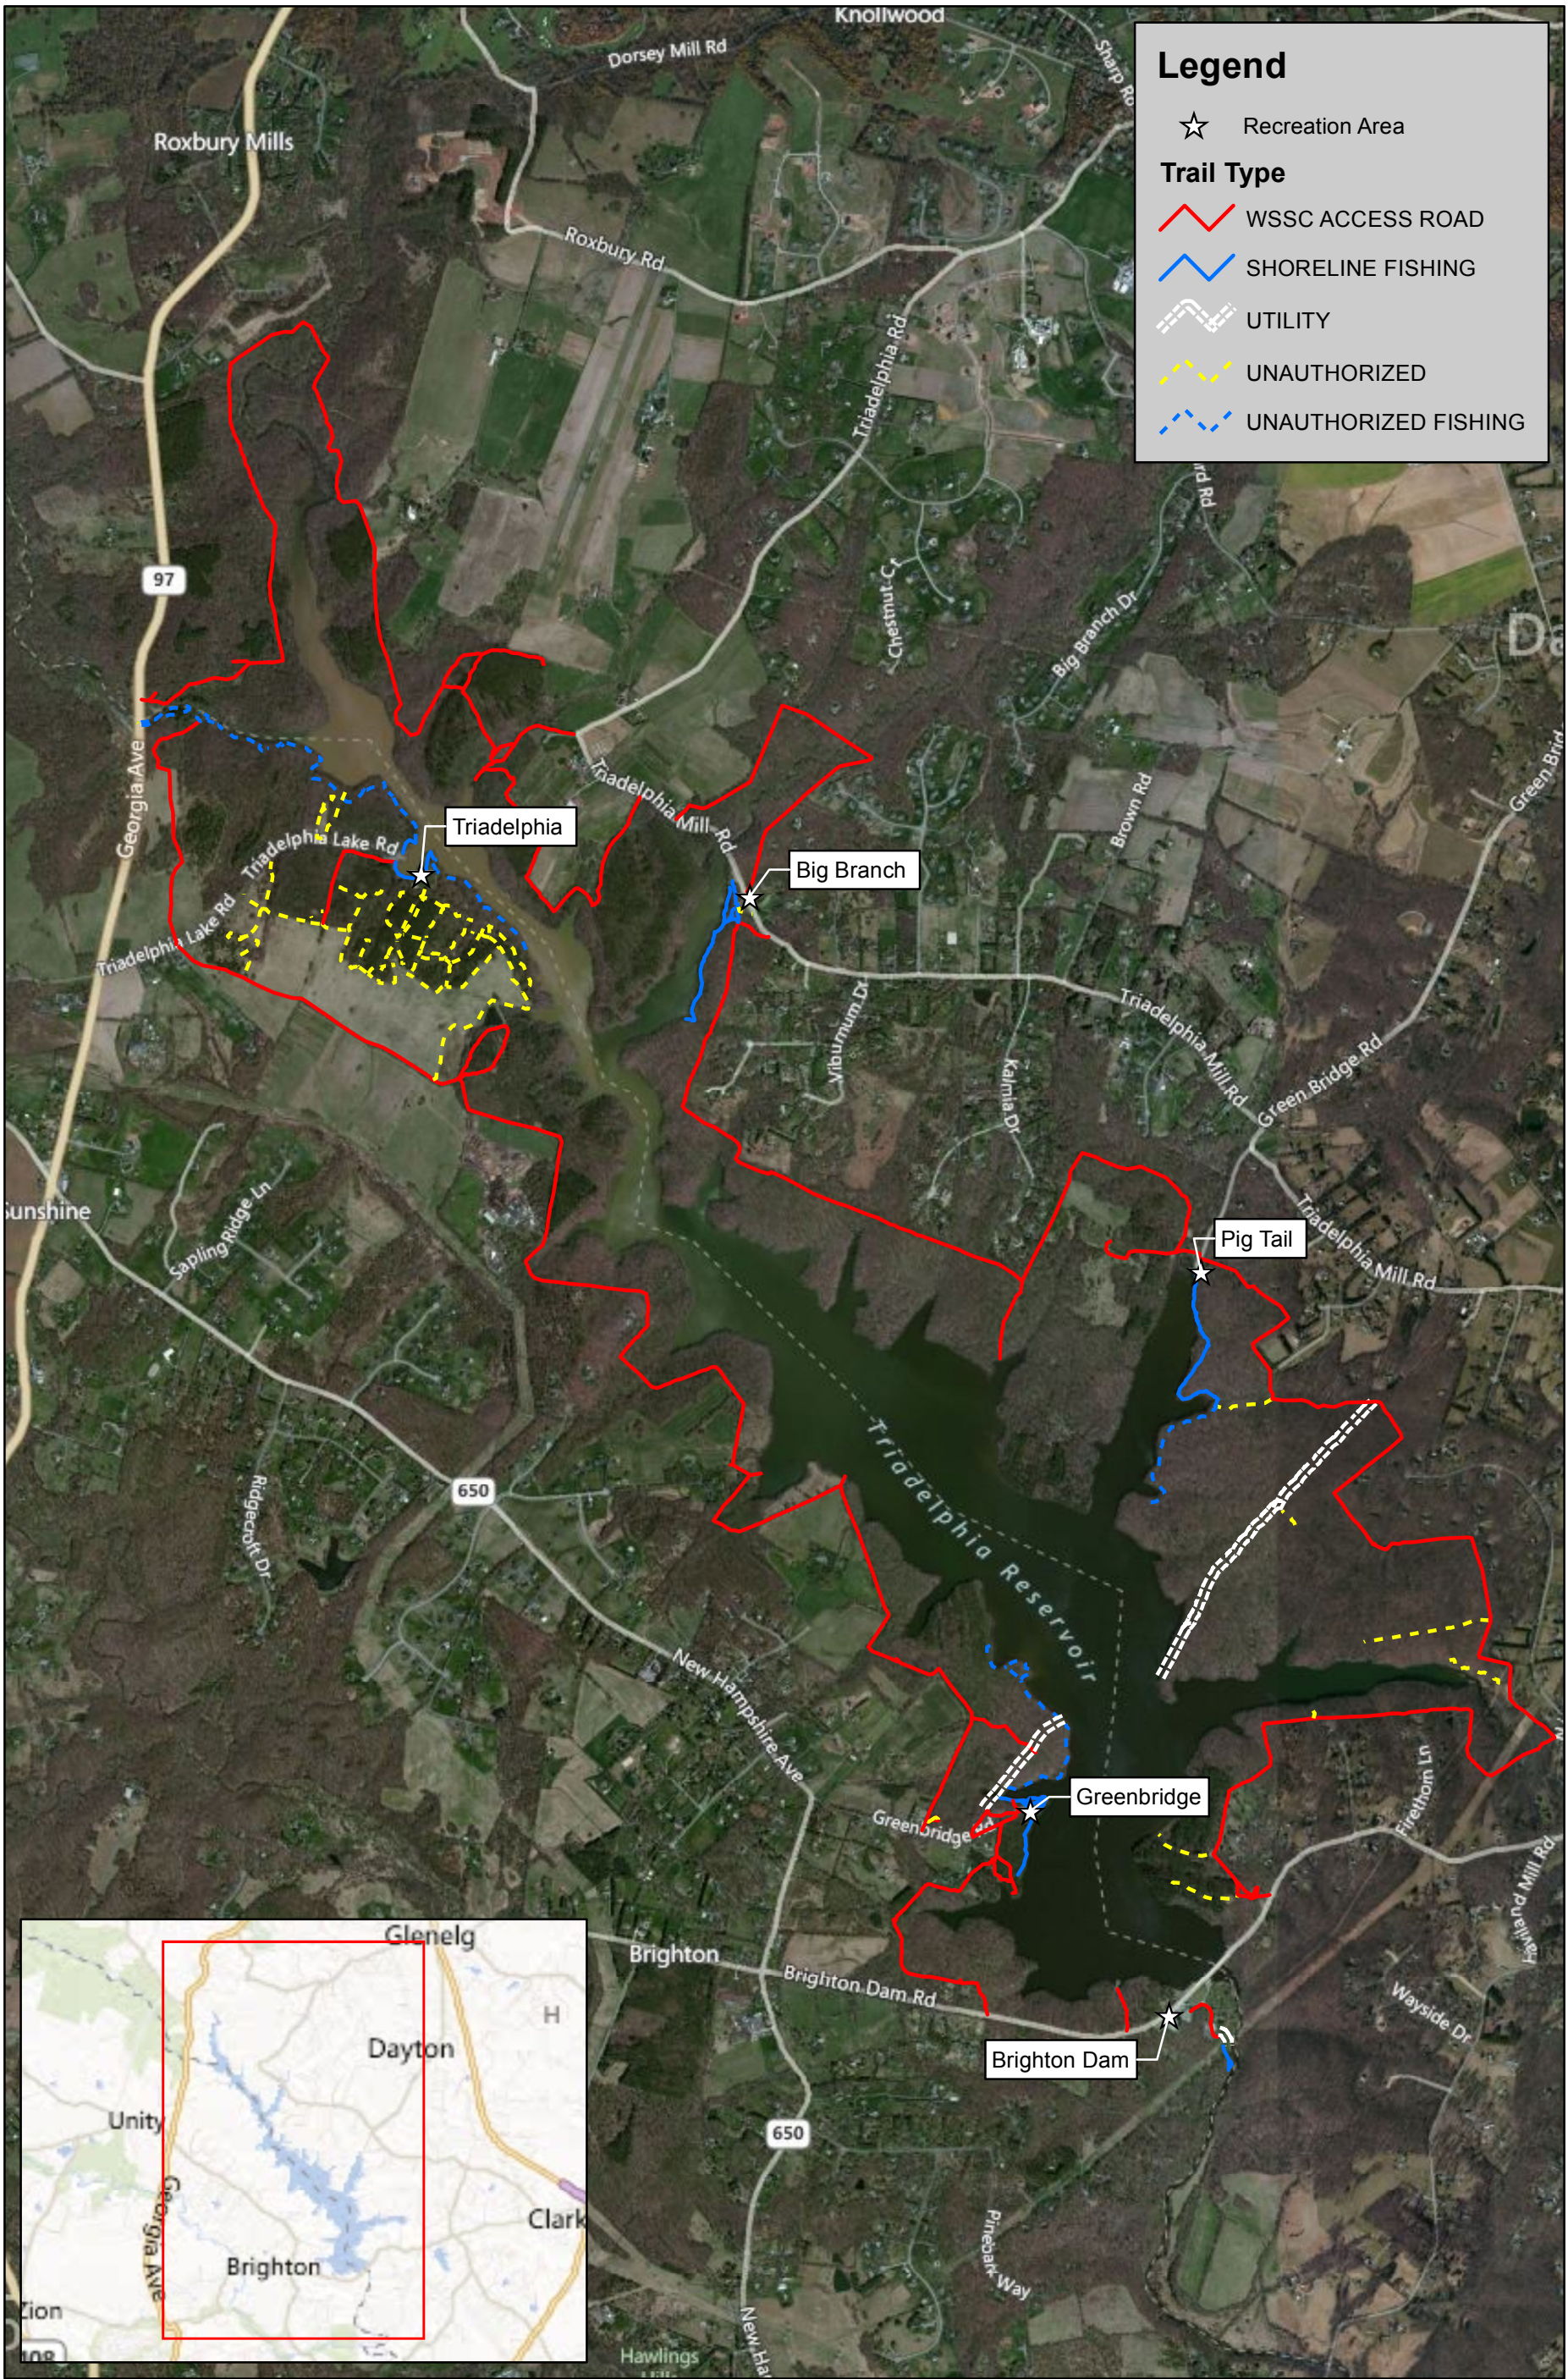
Figure 5-6 presents an overview of the GPS trail mapping for the Triadelphia Reservoir. Approximately 20.4 miles of WSSC Access Roads were mapped around the Triadelphia Reservoir. None of the WSSC Access Road located within the buffer property for the Triadelphia Reservoir is authorized for recreational use of any kind.

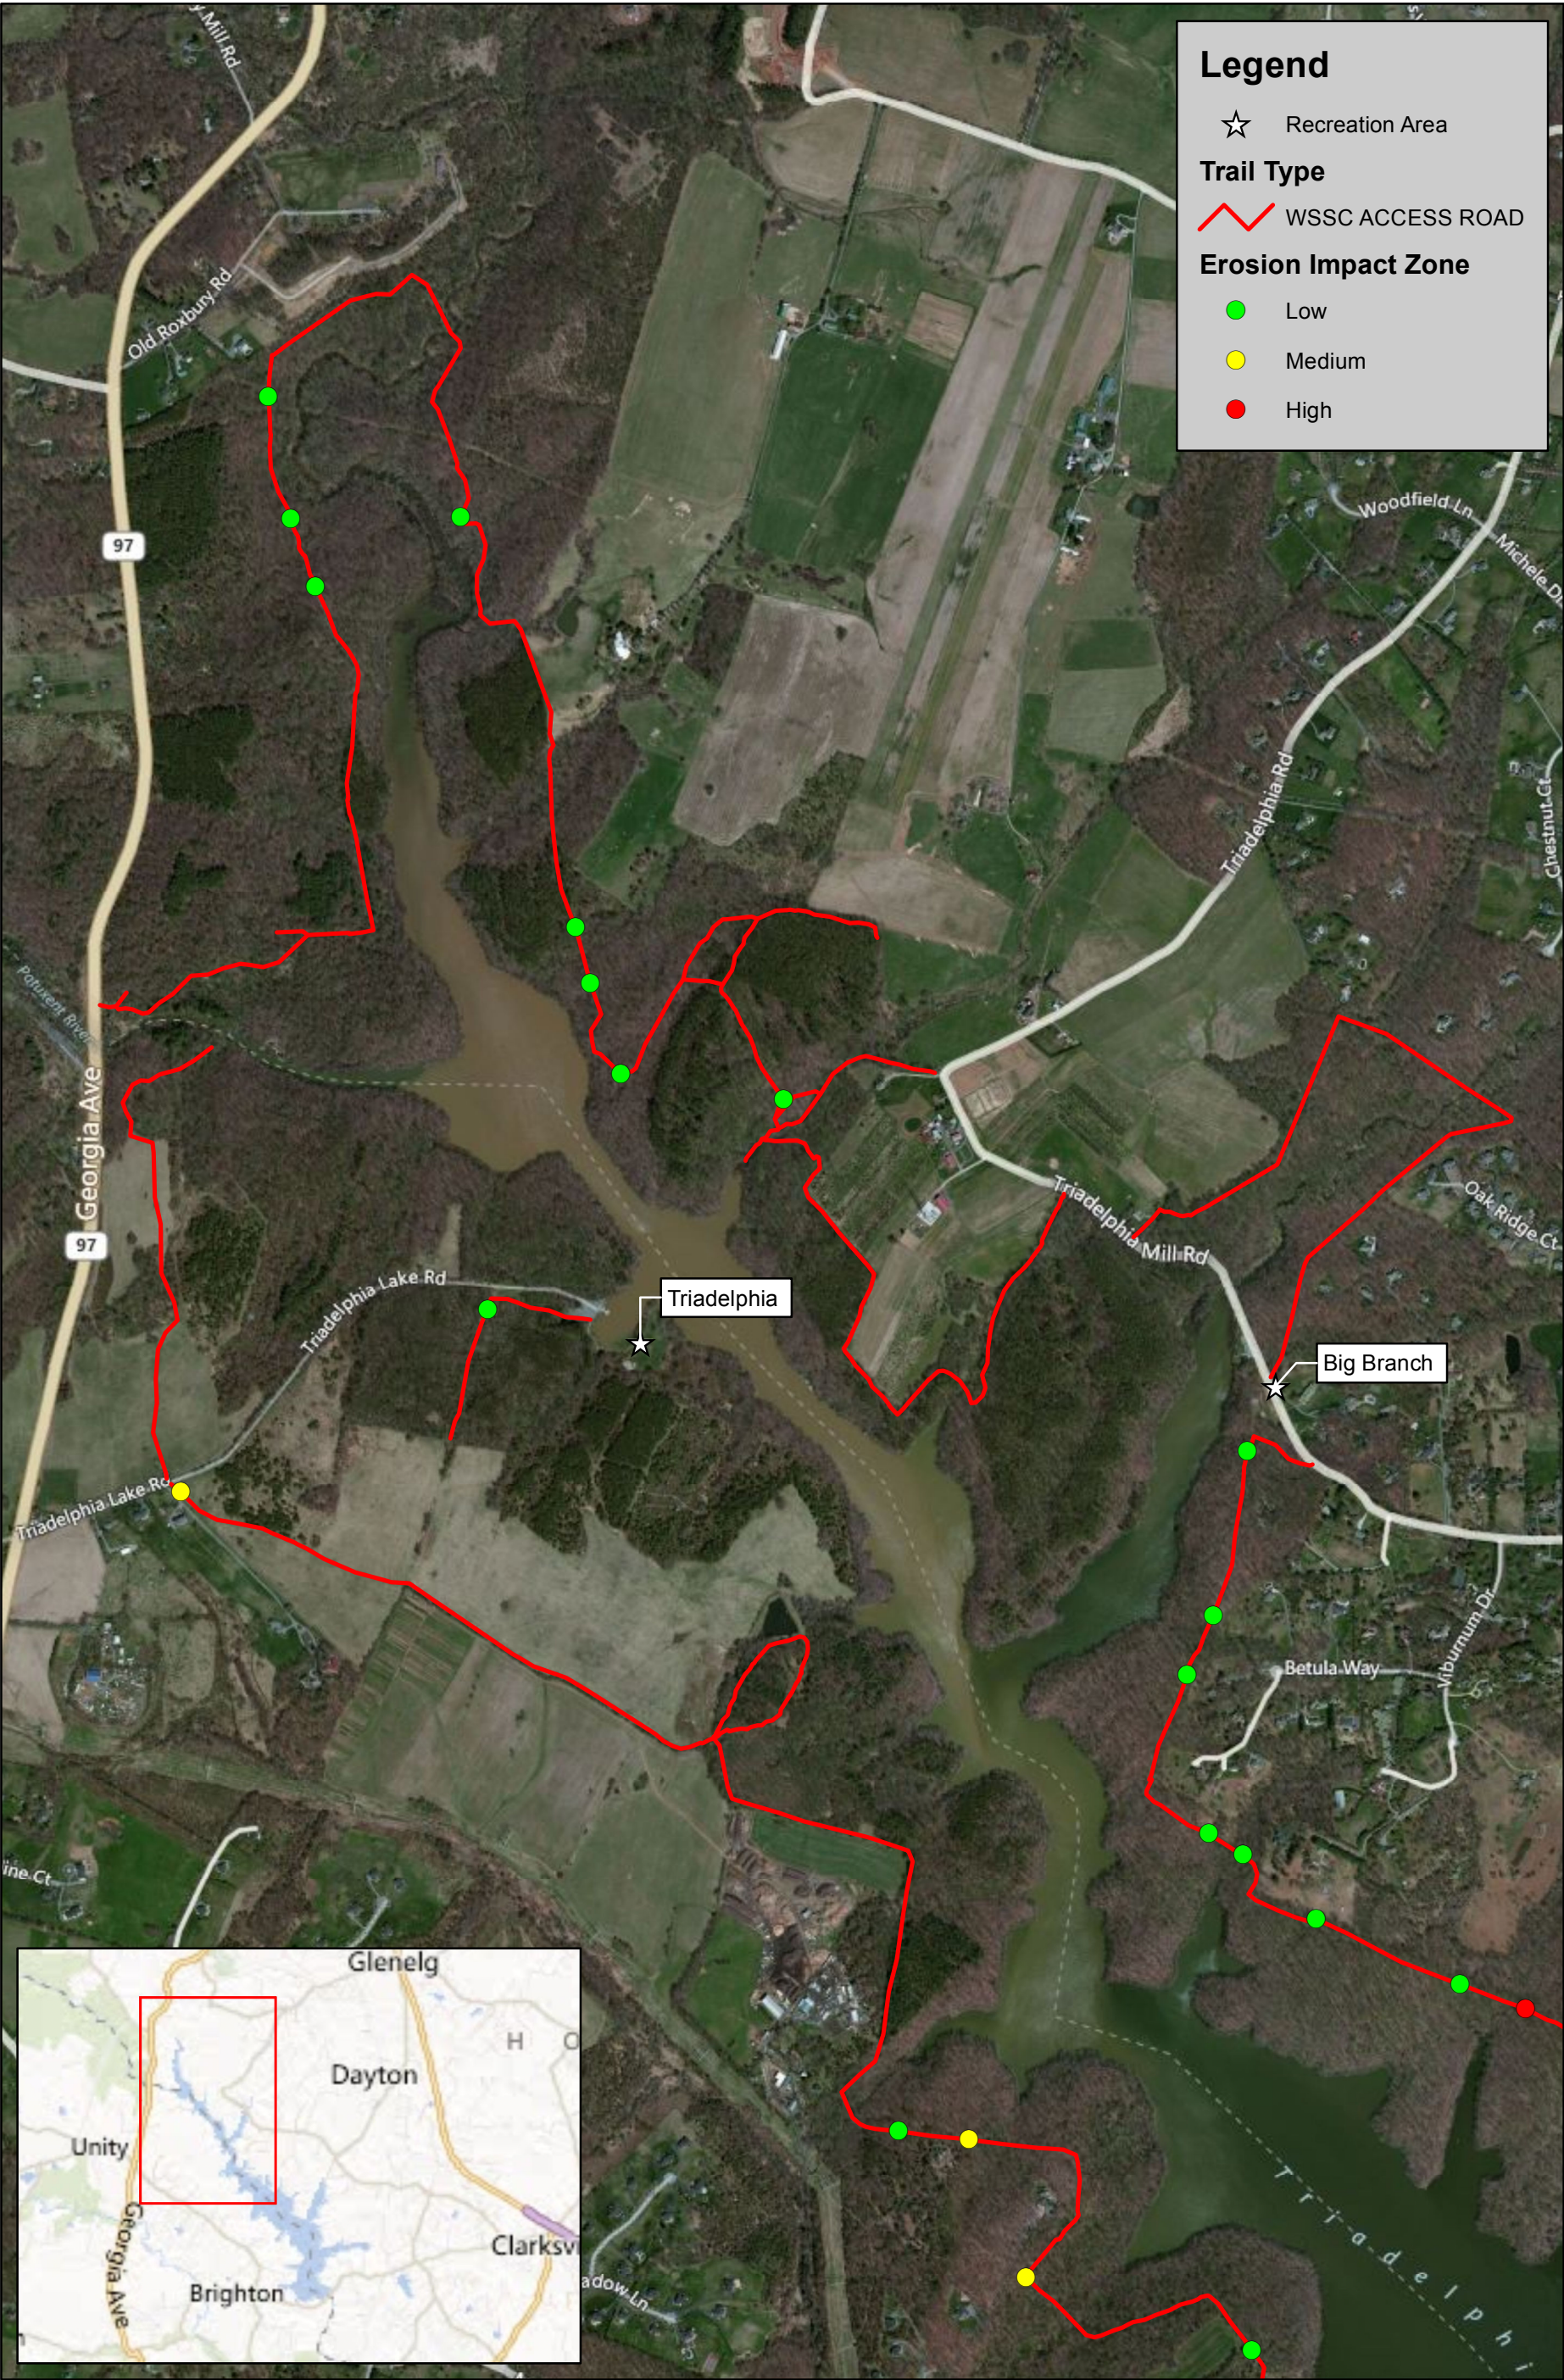
Figure 5-9. Northern Trails, WSSC Access Road
Triadelphia Reservoir

This section of WSSC Access Road extends to the north and south of Triadelphia Lake Road (Figure 5-9). This section of the WSSC Access Road is approximately 1.7 miles in length. The road has an average width of approximately 10 feet, and maximum width of 15 feet (Photo 5-38). Slopes in this section are between 6 and 10 degrees. The Access Road has minor rutting from vehicles (Photo 5-39). Trees along one section of the trail were numbered with red spray paint, and it appeared as if the trail had recently been cleared by a small dozer based on the appearance of the surface. (Photo 5-40).

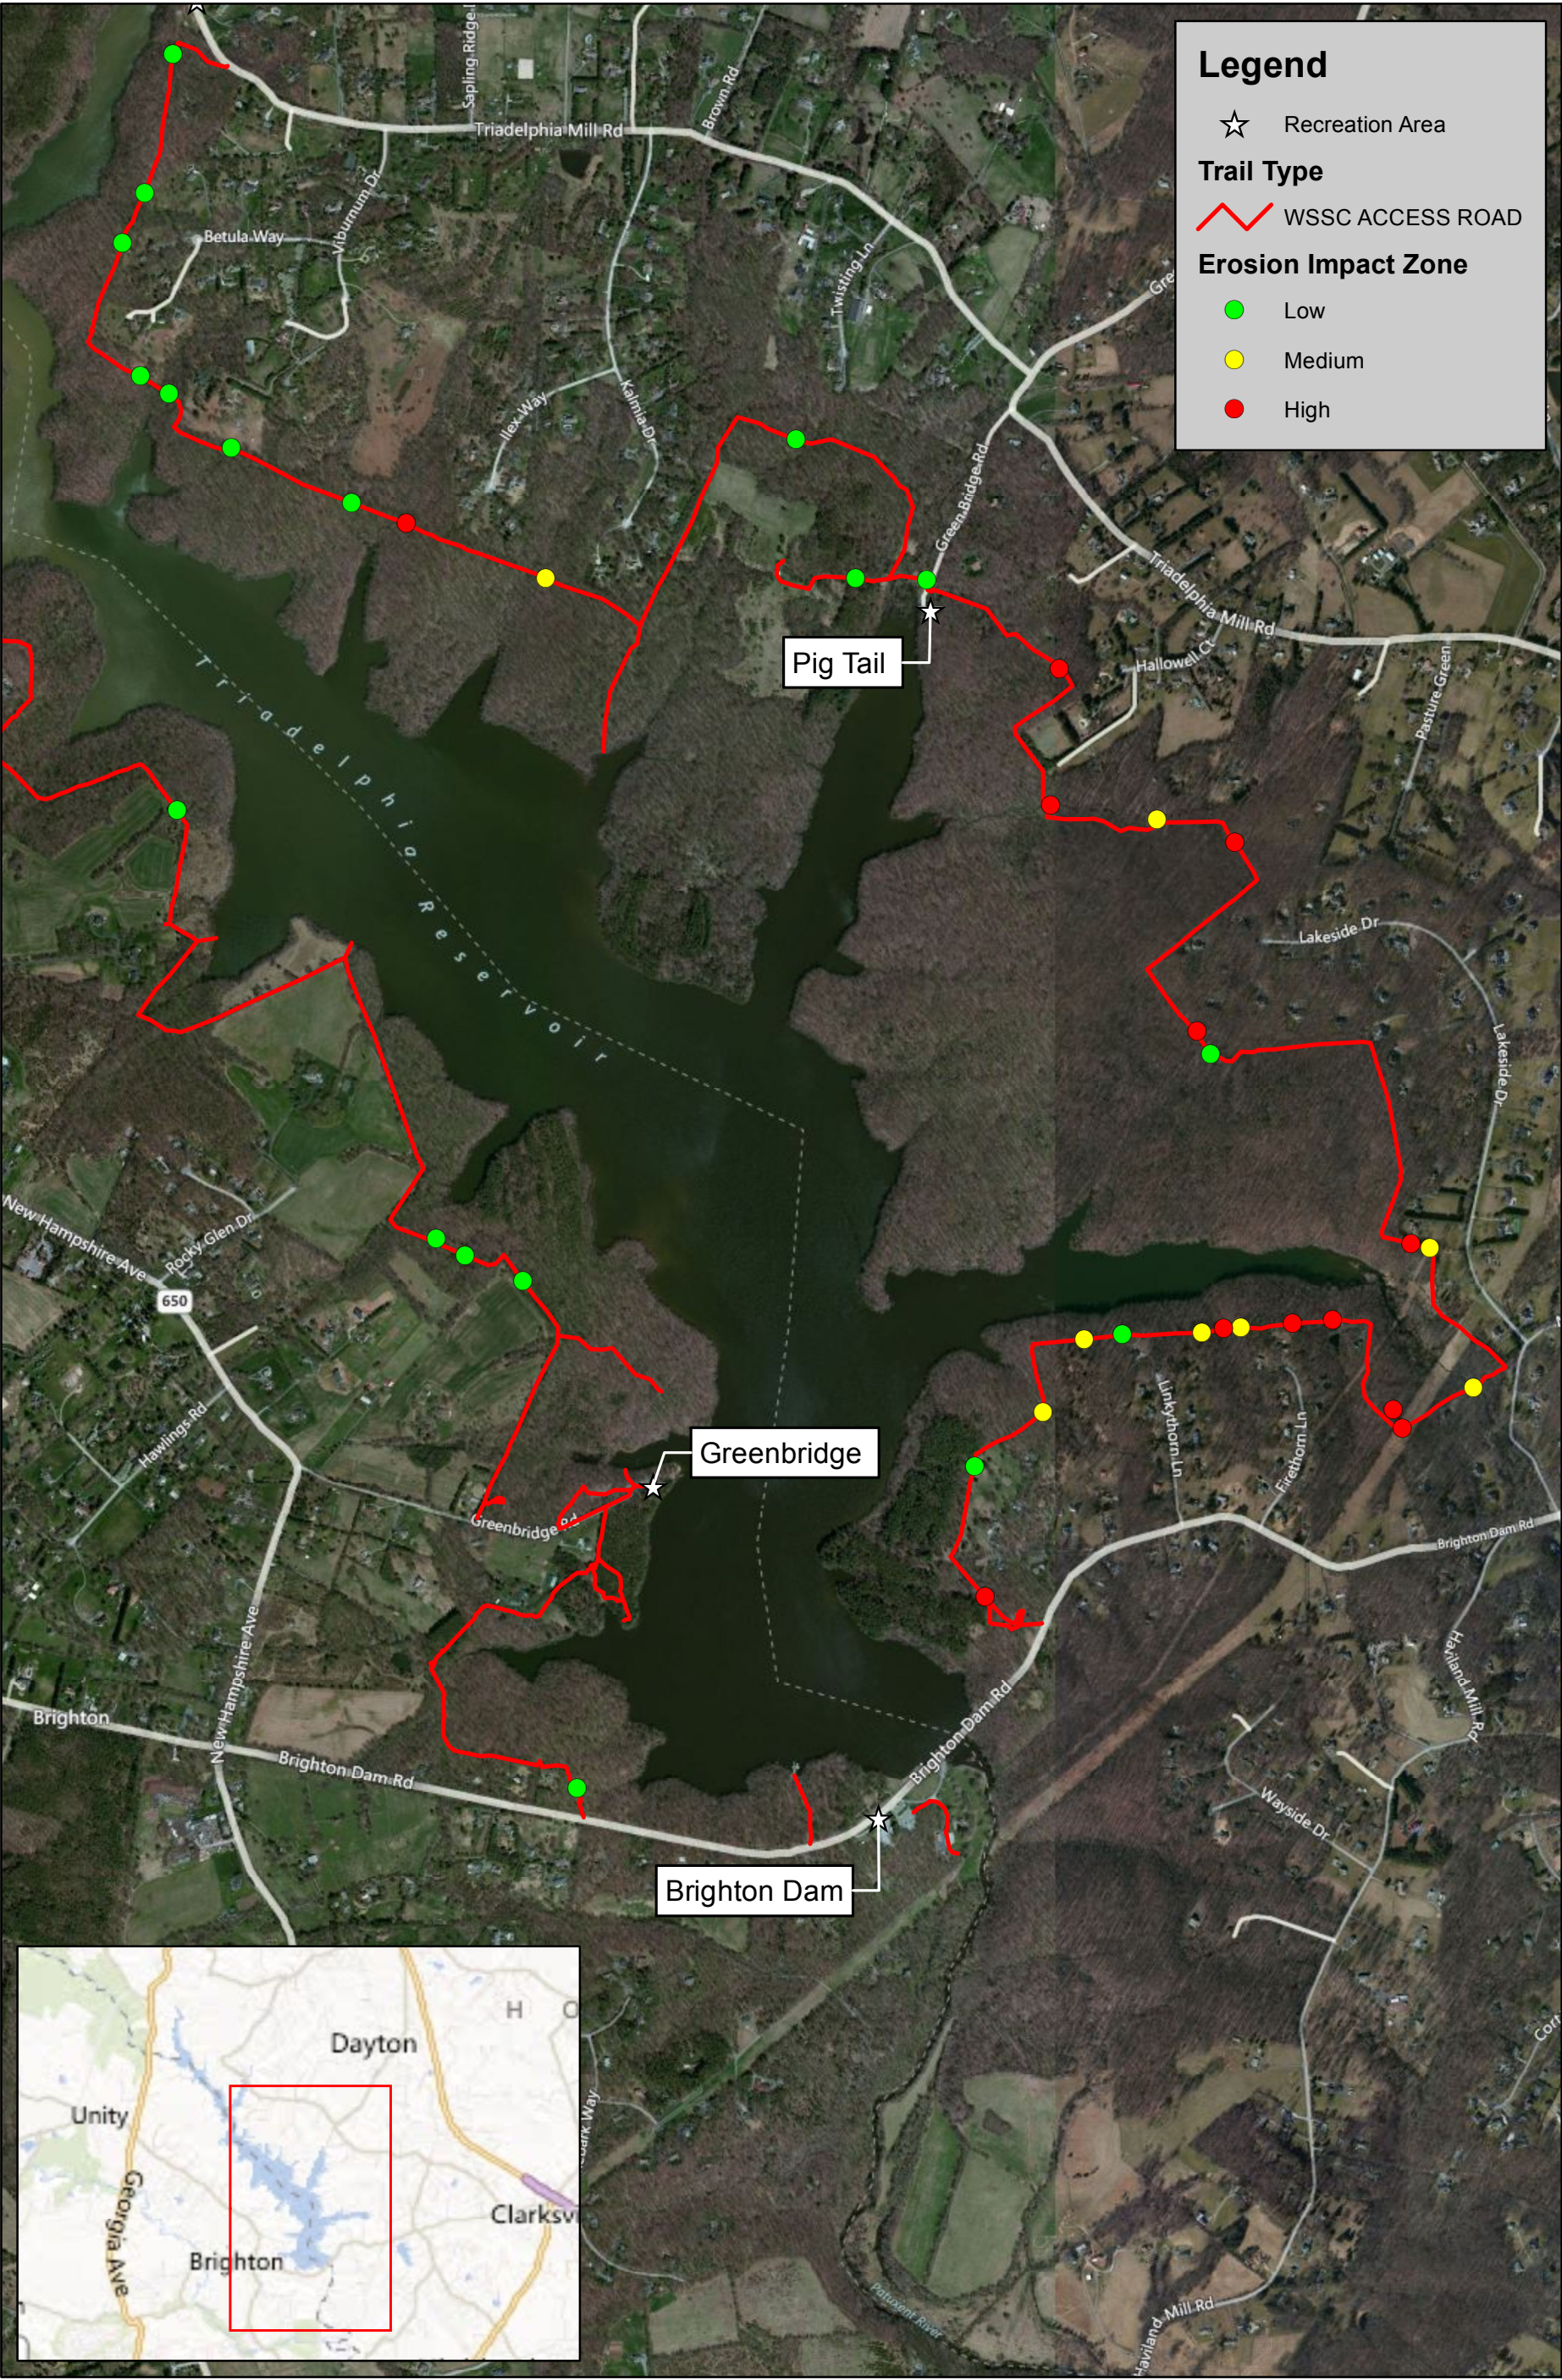
Figure 5-10. Southern Trails, WSSC Access Road
Triadelphia Reservoir

This section of WSSC Access Road is approximately 5.0 miles in length (Figure 5-10). Road width varies between 6 and 13 feet (Photo 5-41), but is about 10 feet on average. The slopes along the road are relatively flat and typically range between 6 and 10 degrees. The midsection of this trail can be accessed from Denit Estates Drive. Rutting and slight erosion are noted throughout most of this trail. However, one area in particular had more significant rutting of 10 inches deep, over a length of about 150 feet and 2.5 feet in width (Photo 5-42).

This section of WSSC Access Road is approximately 1.3 miles in length (Figure 5-10). The width of this trail varies between 8 and 13 feet, but is about 10 feet on average. Slopes vary along the trail between 8 and 15 degrees with most recorded slopes measuring roughly 10 degrees. No erosive conditions were noted on the road, although there are areas with erosion potential due to road alignment and slope conditions. The road crosses areas of open grassland that drain directly into the reservoir (Photo 5-43). There is an unauthorized trail spur from the Access Road leading to the shoreline.

The Access Road is approximately 5.99 miles in length (Figure 5-10). The width of the road ranges from 8 and 11 feet. Moderate slopes are present with a maximum of 15 degrees (Photo 5-44) but average about 10 degrees. Most of the areas west of the Big Branch Access Road were overgrown with thick vegetation (Photo 5-45). The road shows signs of slight rutting caused from vehicle traffic (Photo 5-46).

The Access Road is approximately 5.05 miles in length (Figure 5-10). The majority of the road had a width of roughly 10 feet, but ranged from 6 feet to 16 feet. The slope of the road varied significantly with a typical slope of 10 degrees and a maximum slope of 24 degrees. Most of the road is in good condition, though there were areas with rutting. The most significant rutting was 10 inches deep, over a length of 200 feet and about 1 foot width (Photo 5-47).
