# Montgomery County Department of Environmental Protection Conductivity Monitoring

# Why we monitor

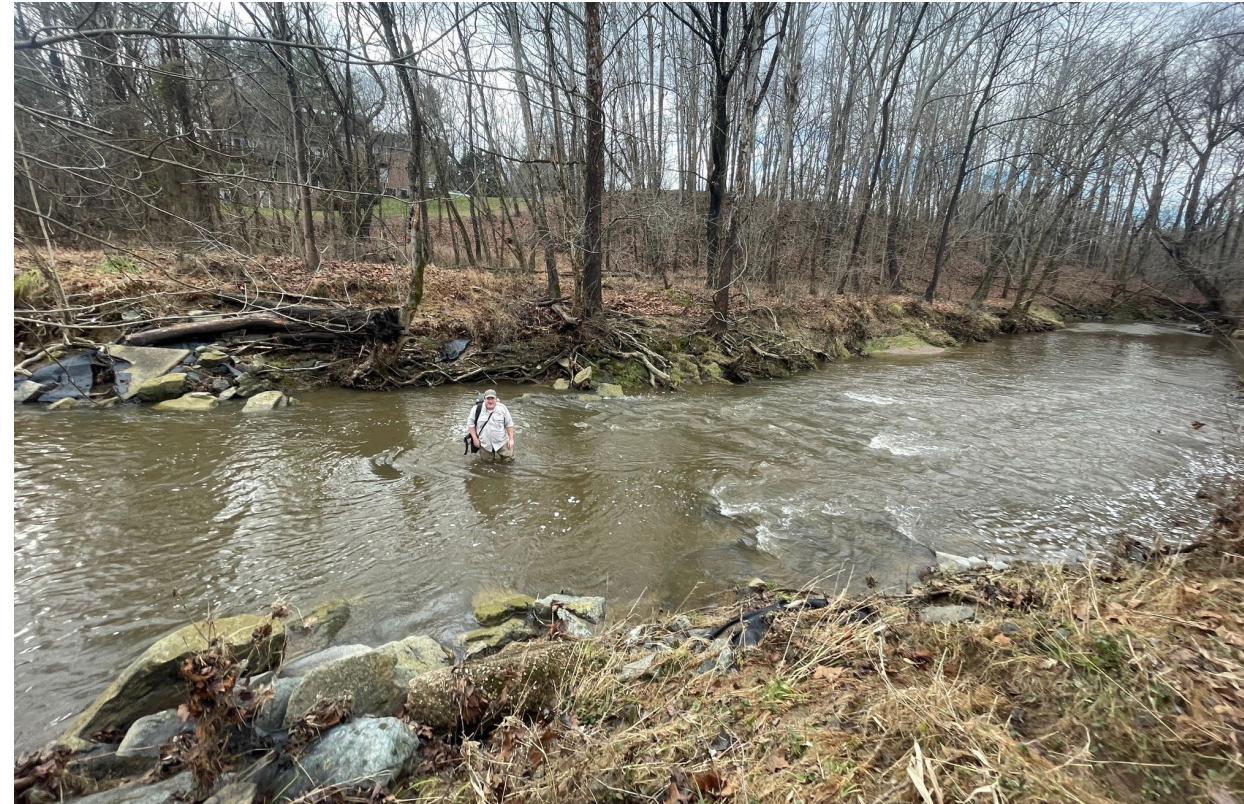
- A partnership between University of Maryland, WSSC, and MCDEP
- Measure the contribution of Watt's Branch ions to the Potomac Filtration Plant
- Two continuous conductivity loggers
  - Piney Branch tributary to Watt's Branch
  - Mainstem of Watt's Branch 1.2 miles above confluence with Potomac
- Collection of grab samples every 4-6 weeks to generate watershed specific ion curves. (Thanks Sujay!)
