**Washington Suburban
Sanitary Commission**

WSSC Ad-Hoc Committee on Large Diameter Water Mains

August 2, 2013

PCCP Management Program

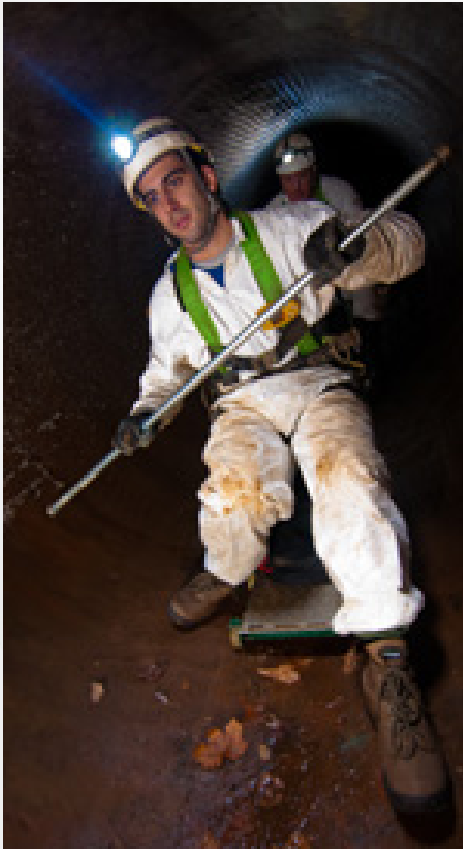
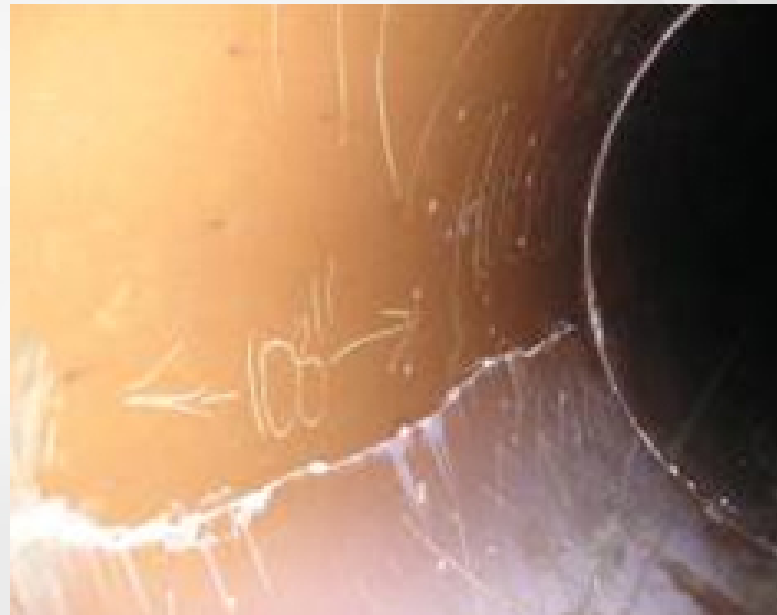
Visual and Sounding 48-Inch and Larger

Visual and Sounding: (48-inch and Larger)

- Pipe Numbering for Documentation and AFO Monitoring, Lay Schedule.
- Visual Inspection for Defects.
- Sounding Inspection for Hollows.

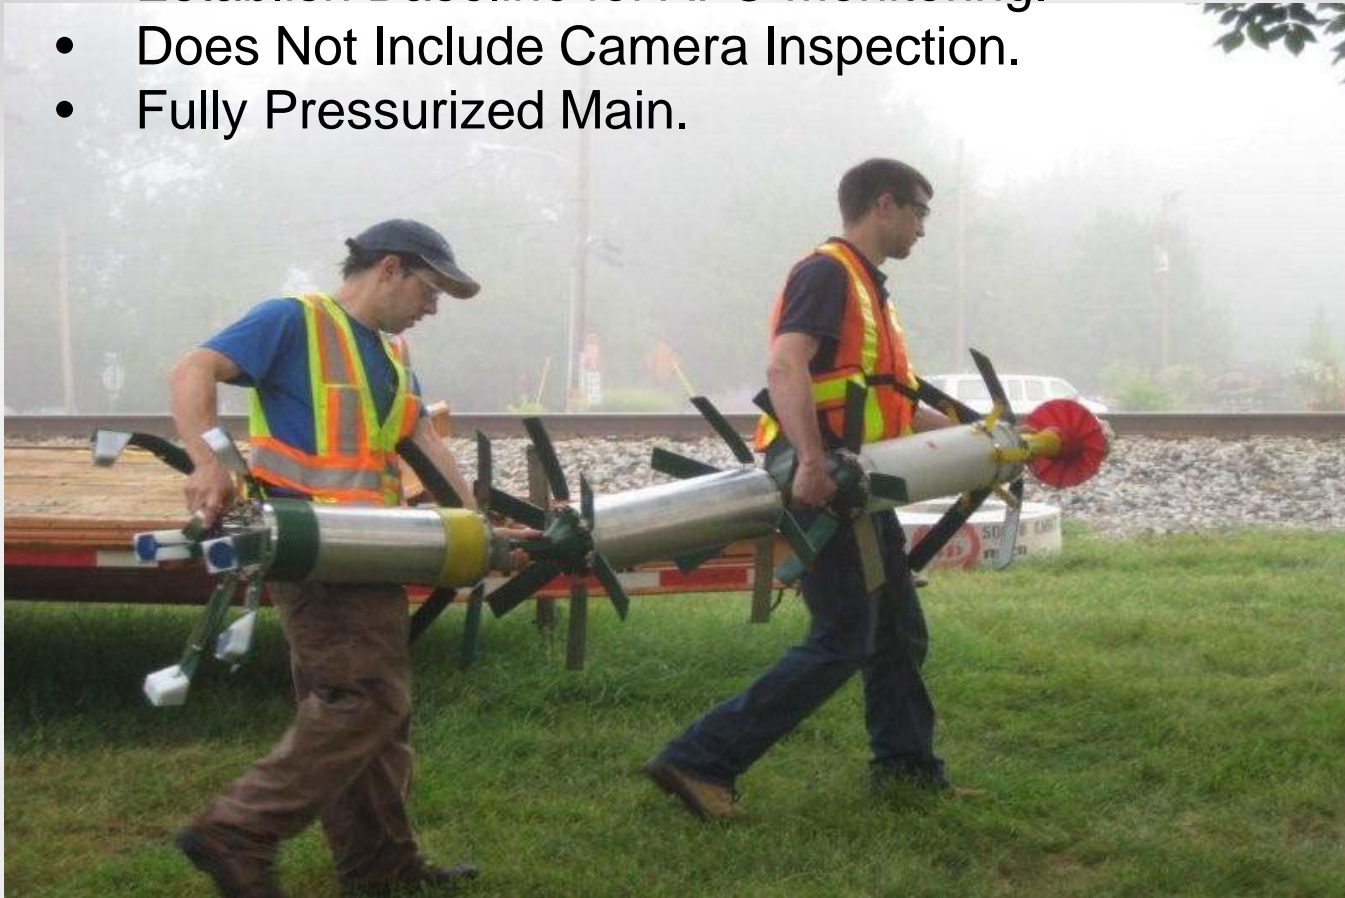
Robotic (Free-Floating) Electromagnetic 36 and 42-inch PCCP

Robotic (Free-Floating) Electromagnetic Testing: (36 and 42-inch)

- Locate/Estimate the Number of Broken PCCP Wires.
- Establish Baseline for AFO Monitoring.
- Does Not Include Camera Inspection.
- Fully Pressurized Main.

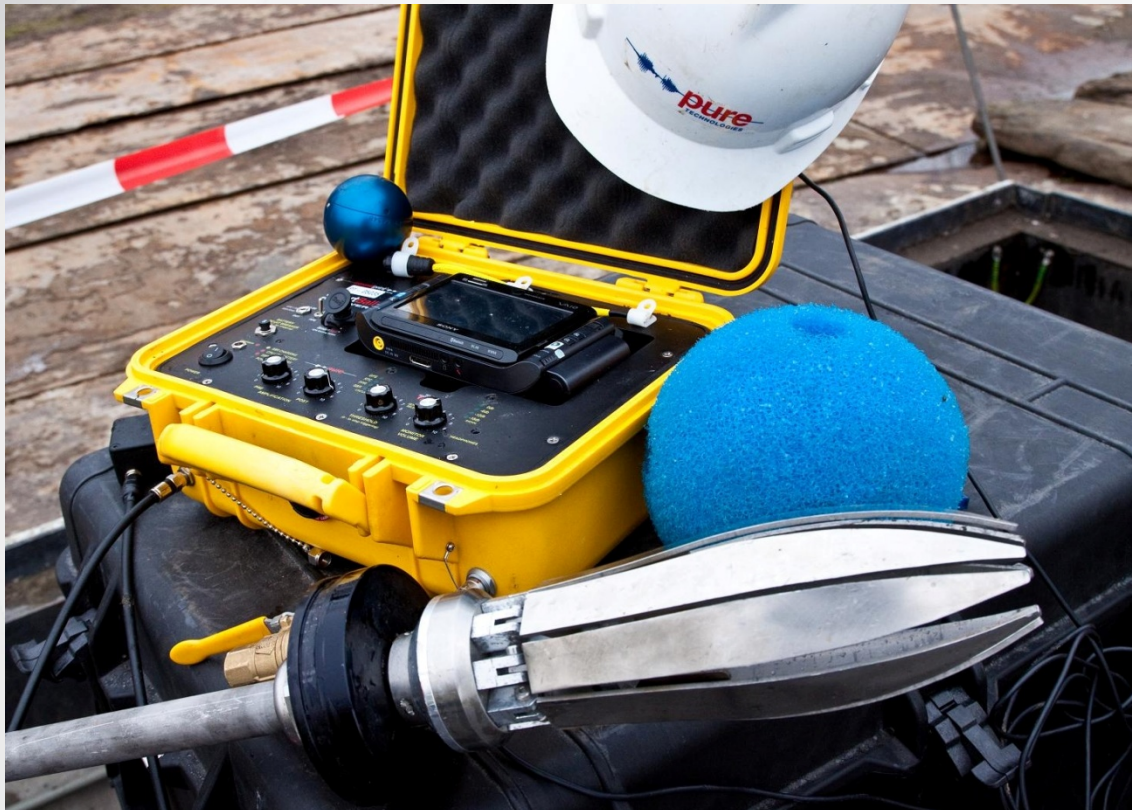
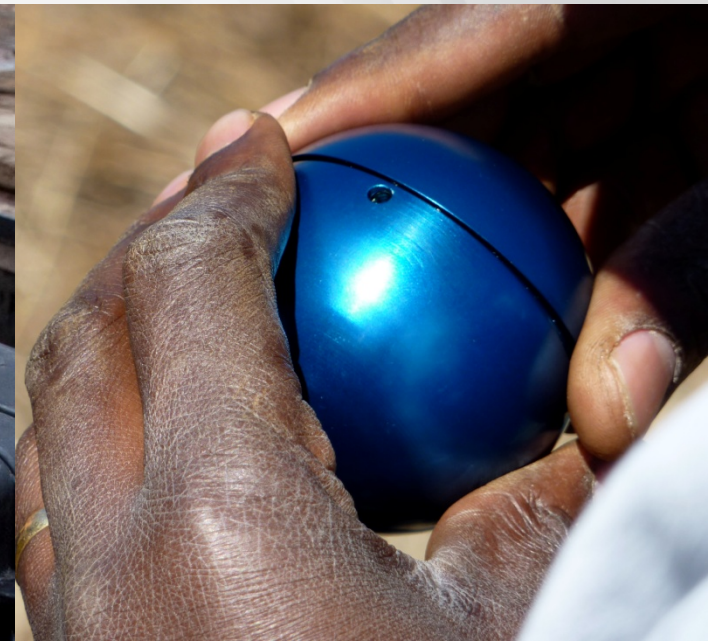
SmartBall - Acoustical Leak Testing

Acoustical Leak Testing: (36-inch and Larger)

- Deployed/Retrieved in Pressurized Main – Free Floating.
- Requires all Branch Valves to be Closed.
- Pinpoints Acoustical Leaks.
- Leaks Repaired Following Main Dewatering.

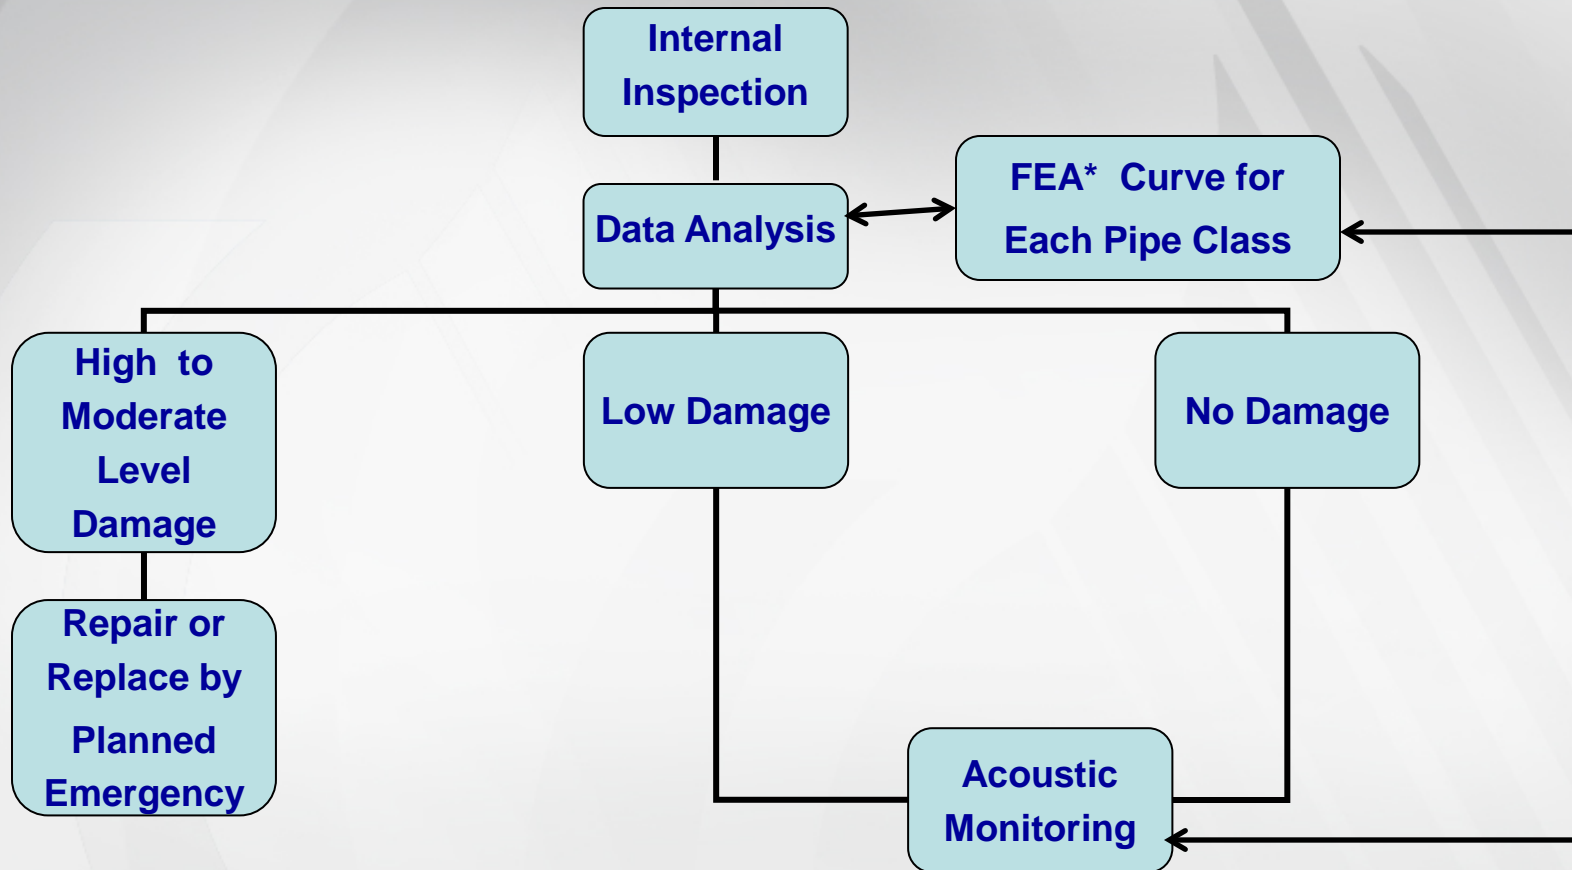
* Finite Element Analysis

Repairs or Replacements Following Inspection

- The Pipe Sections Found with a High to Moderate Level of Damage as Determined by the Finite Element Analysis Curve are Repaired or Replaced.
- Repair versus Replacement is Based Primarily on Location of Pipe for Excavation.
- Replacements:
 - Ductile Iron or PCCP Repair Kit used for Pipe Sizes 54-inch and Below.
 - PCCP Repair Kit used for Greater than 54-inch (Non-DIP Sizes).
- Repairs: Primarily Internal with Full Stand Alone Carbon Fiber Composite.
- All Repairs and Replacements are Permanent for the Life of Pipeline.

- Acoustical Wire Breaks Go Directly to Pure Technologies Calgary Office for Analysis.
- Baseline Wire Break Count added to AFO Wire Breaks.
- Compared to FEA Curve for that Pipeline.
- No Concern: No Action
- Concern: WSSC is advised by Pure Technologies of Recommended Action.

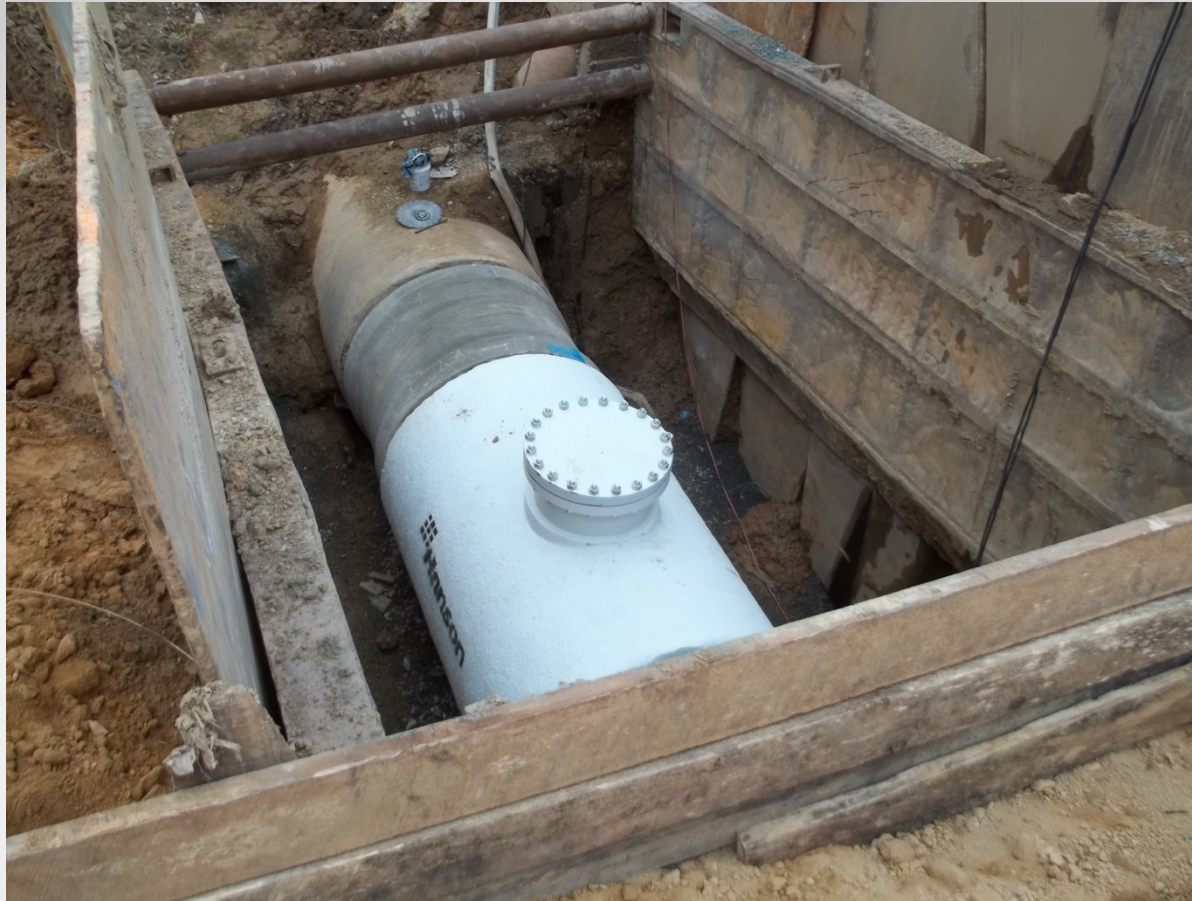
PCCP Replacement with PCCP Repair Kit

PCCP Repair Kits are
Not Pre-Stressed Pipe –
Made of Steel Pipe with
Concrete Encasement

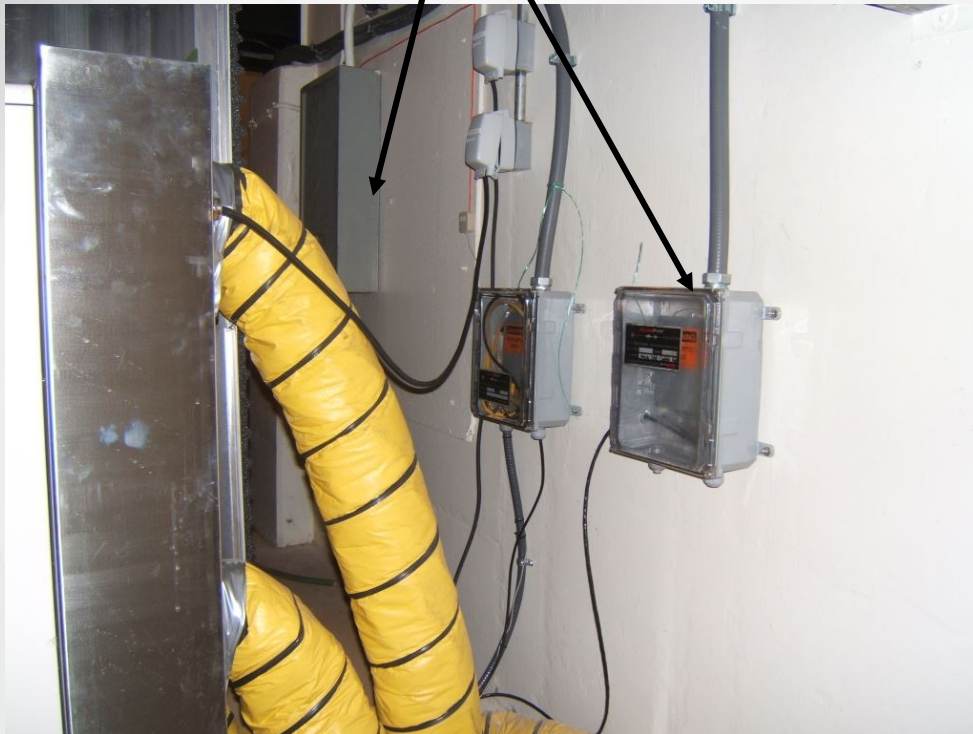
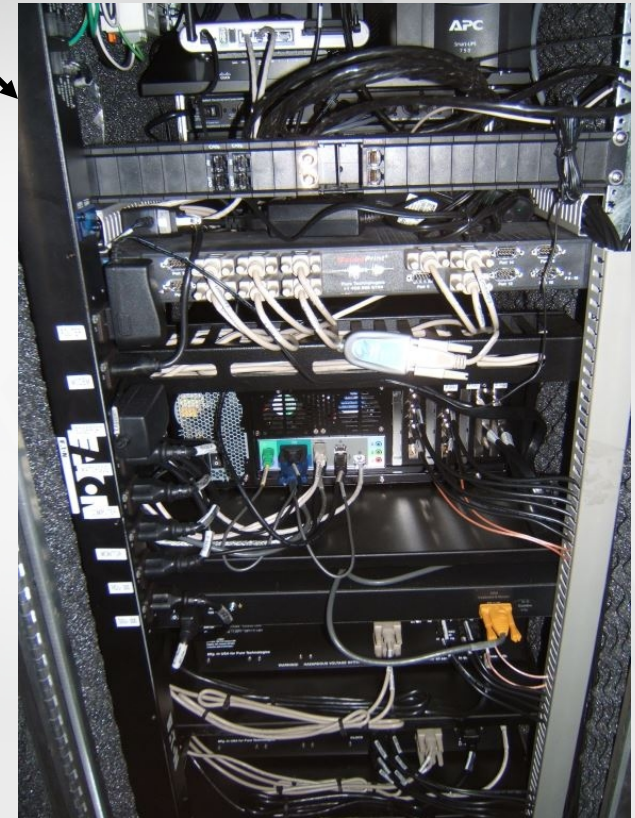
Fiber Optic Cable Installed Inside Pipe

**Data Acquisition and
Communications
Wire/Power
Connections**

**Back of Data
Acquisition Unit**

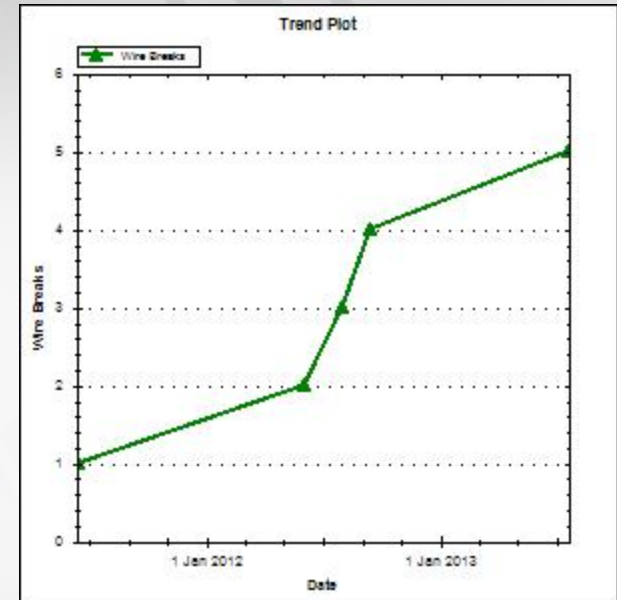
The SoundPrint® Data Processing Center has classified a Wire Break event for the monitoring station at WSSC-PAFO48.

Location: PFO48 (13) 66-2621 Station # 4+87

61-12	61-13	61-14
PCCP	PCCP	PCCP
0+0=0	0+5=5	0+0=0
0	5	0
4+90.64	4+86.88	4+77.21

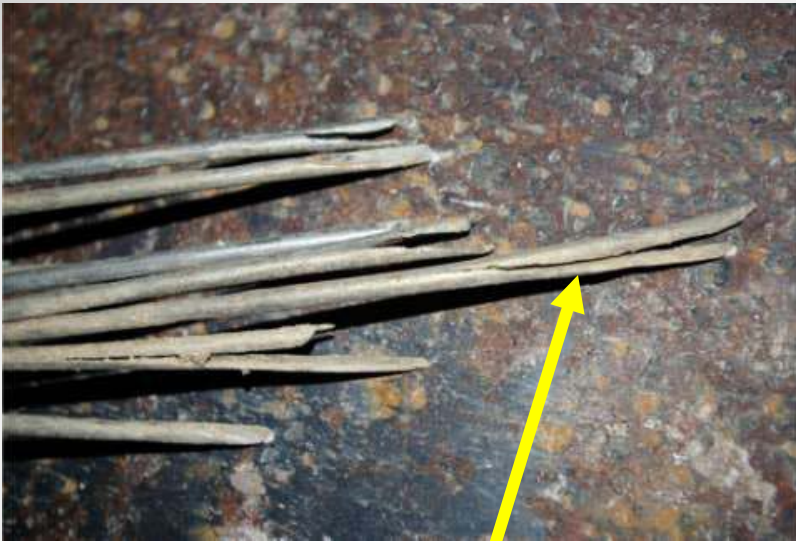
Hydrogen Embrittlement Wire Failures:

**Wire Split
Fractures**

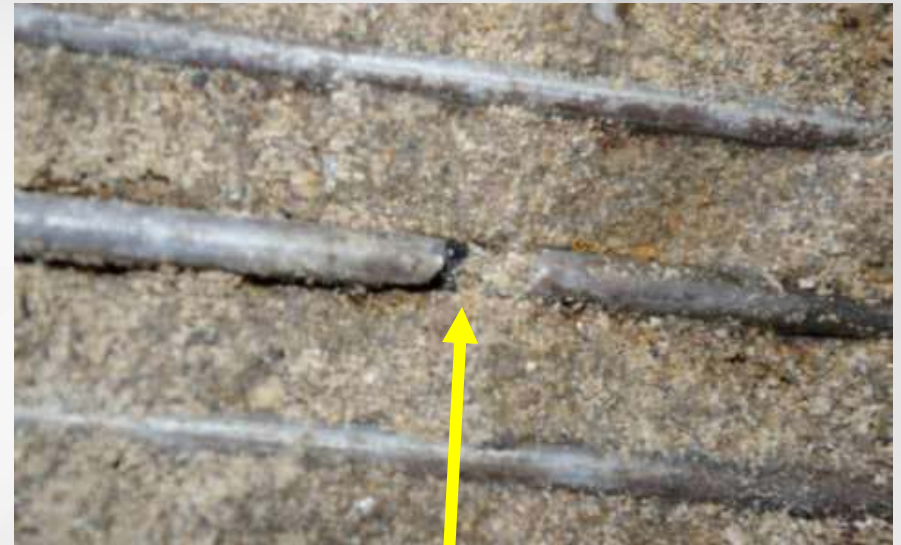
**Wire Tensile
Fracture**

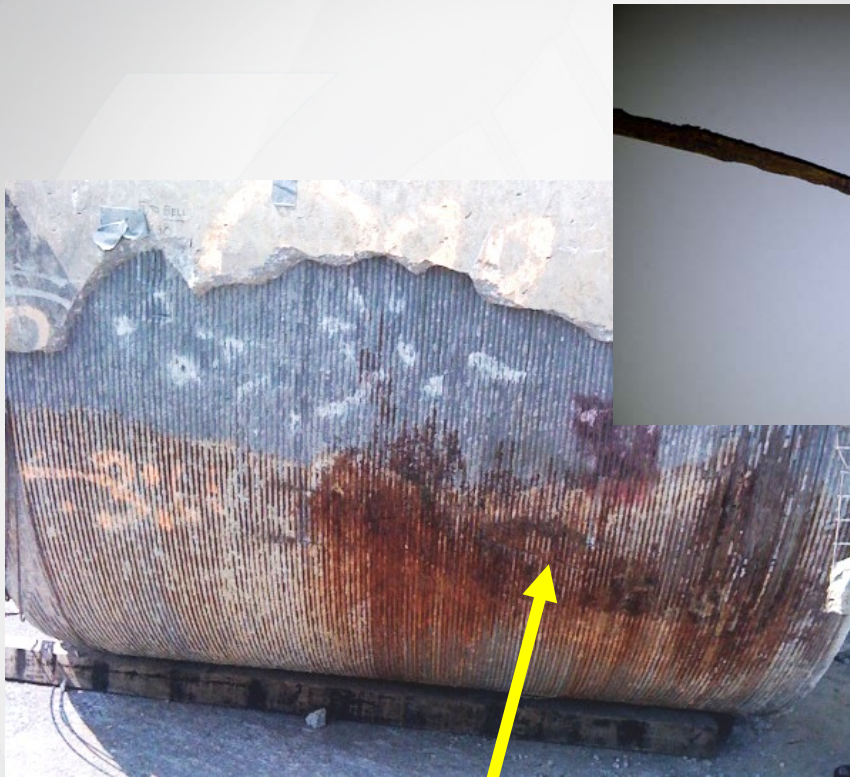
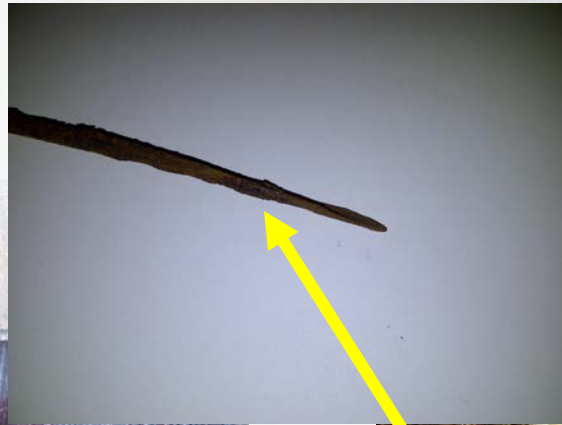
Wire Failures Due to Electrochemical Corrosion:

Wire Corrosion
