Study Results, Observations, and Recommendations

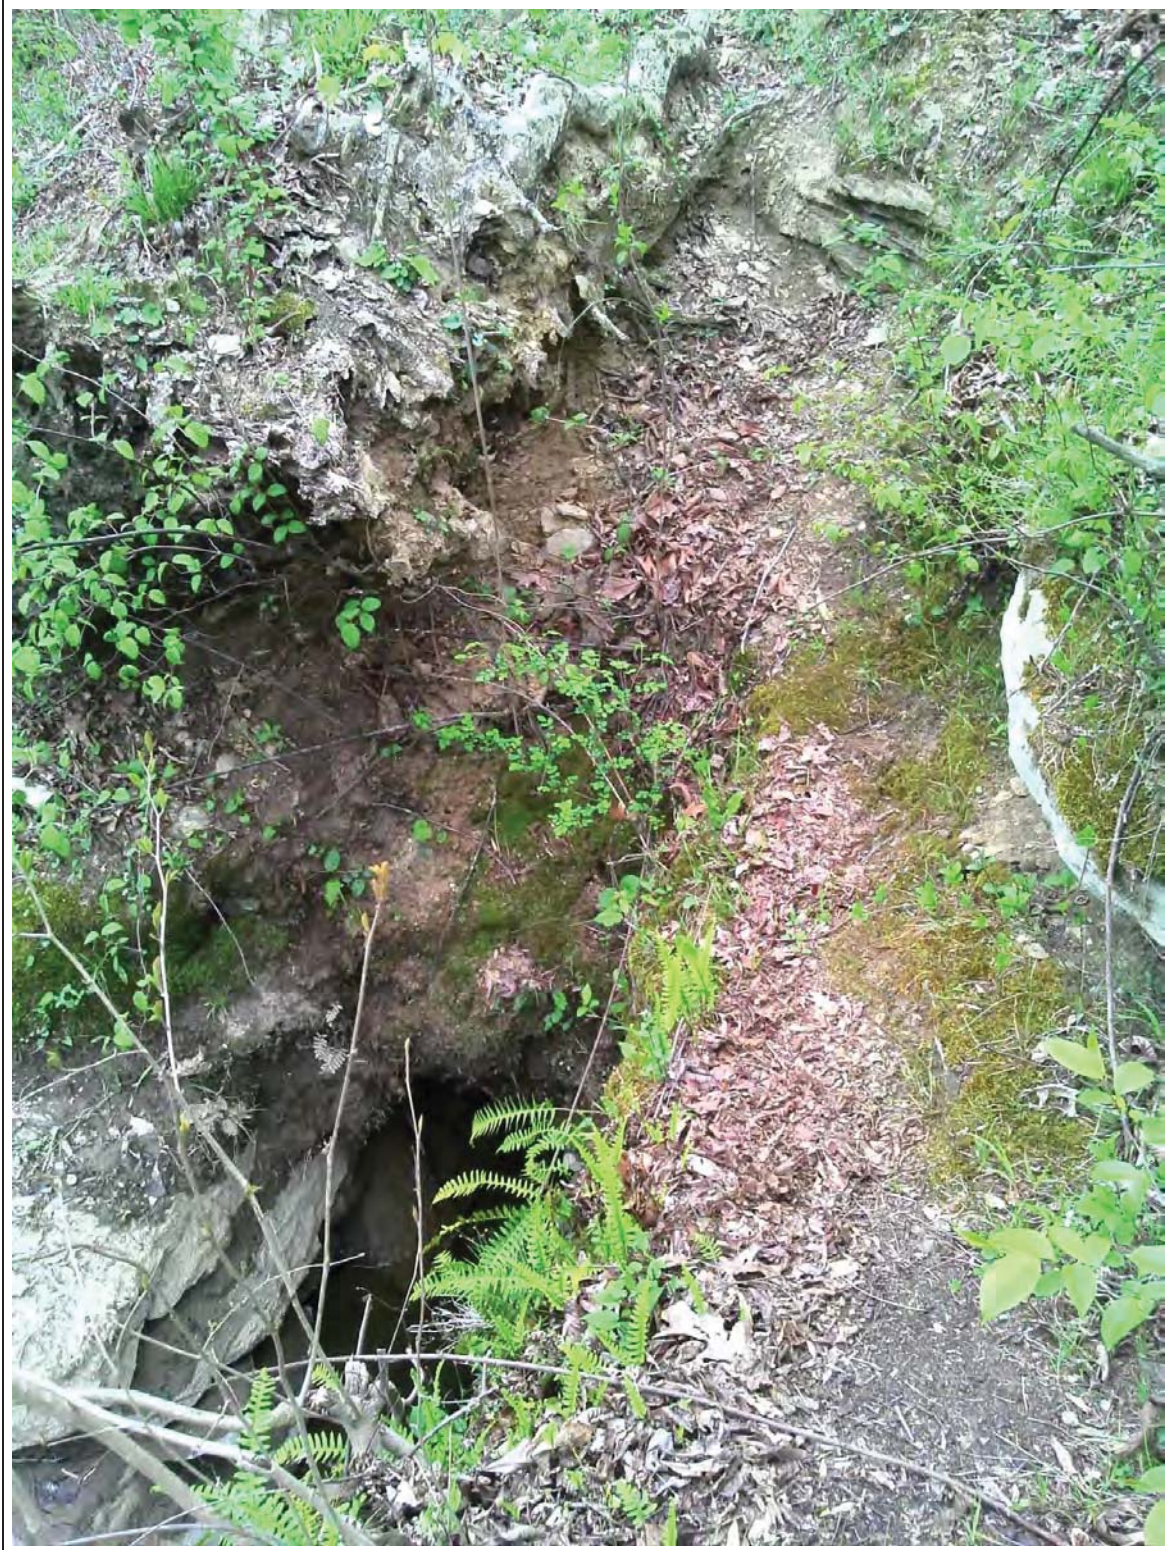
Photo 5-2: Tucker Lane hole in trail

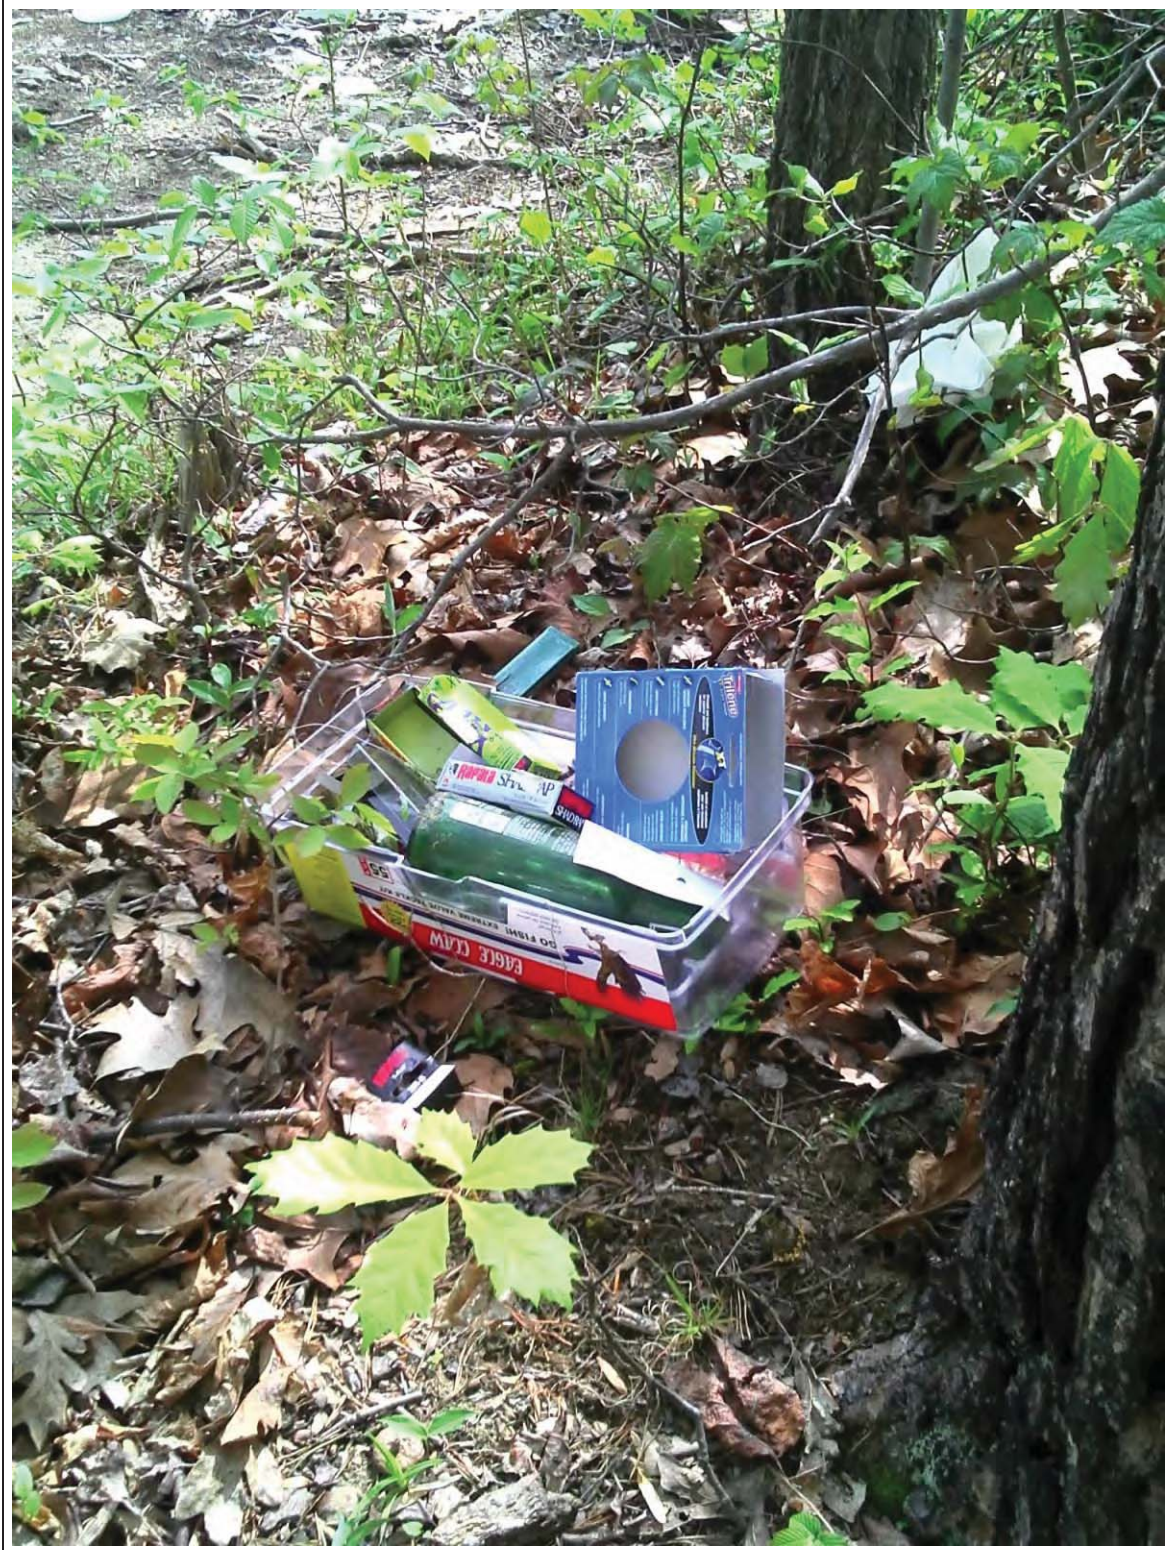
Photo 5-5: Supplee Lane Recreation Area fishing equipment packaging found along the trail

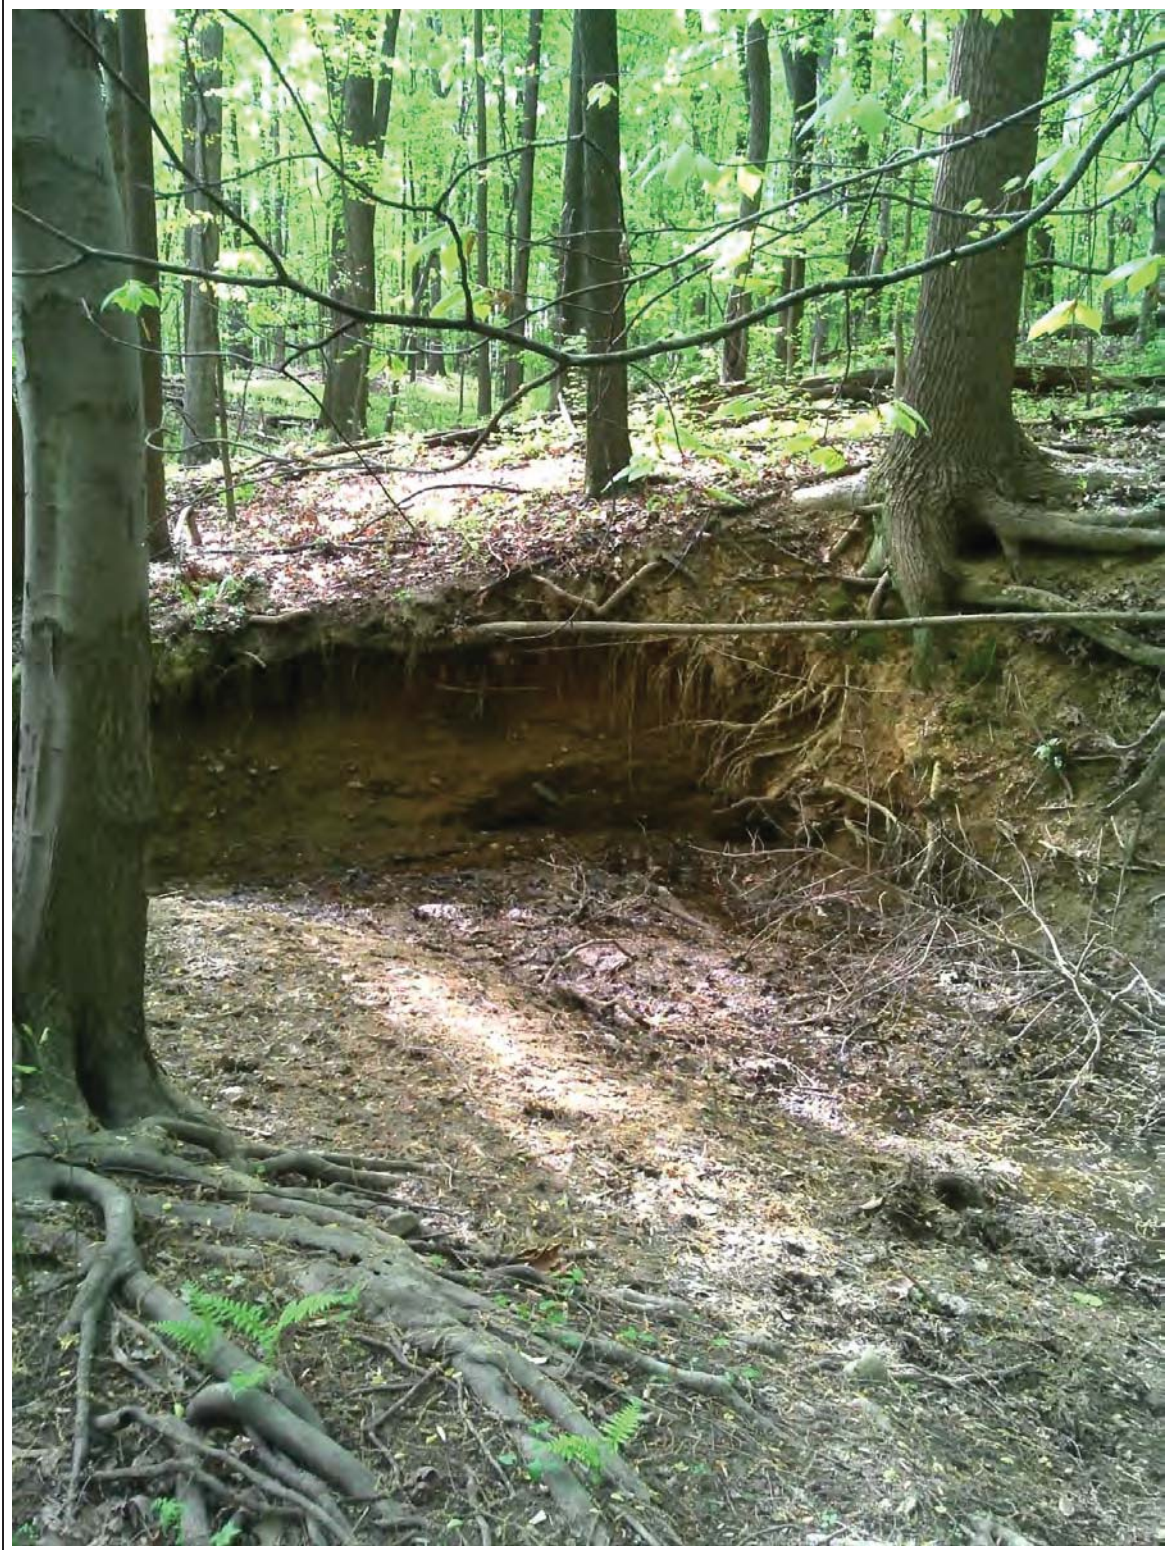
Photo 5-6: Supplee Lane Recreation Area unauthorized shoreline trail with substantial bank erosion

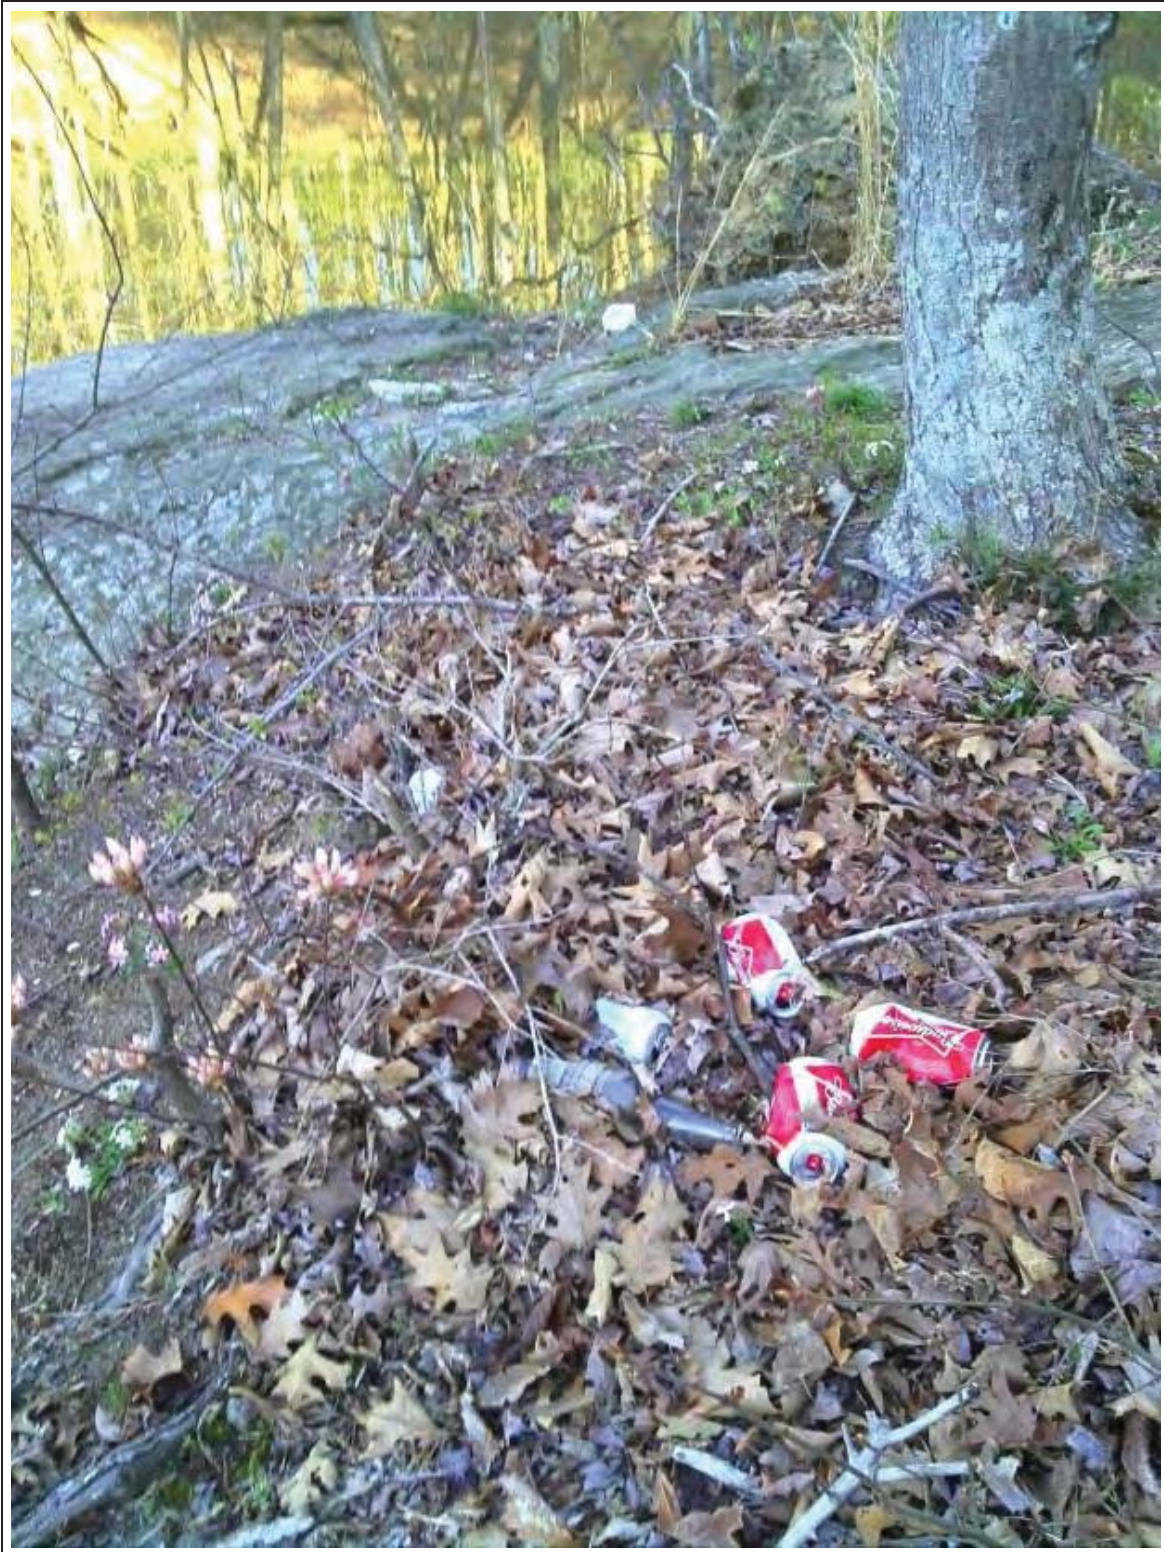
Photo 5-11: Scotts Cove West Shoreline Trail trash on trail

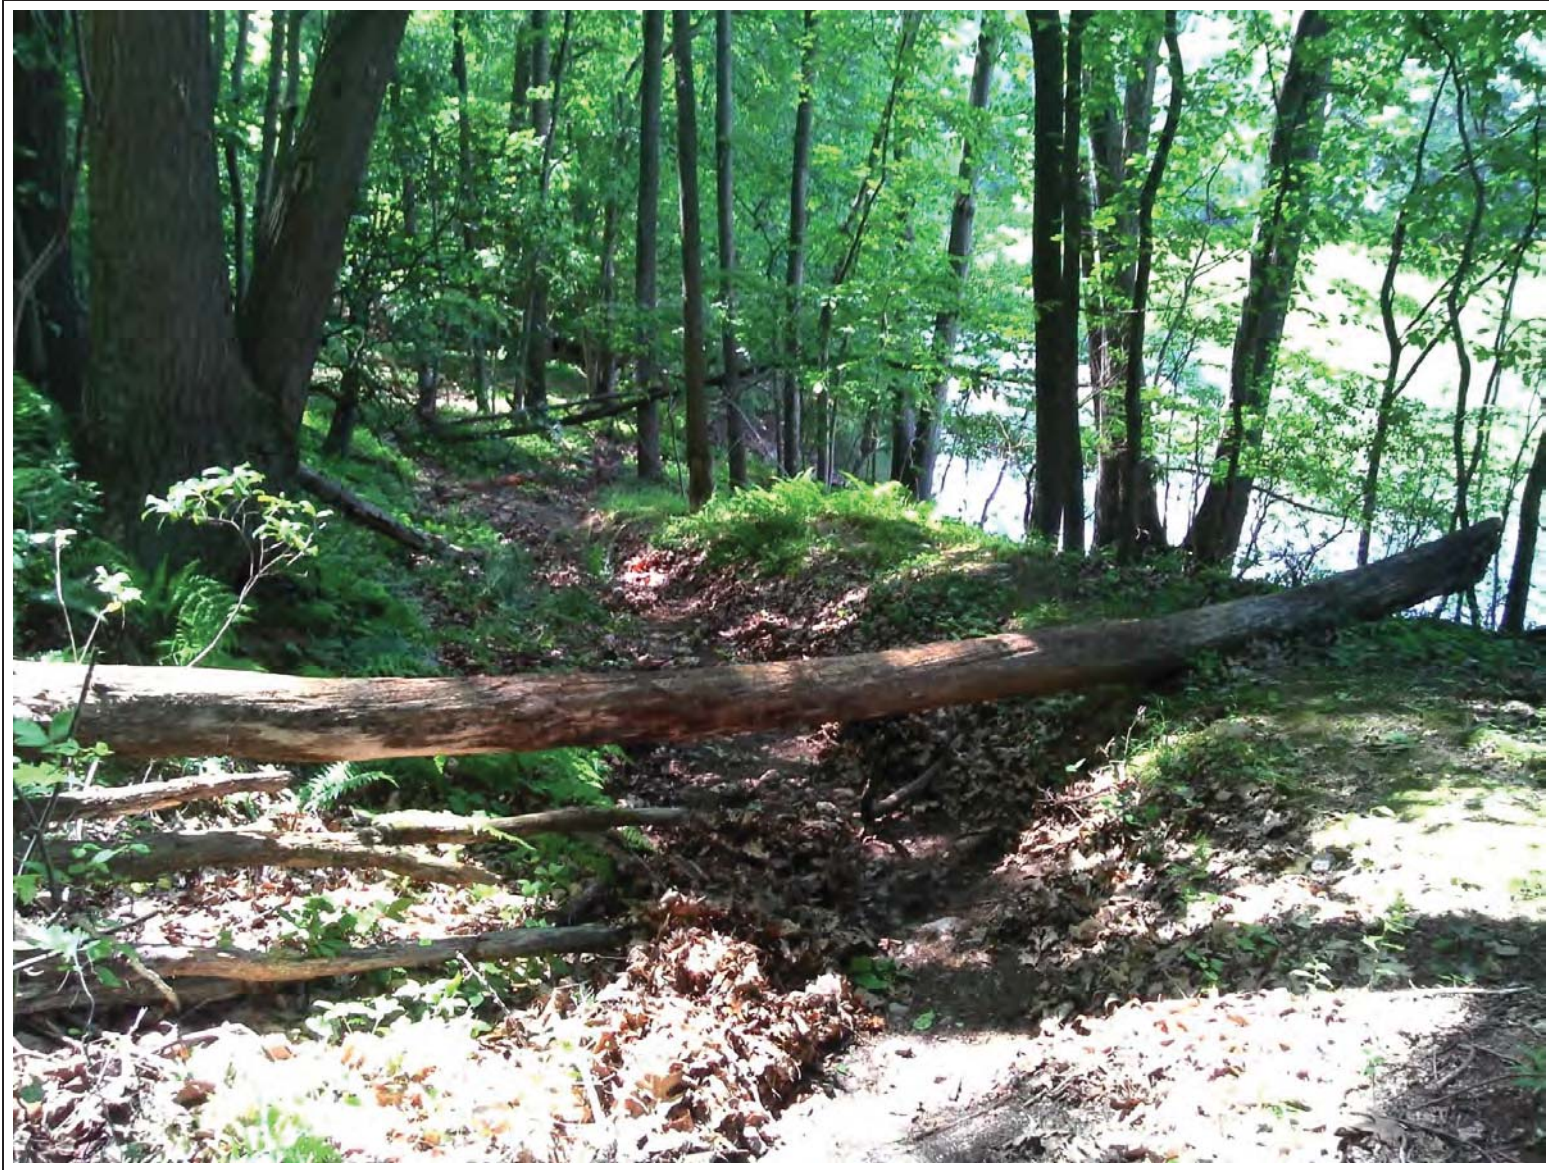
Photo 5-17: Pat Oliva Trail close to water at the Olivia Pass

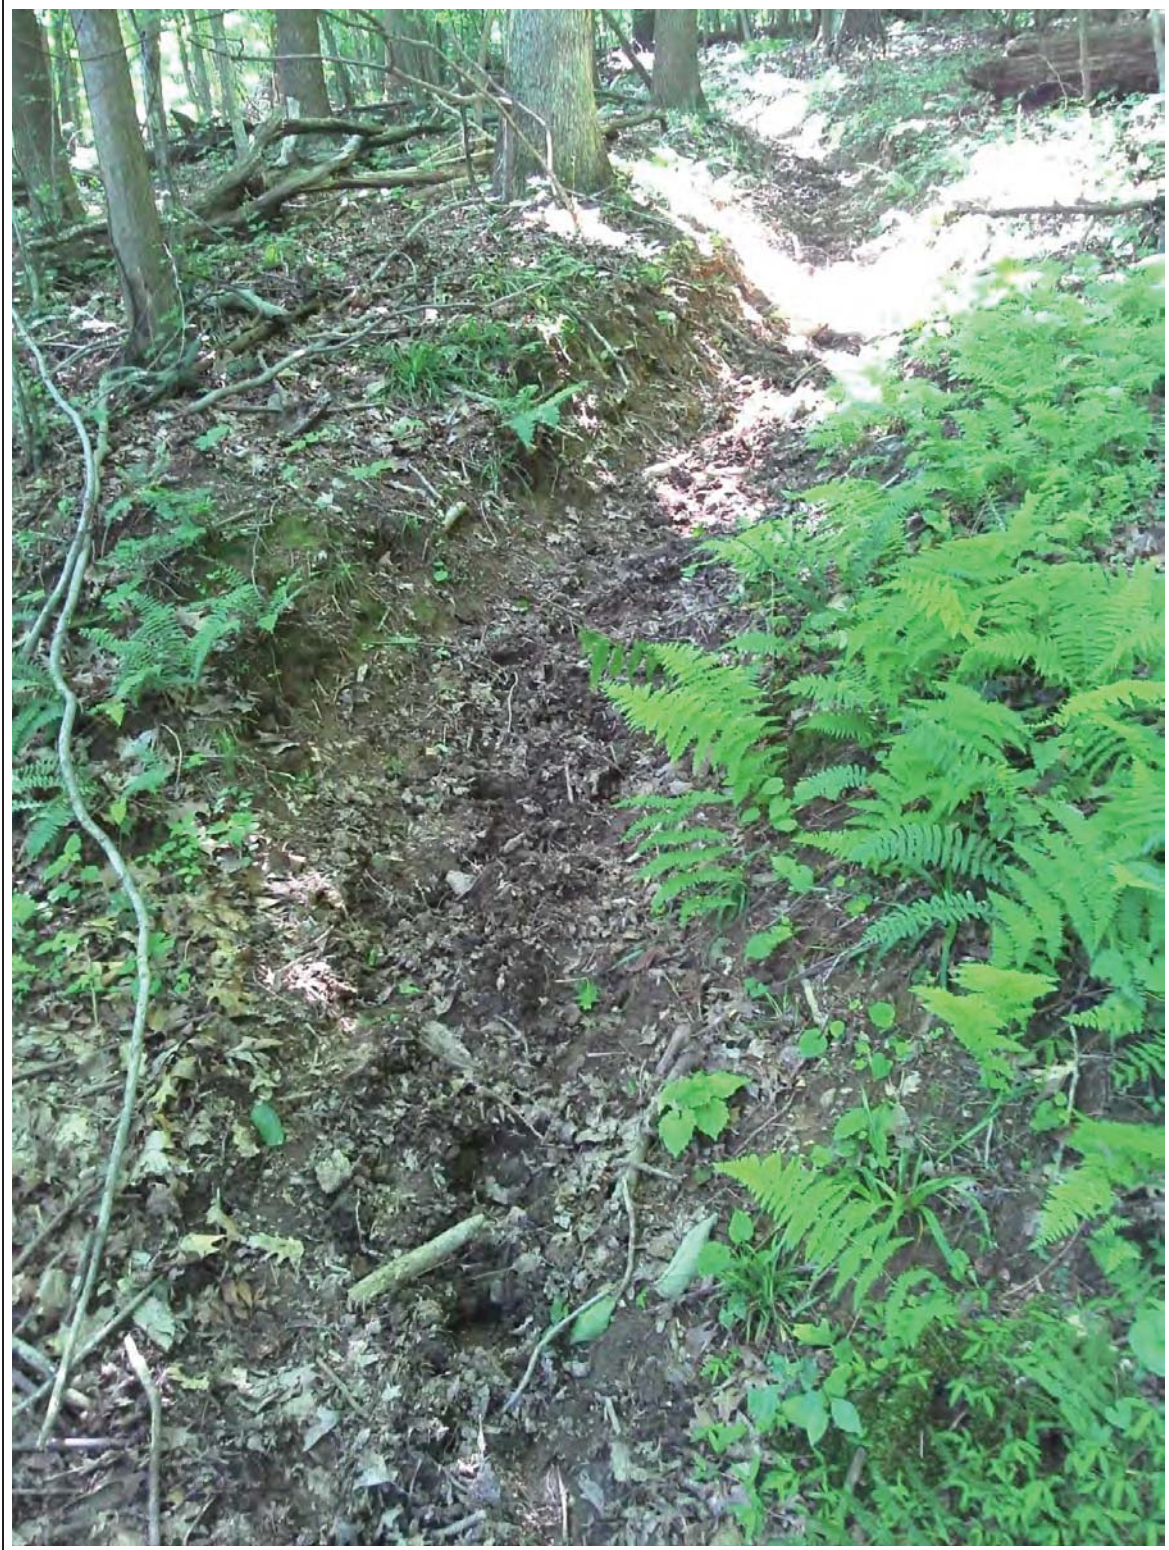
Photo 5-20: Pat Oliva Trail channelized erosion

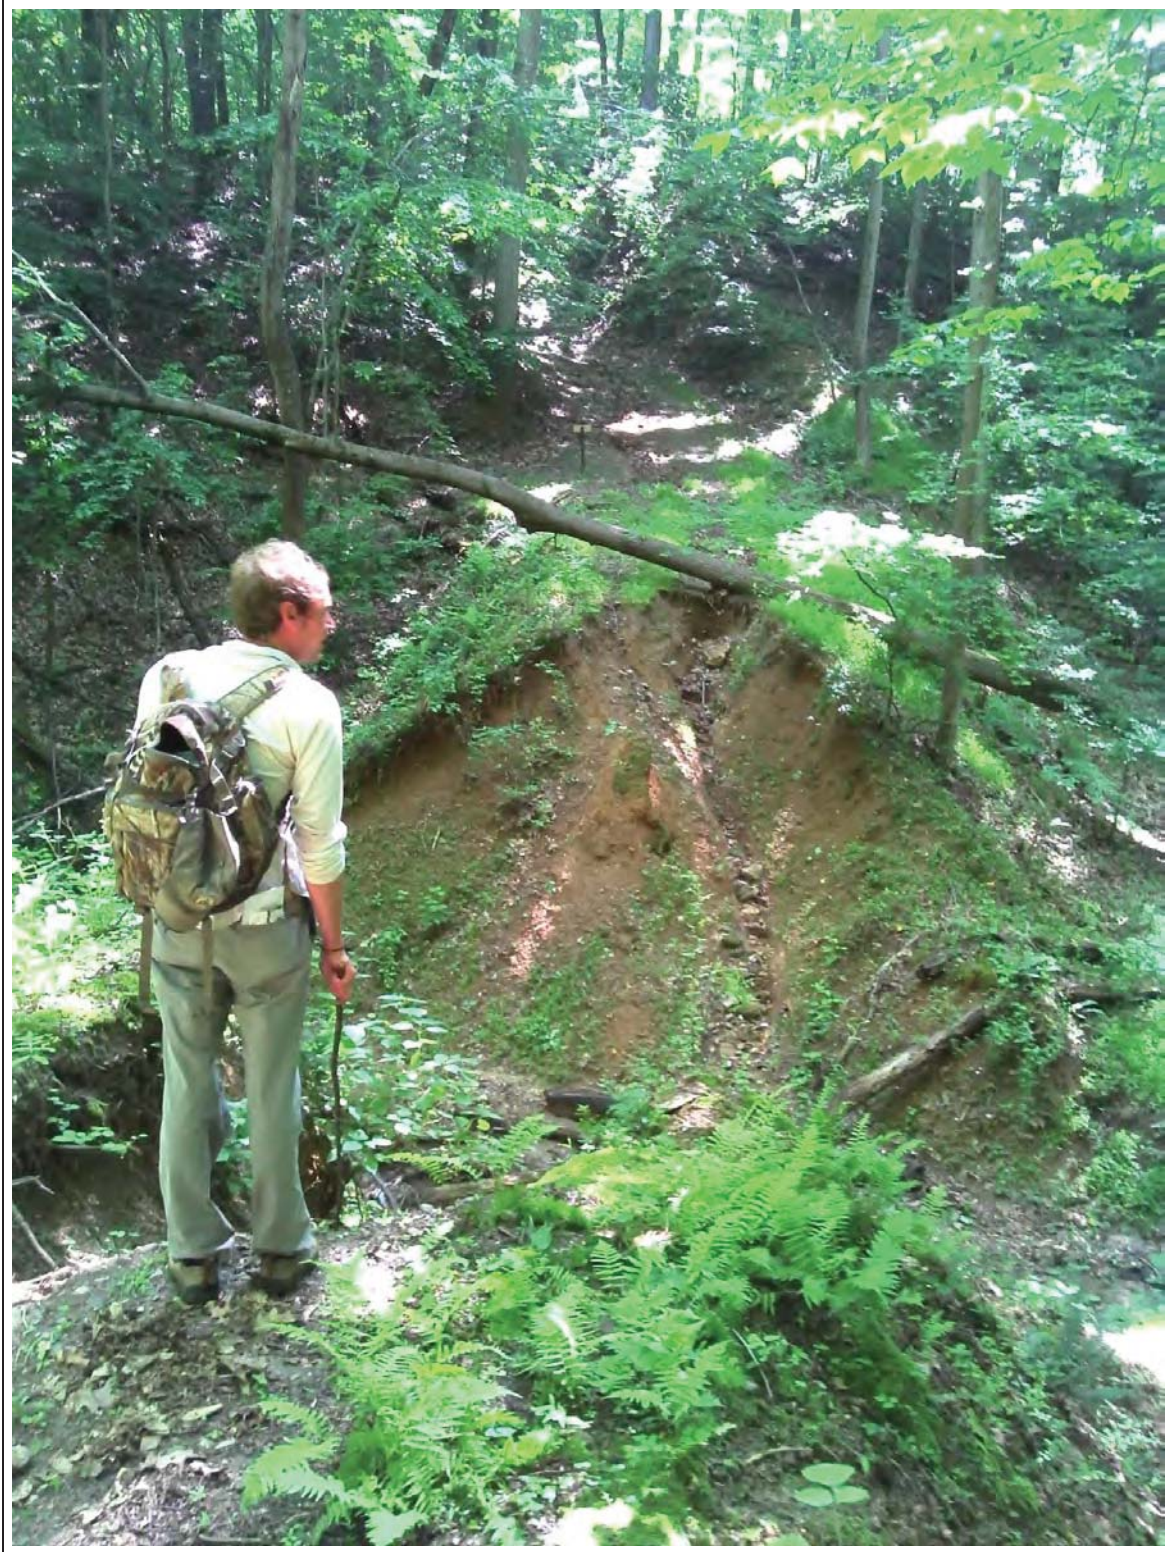
Photo 5-24: Washout area within Section 5 of the Access Road

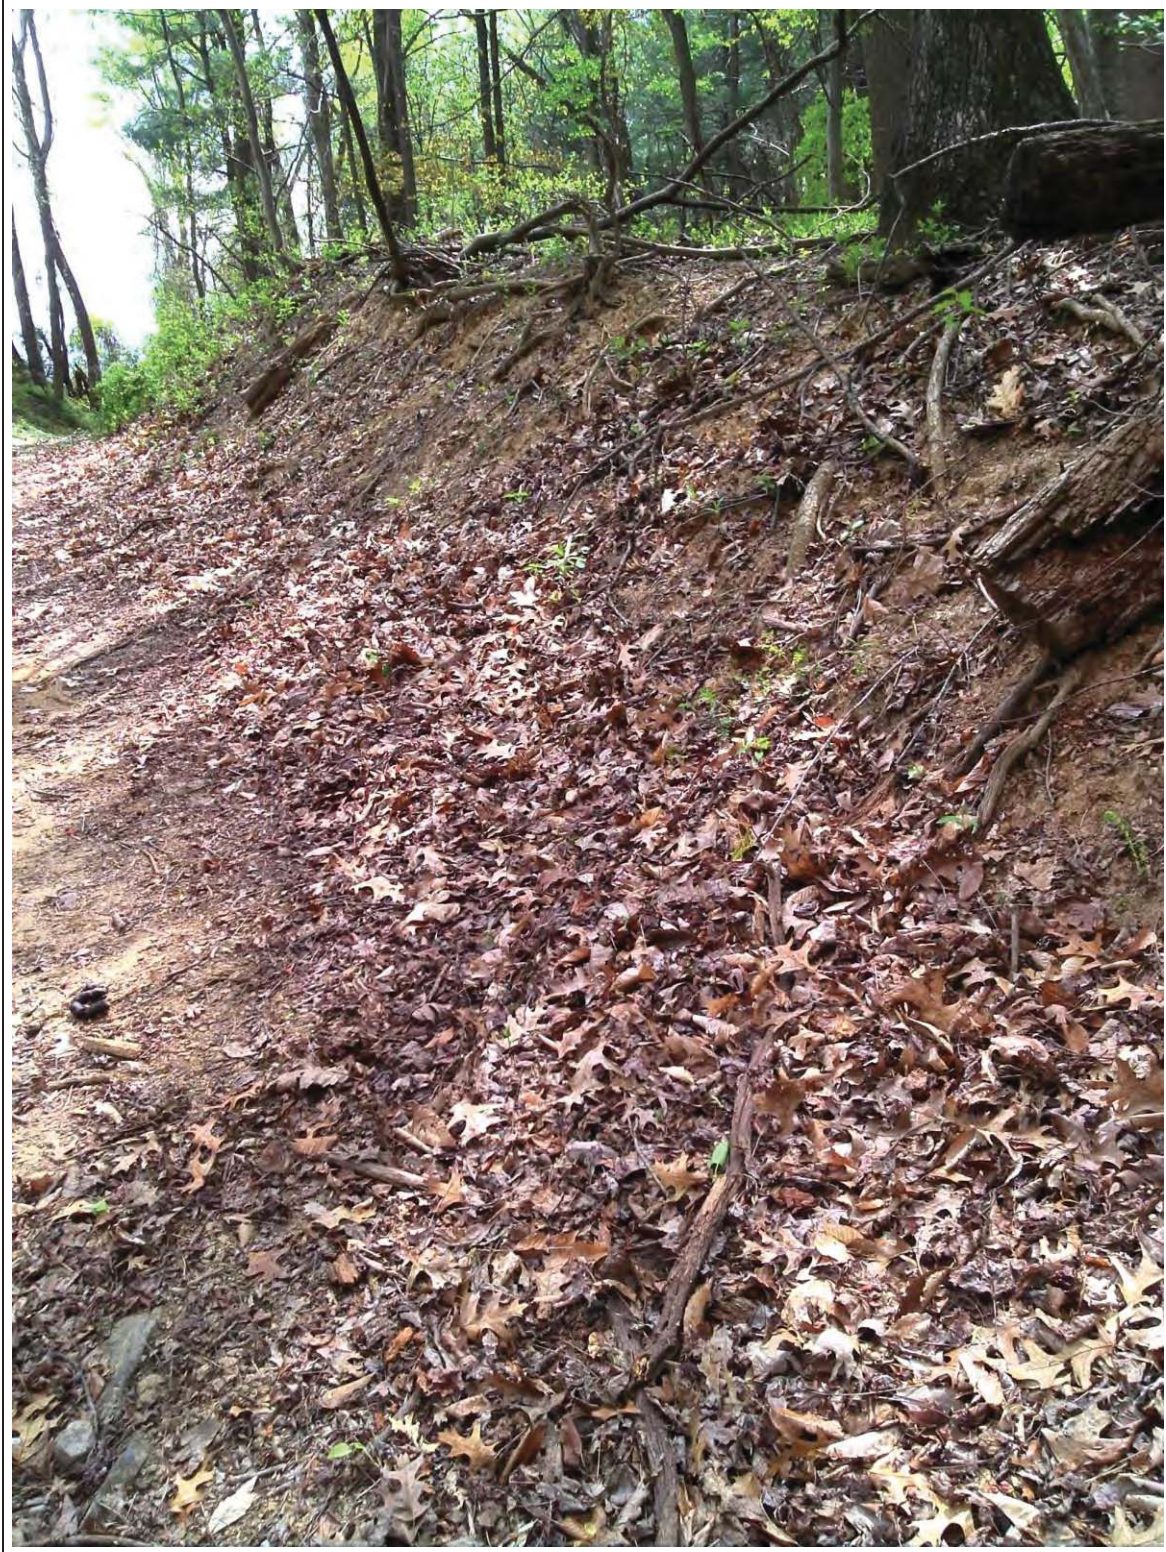
Photo 5-29: Route 29 to Brown's Bridge North Section erosion

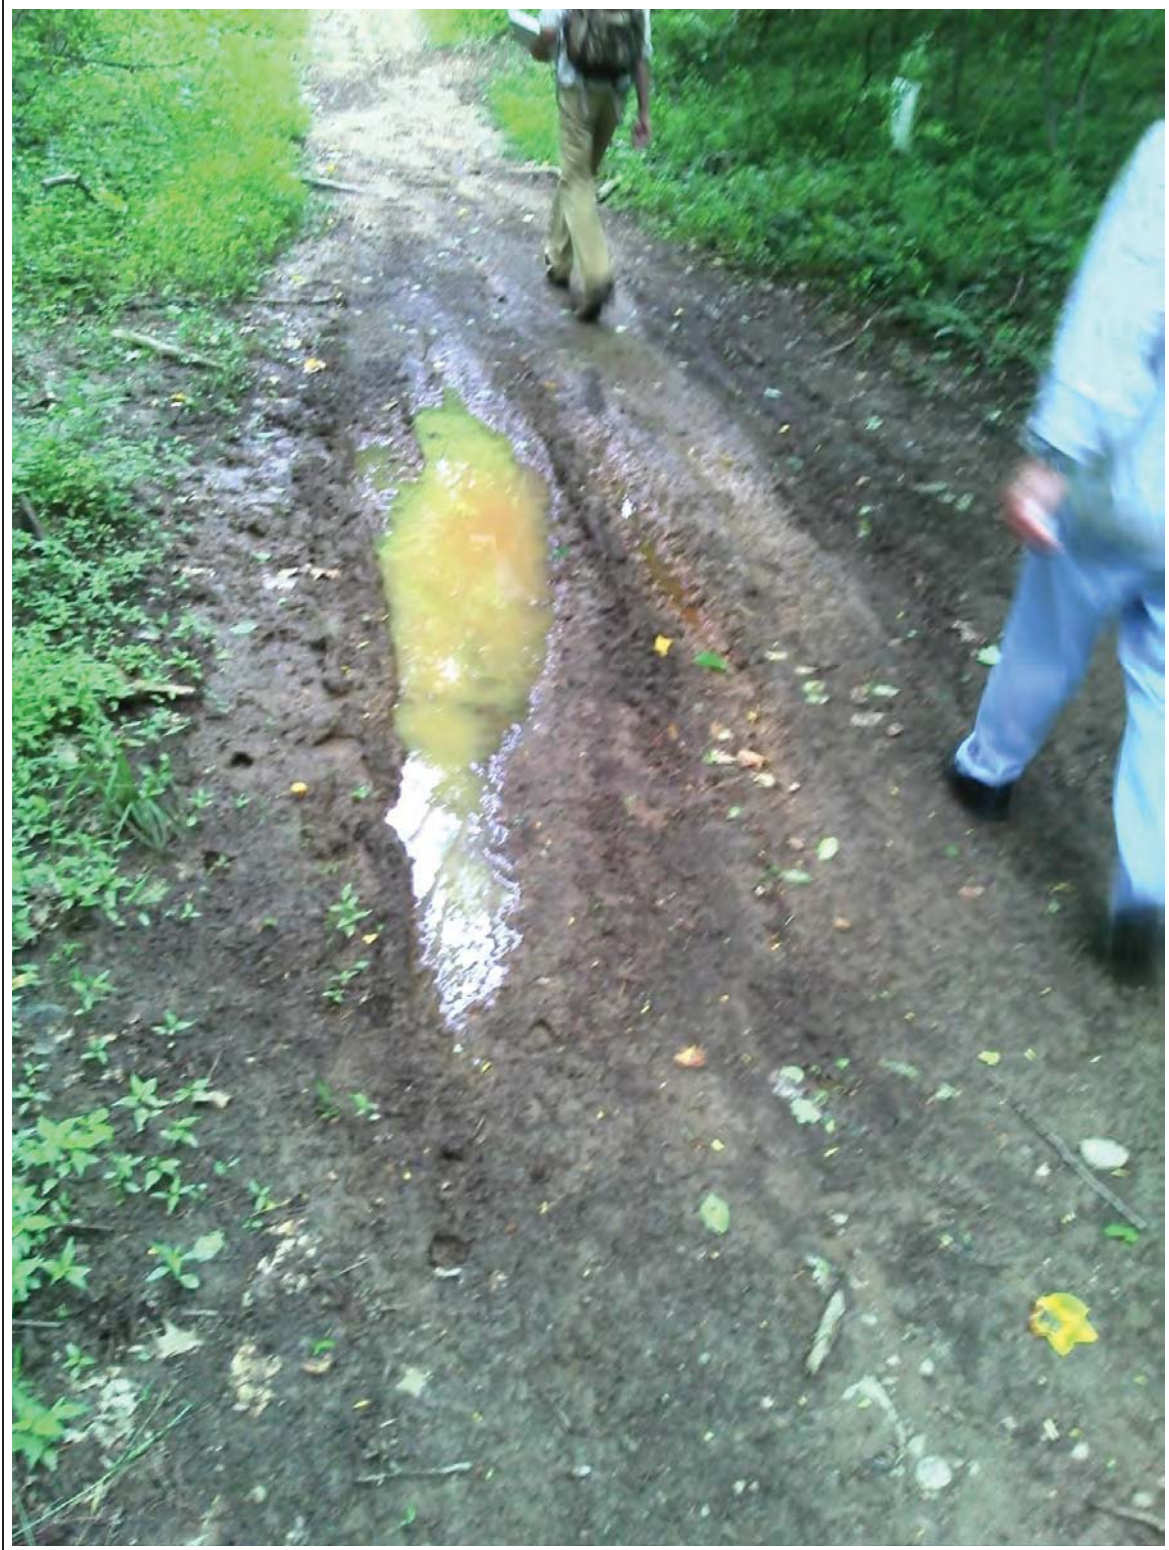
Photo 5-31: Brown's Bridge North to Fox Haven Section rutting

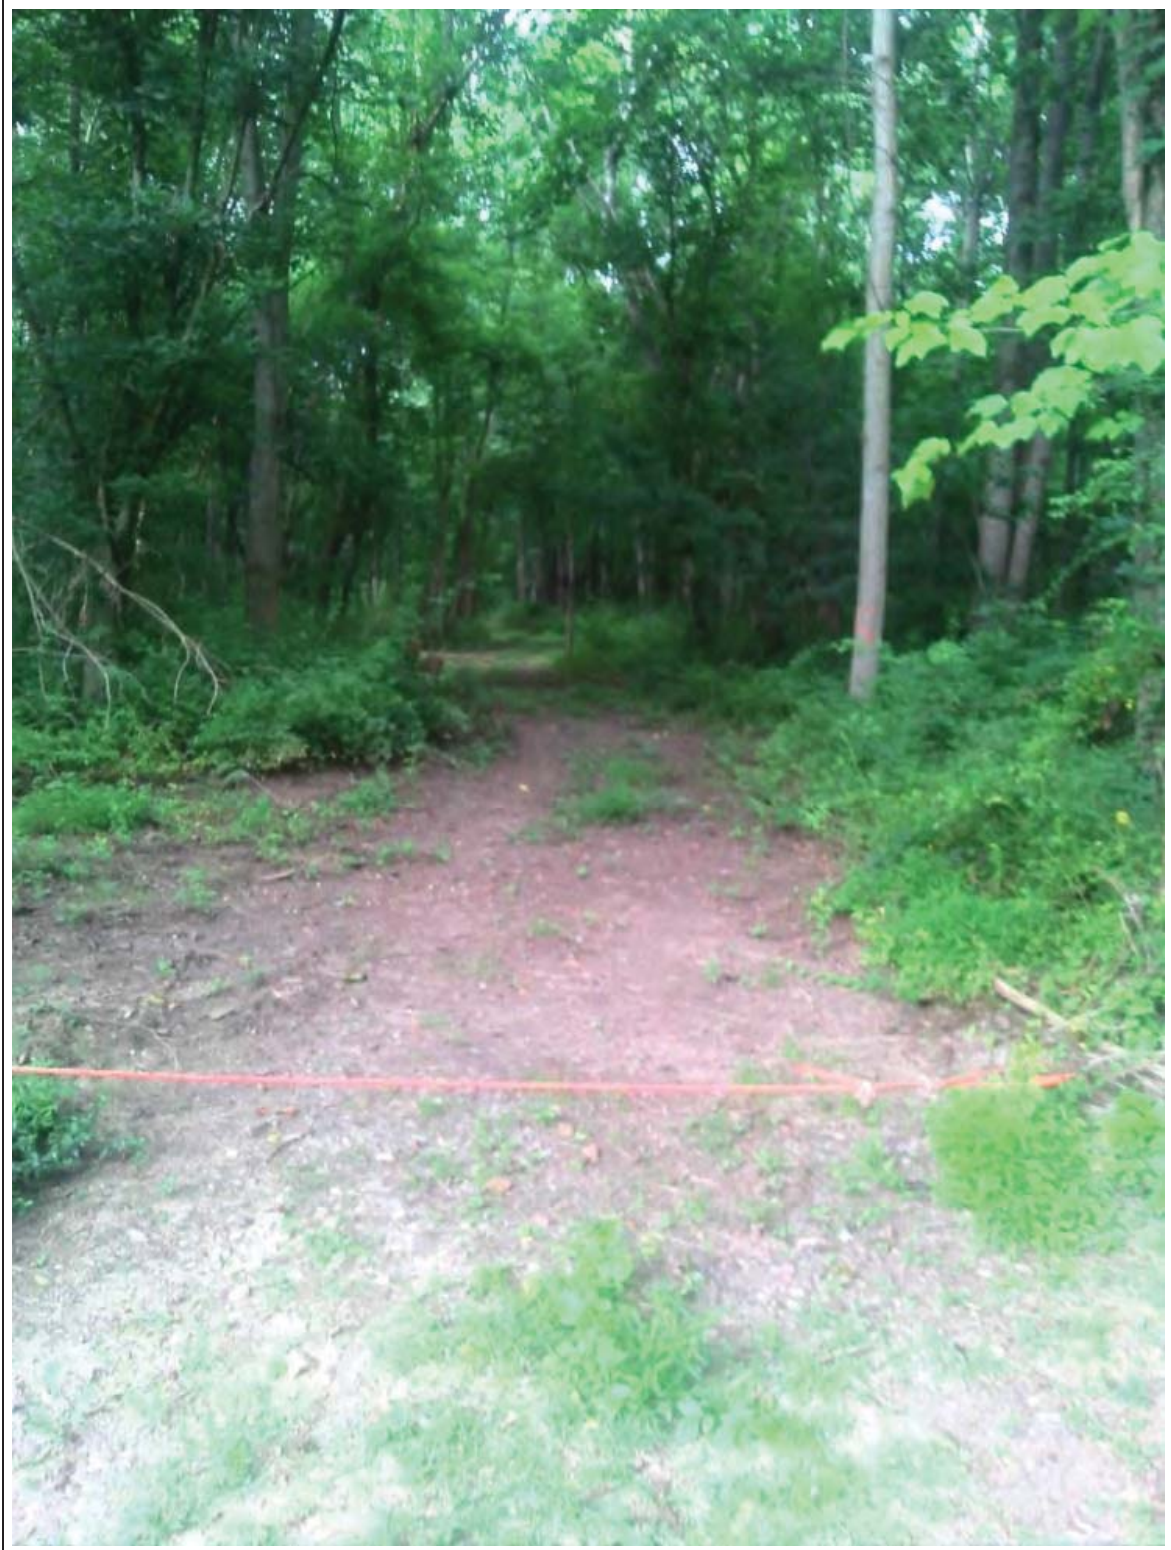
Photo 5-40: Triadelphia Lake Road area cleared by a small dozer

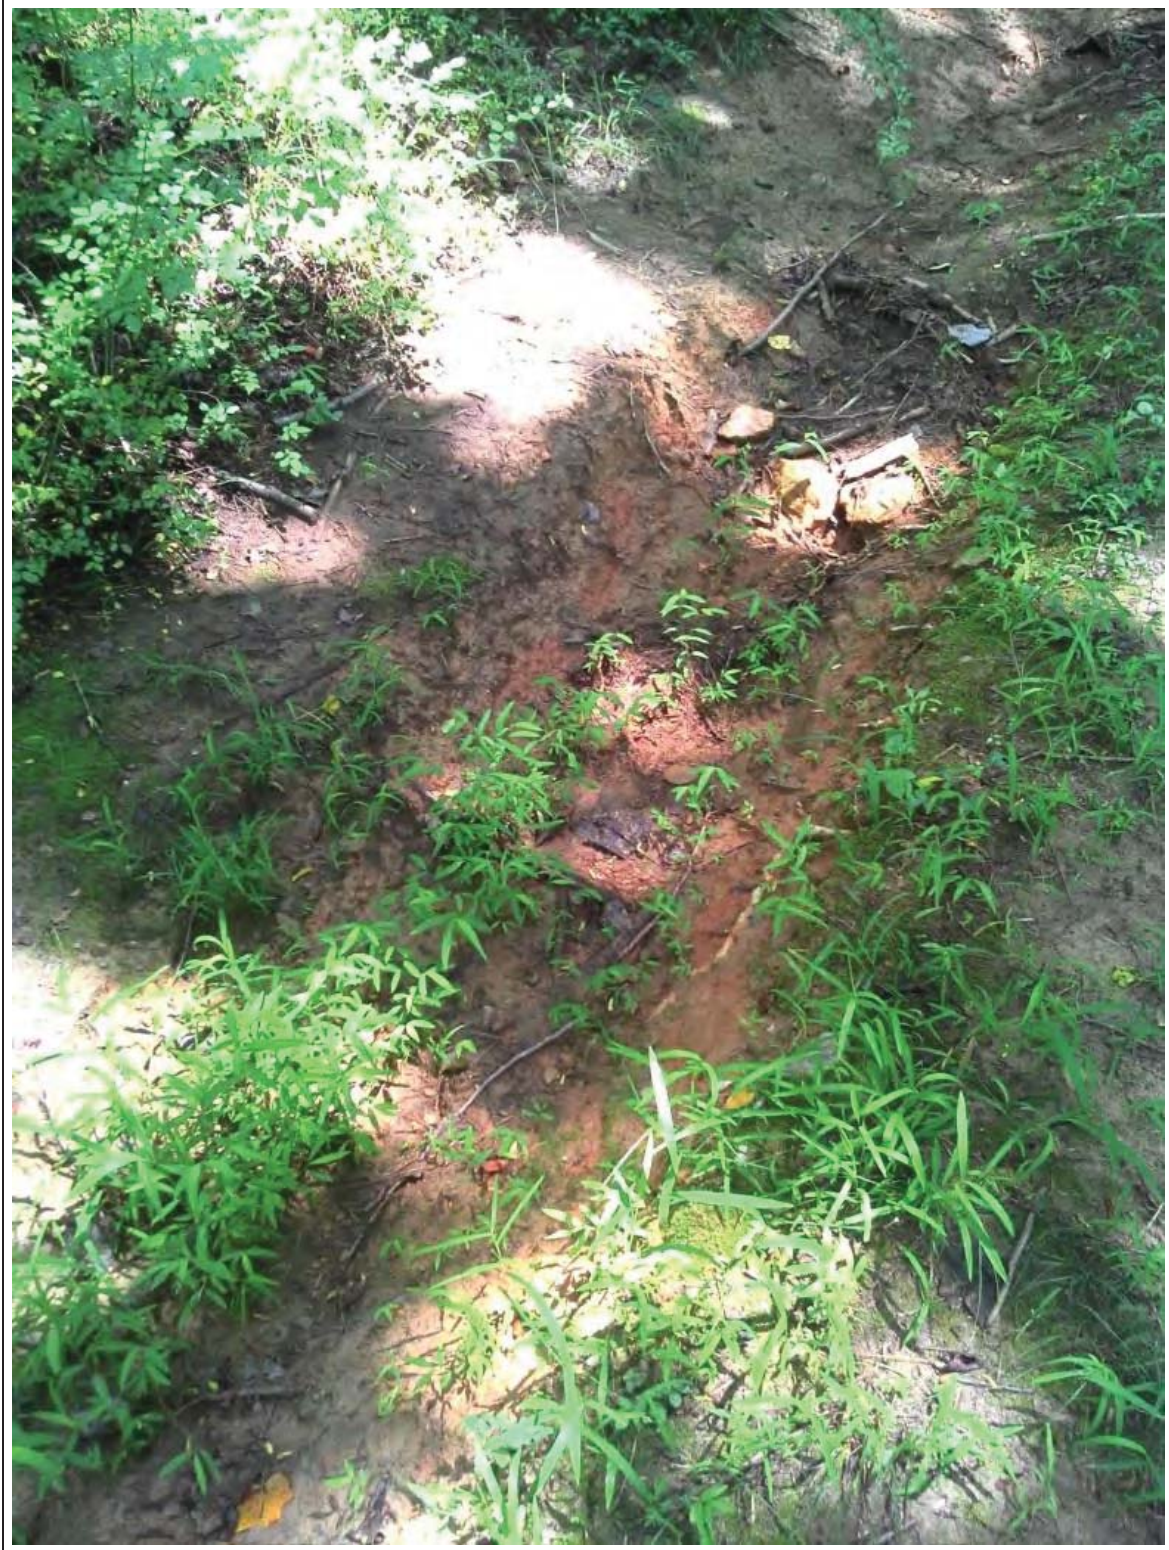
Photo 5-42: Greenbridge West Access Rd significant rutting and erosion

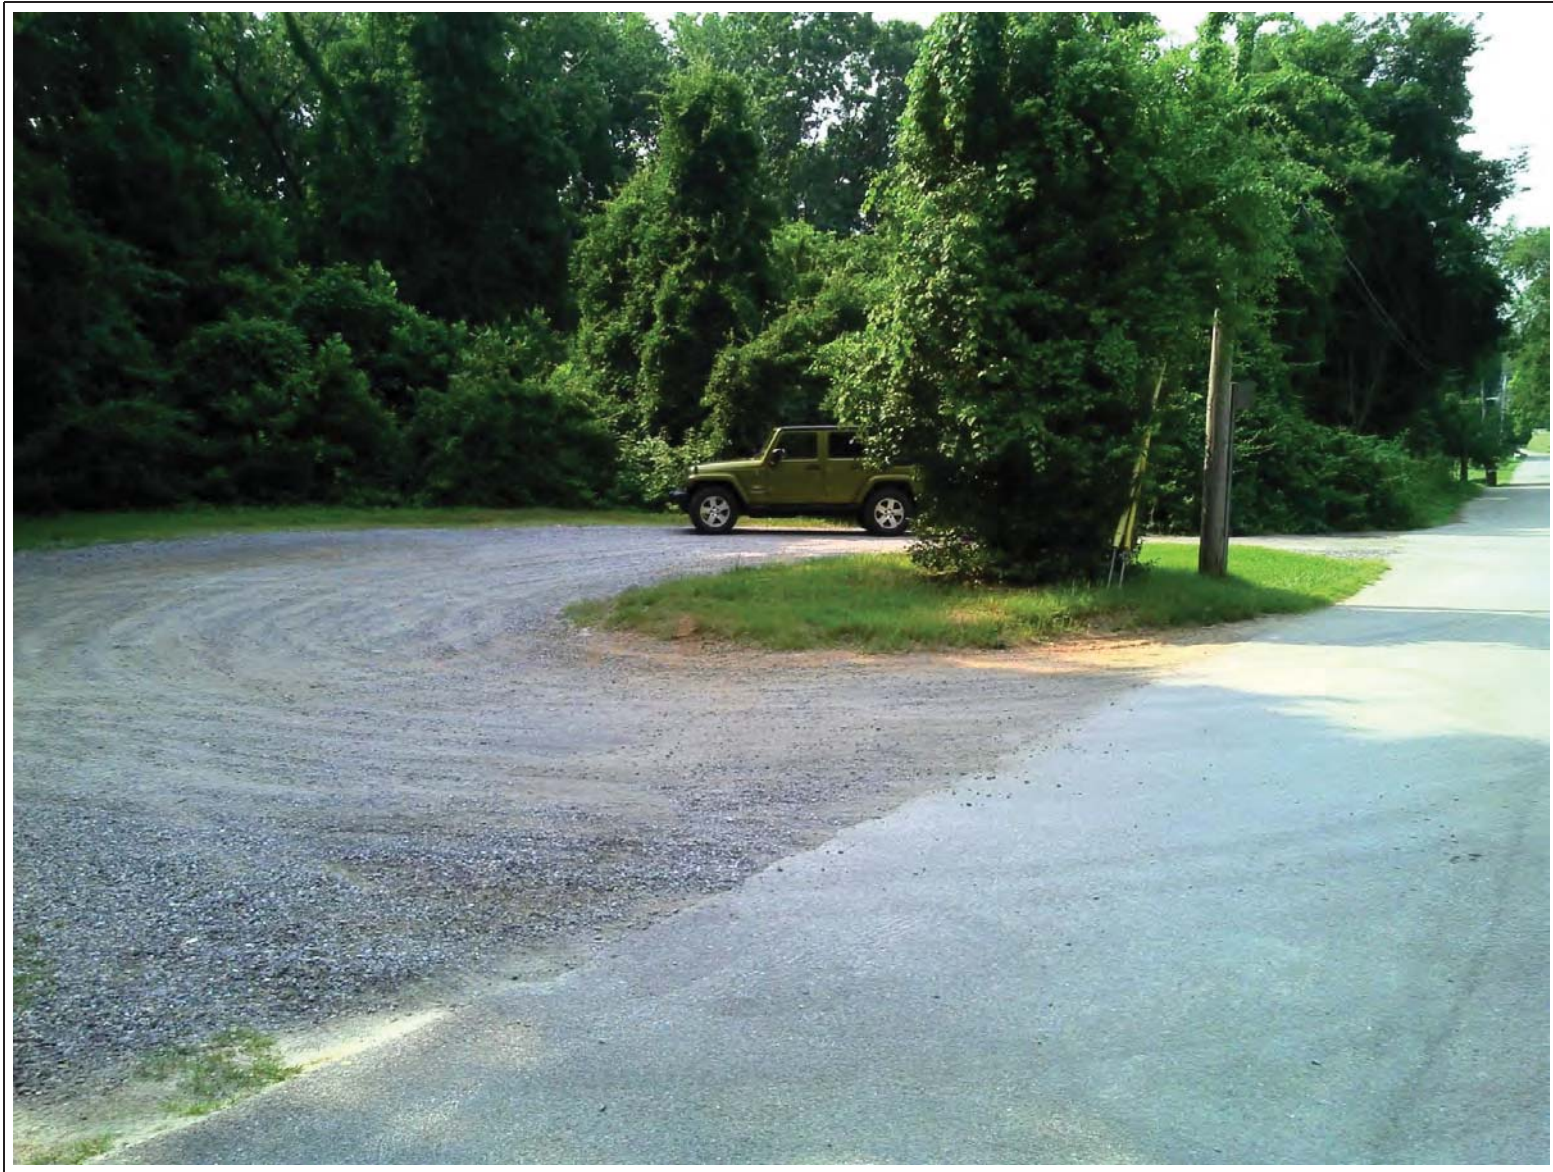
Photo 5-53: Brogden Road parking area at cul-de-sac used by school buses are turn around
