Study Results, Observations, and Recommendations

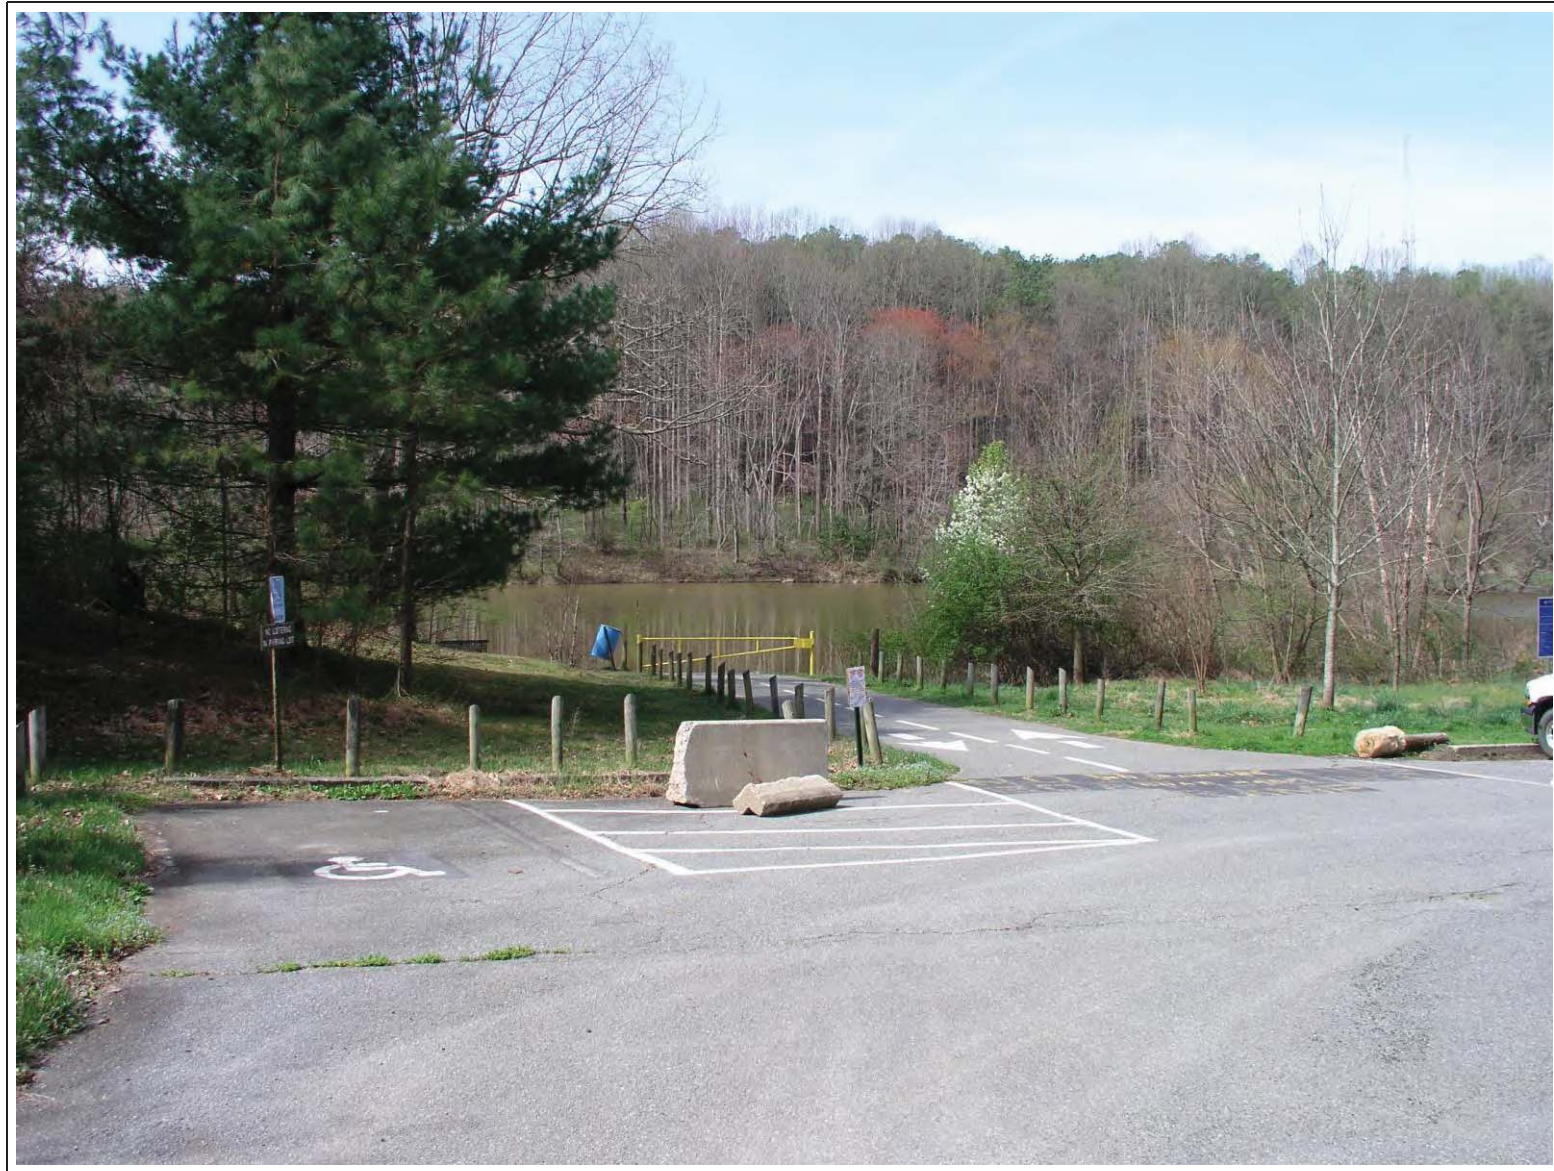
Photo 5-70: Big Branch Recreational Area drains toward Triadelphia Reservoir

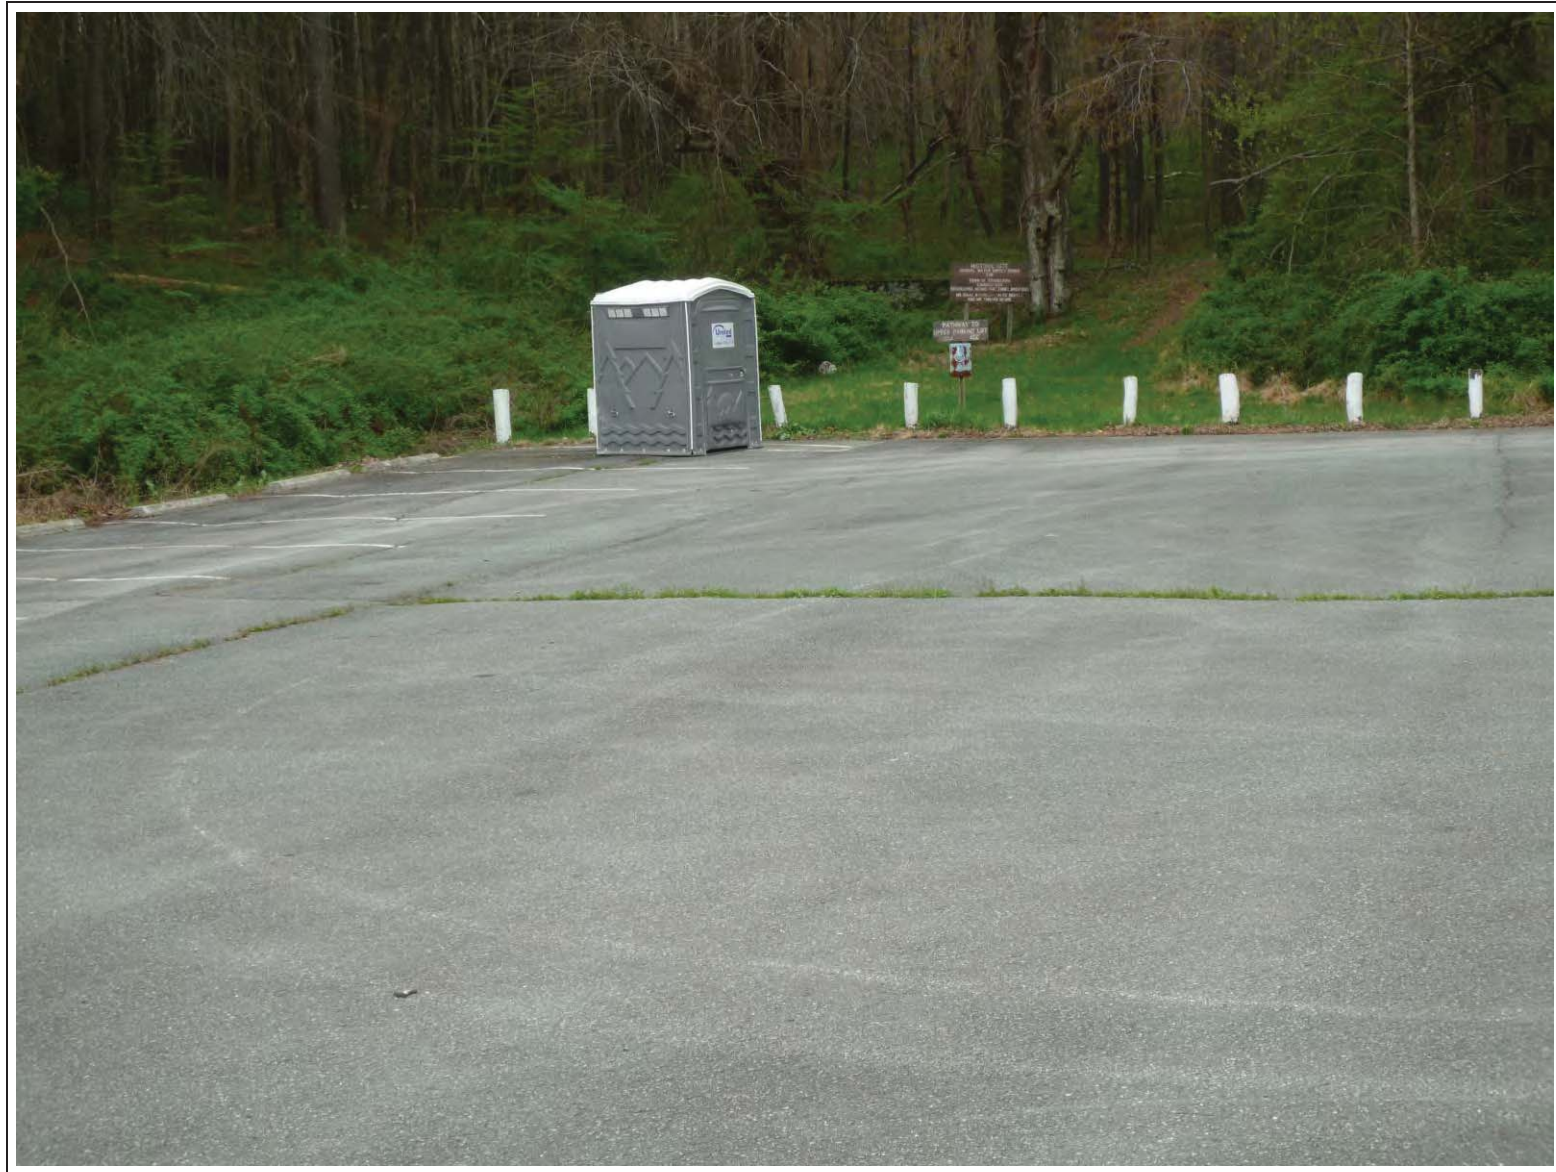
Photo 5-71: Triadelphia Recreational Area outdoor restroom facility

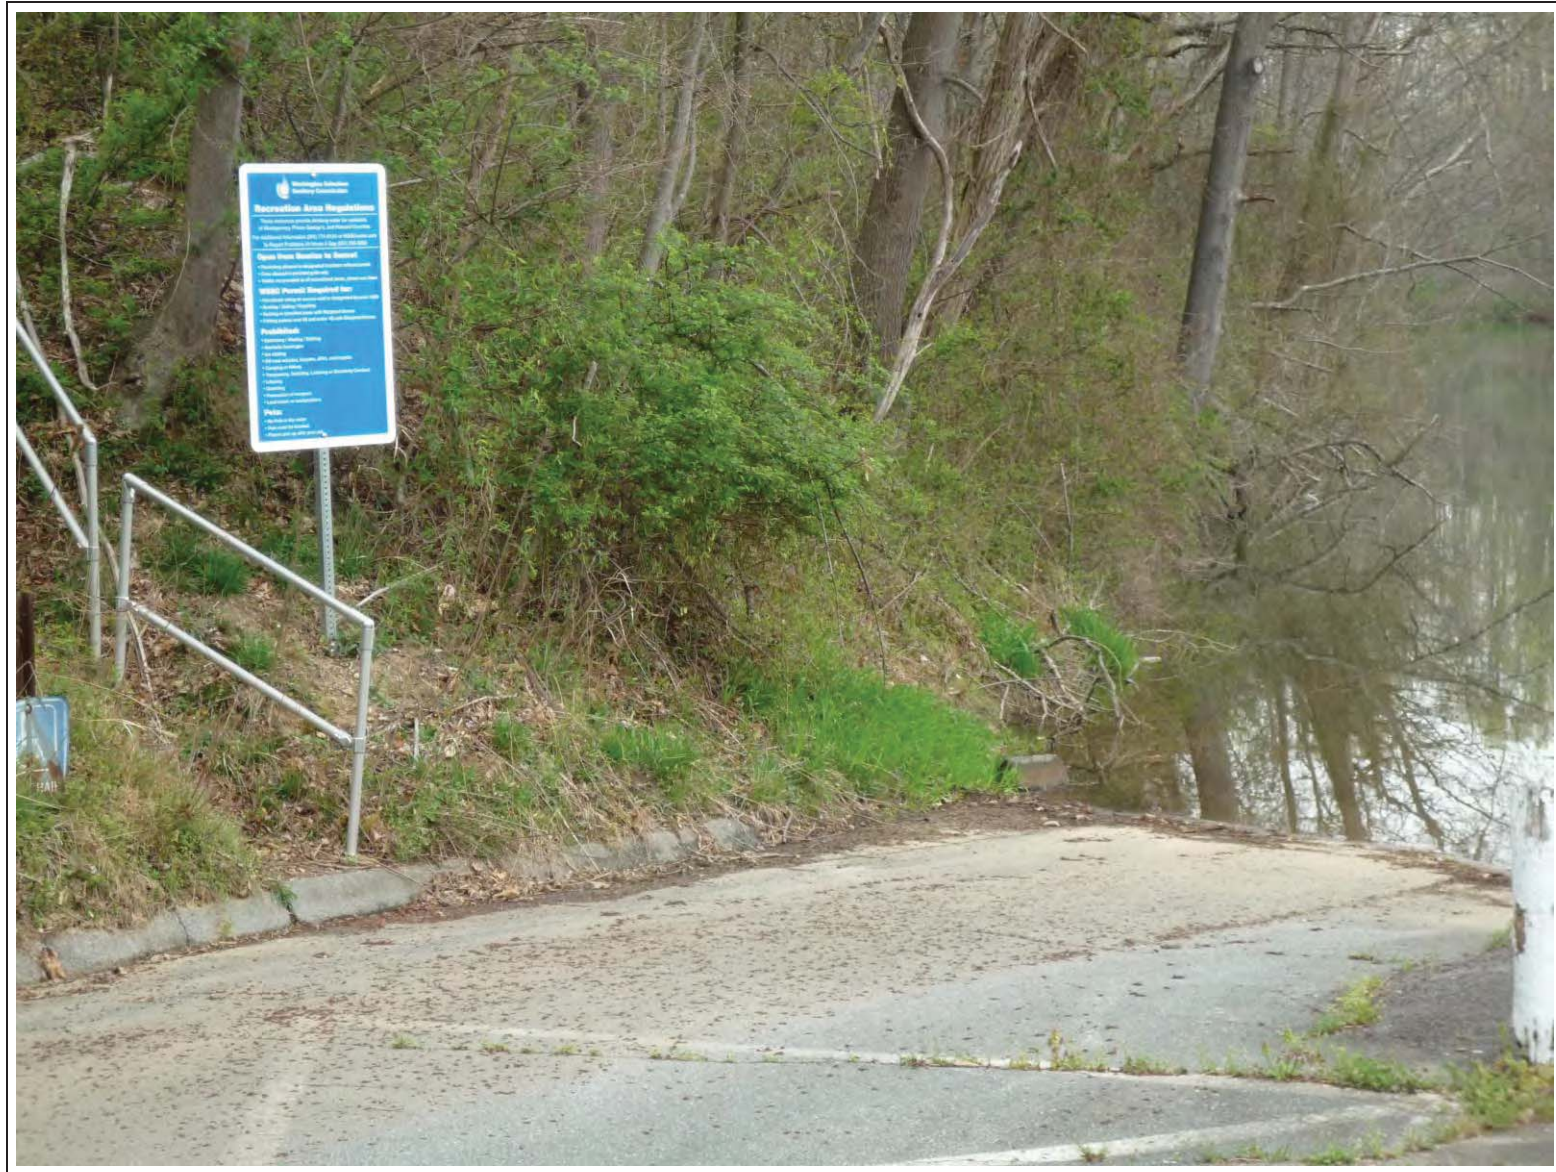
Photo 5-72: Triadelphia Recreational Area boat launch ramp

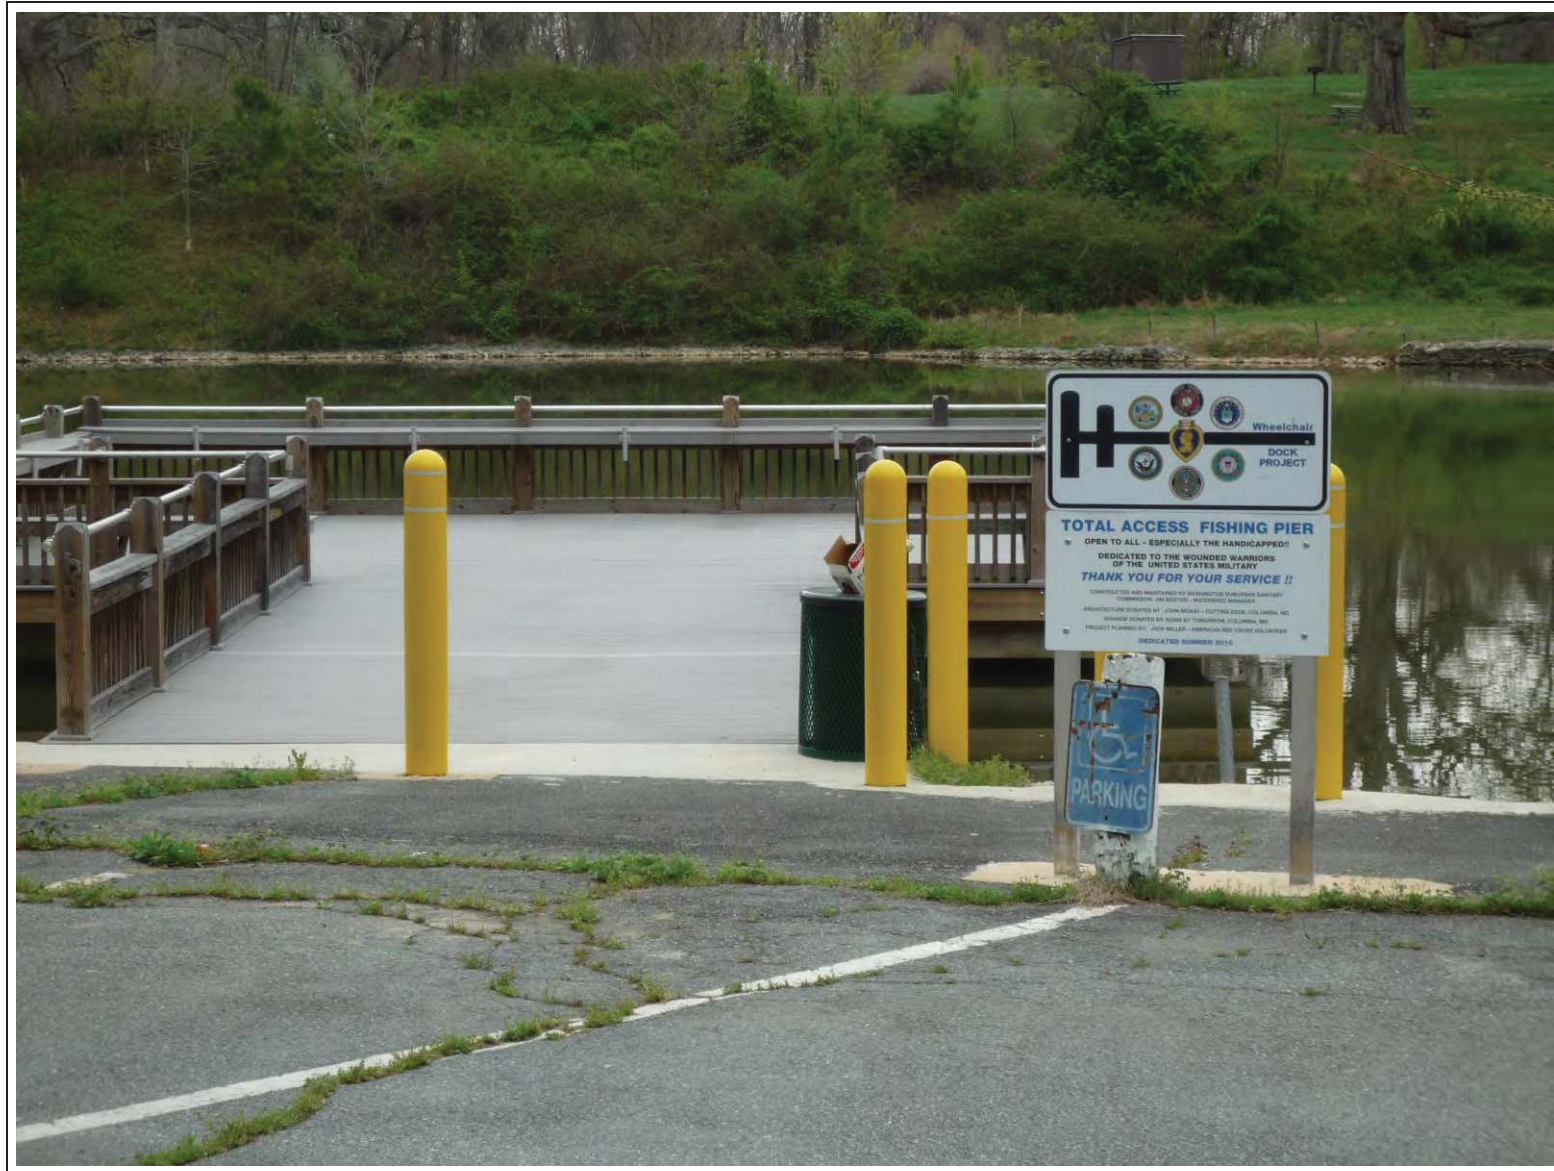
Photo 5-73: Triadelphia Recreational Area fishing dock

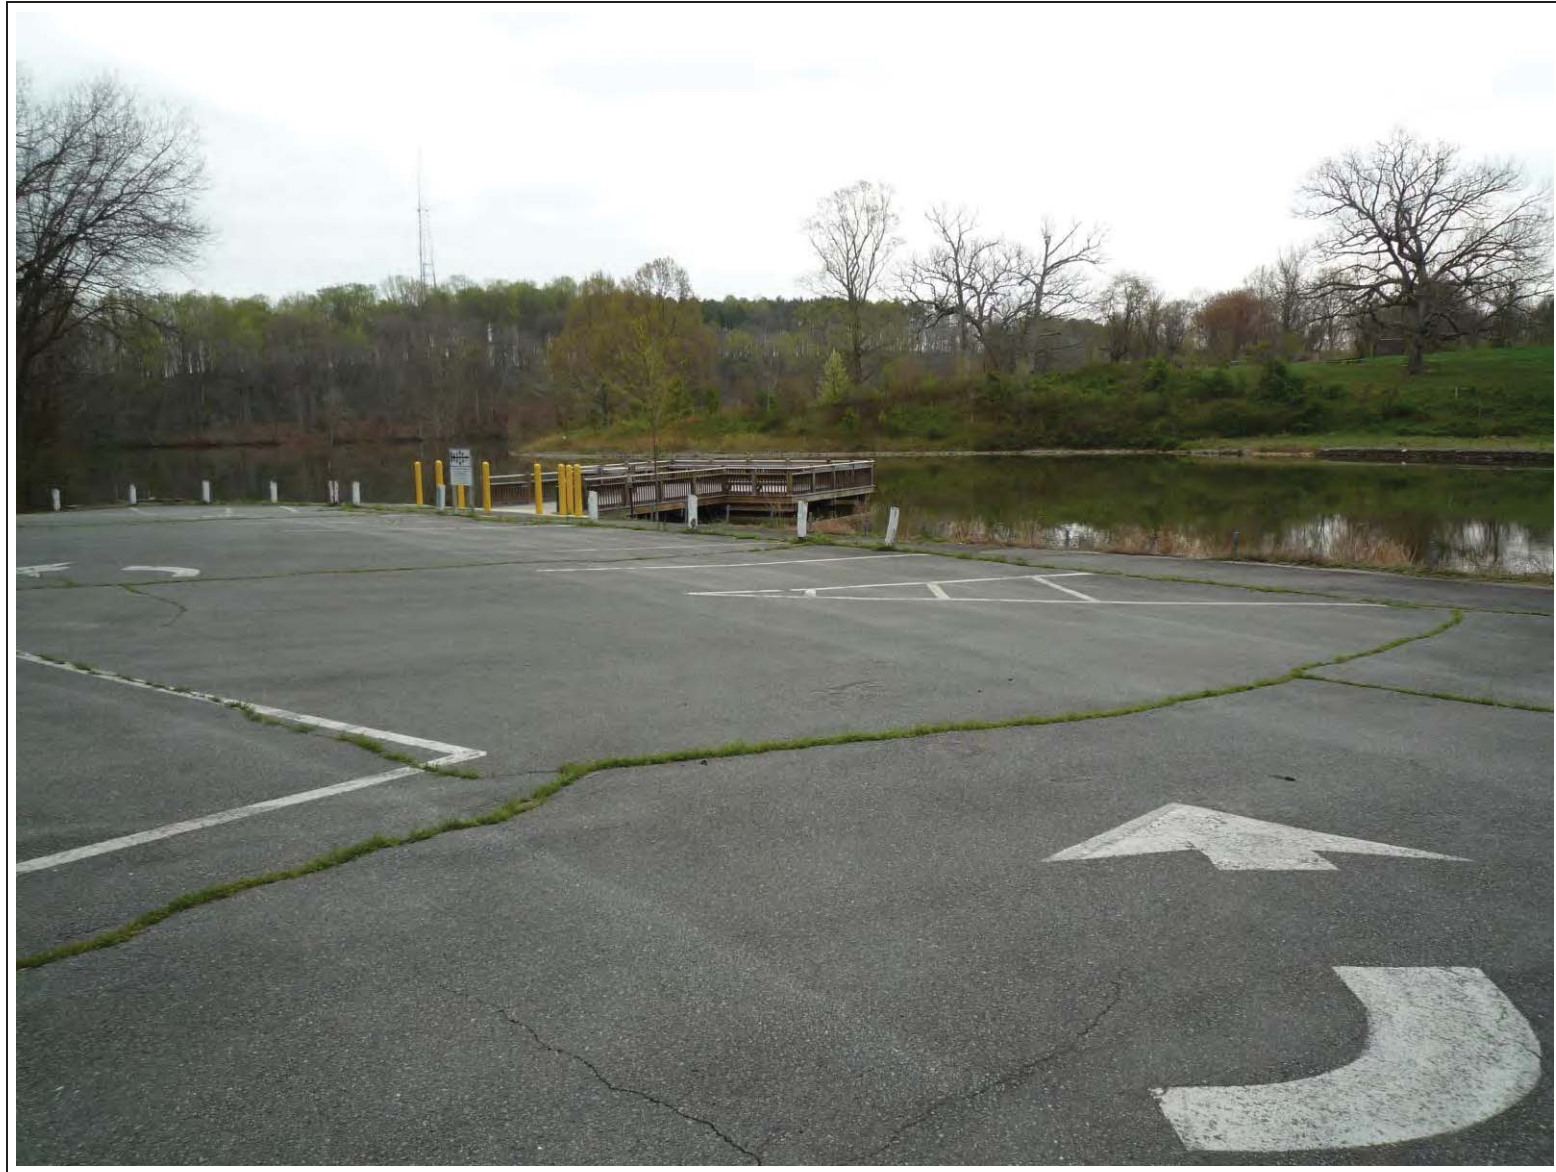
Photo 5-74: Triadelphia Recreational Area parking lot

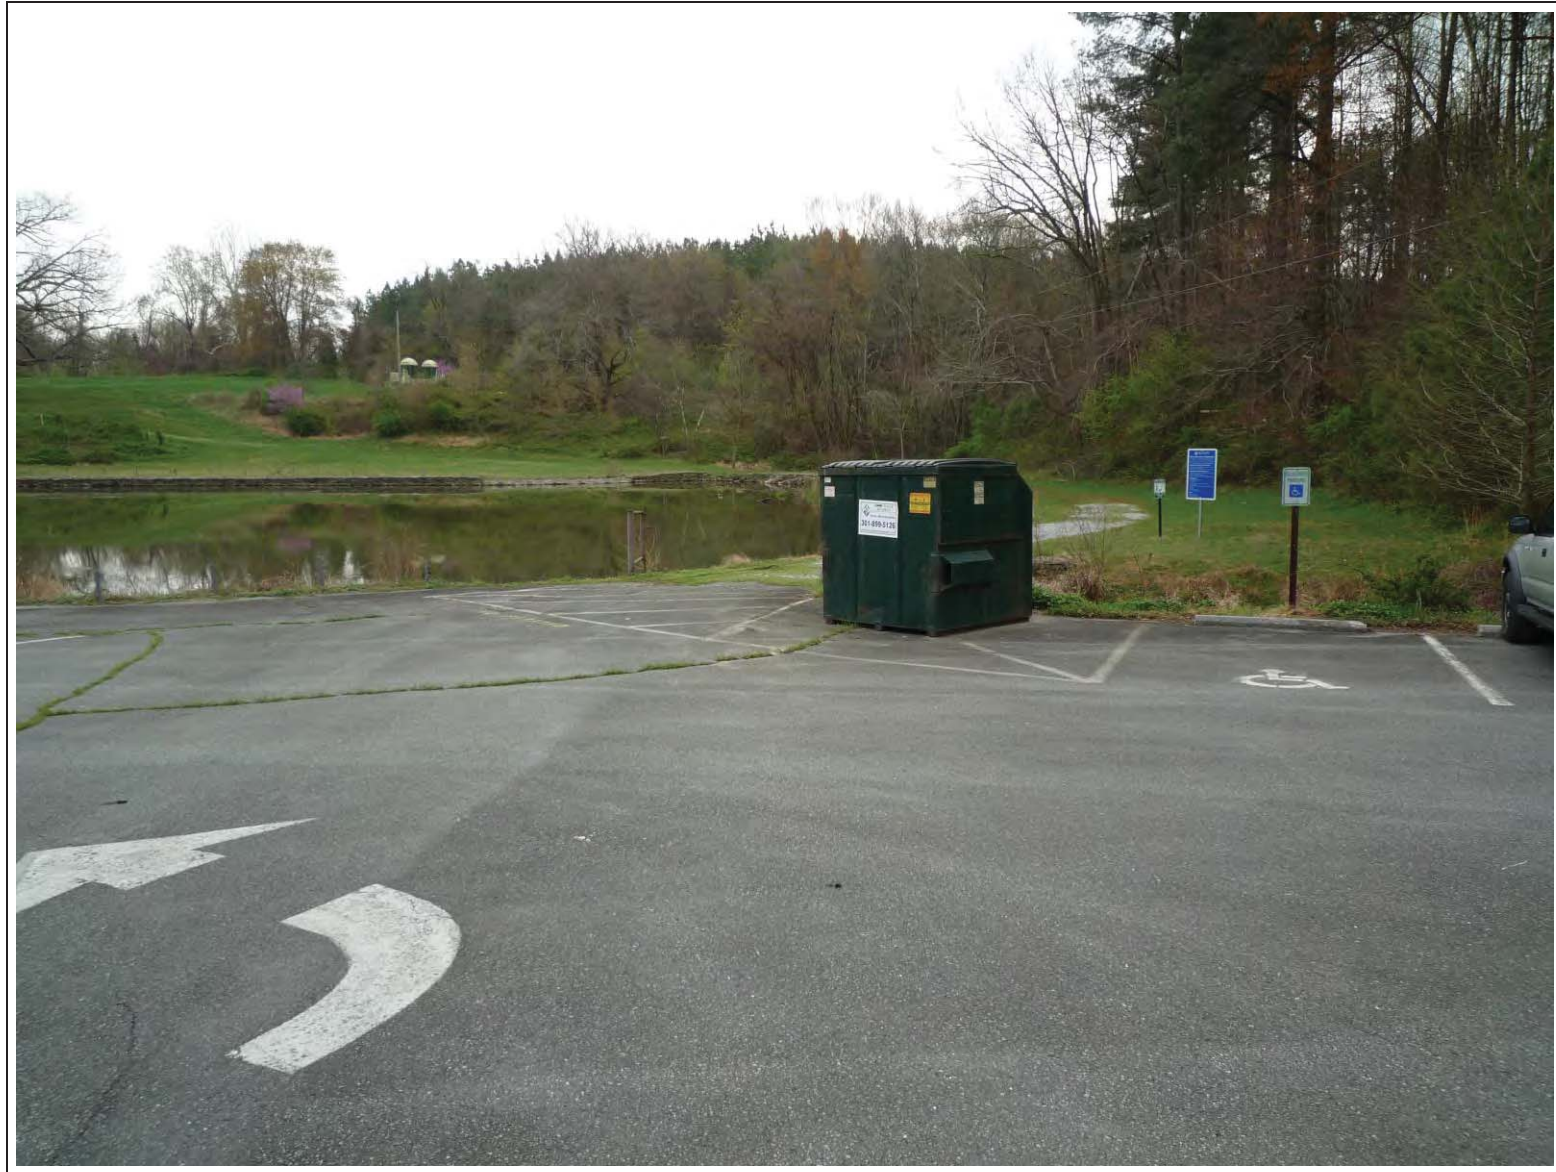
Photo 5-75: Triadelphia Recreational Area trash receptacles

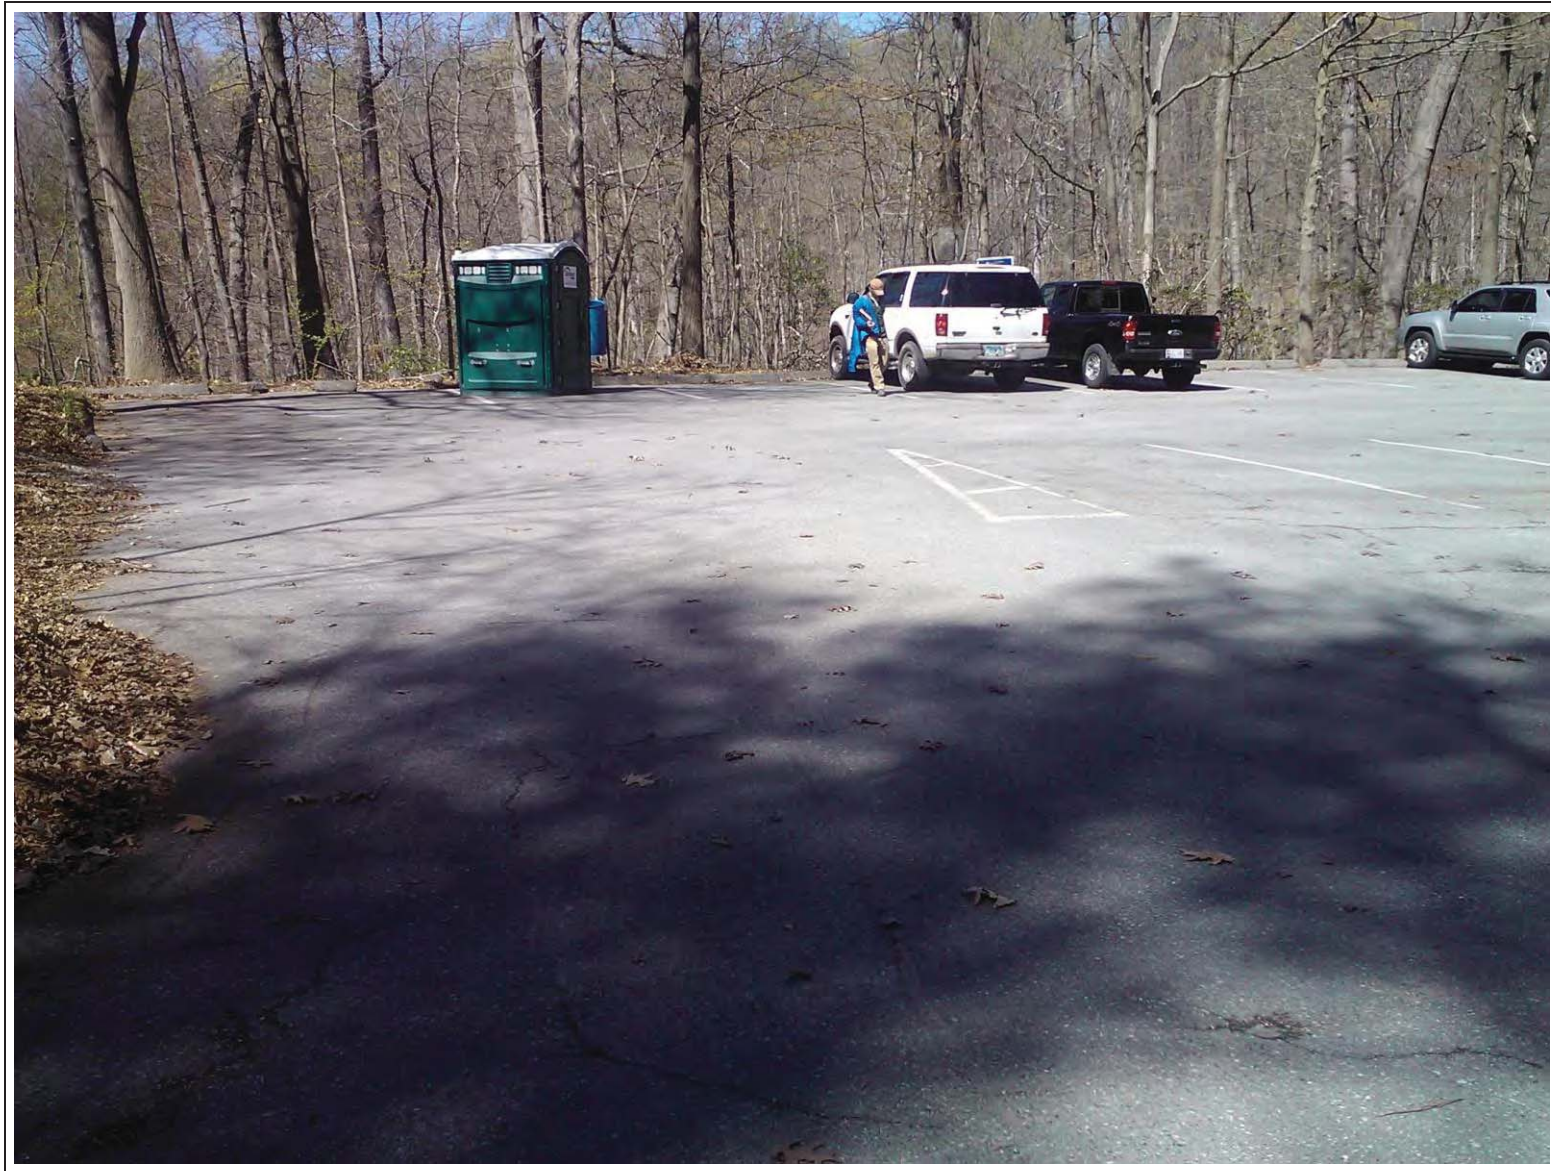
Photo 5-76: Greenbridge Recreational Area paved parking and outdoor restroom facility

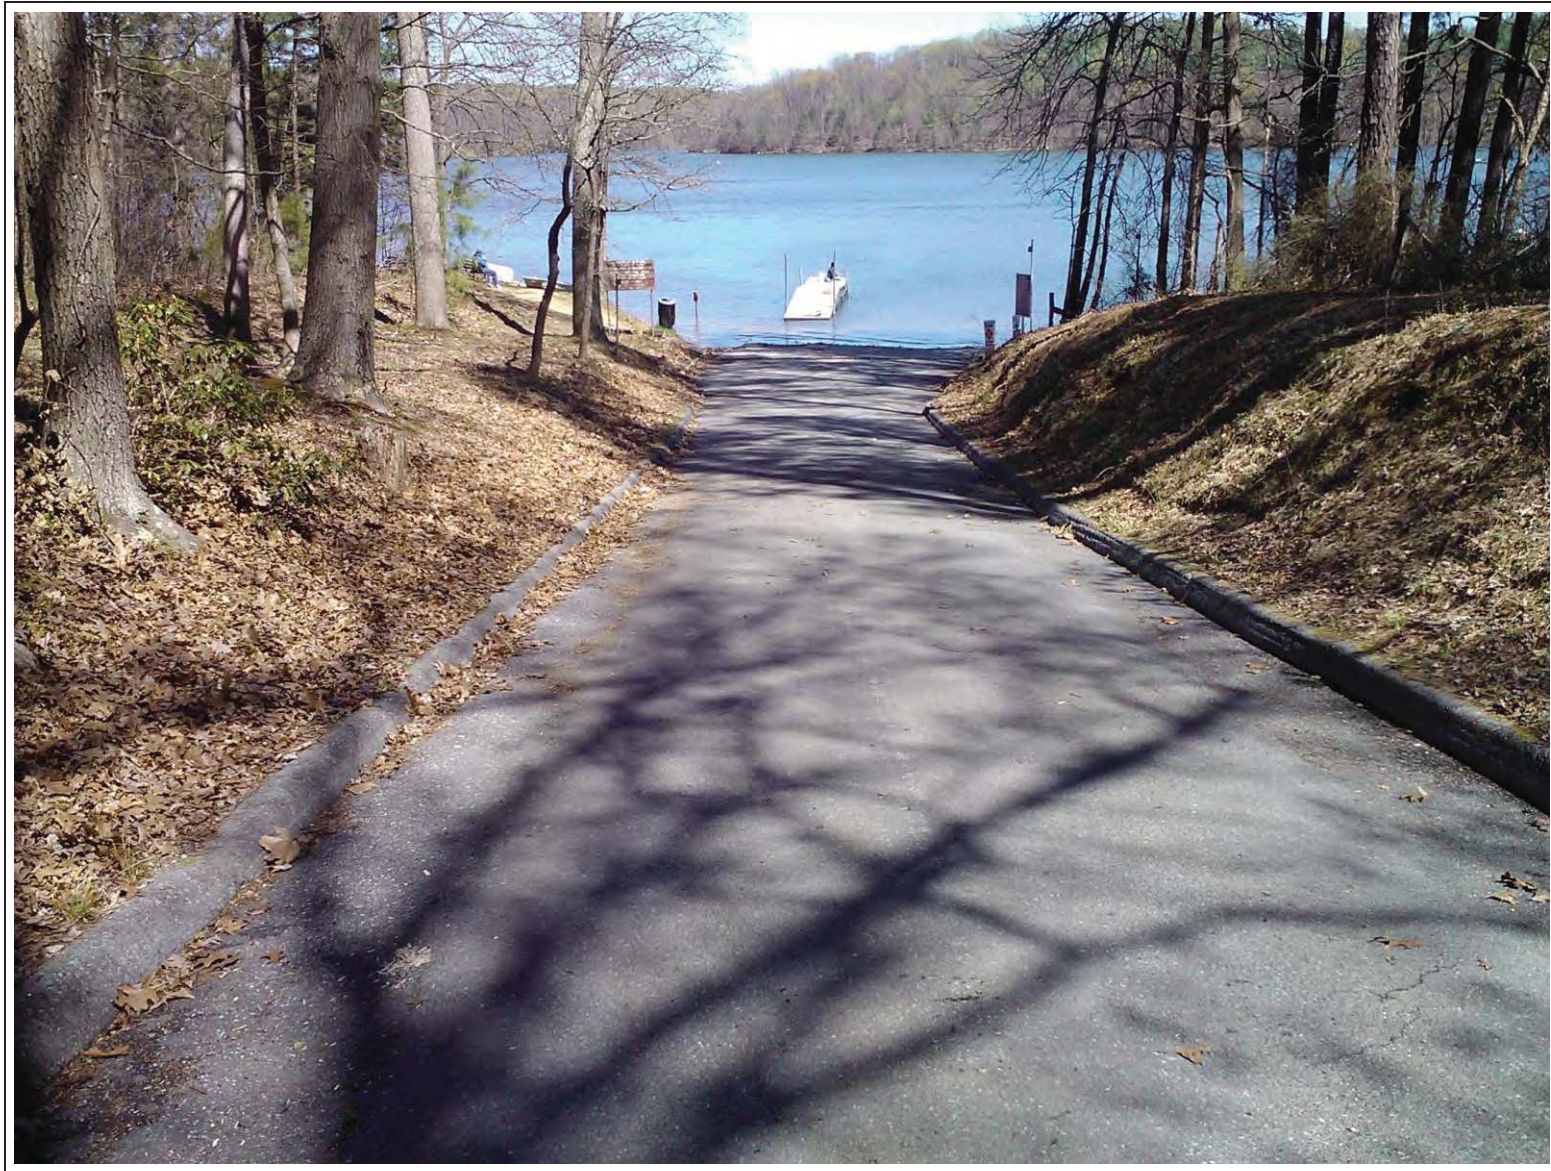
Photo 5-77: Greenbridge Recreational Area boat launch ramp

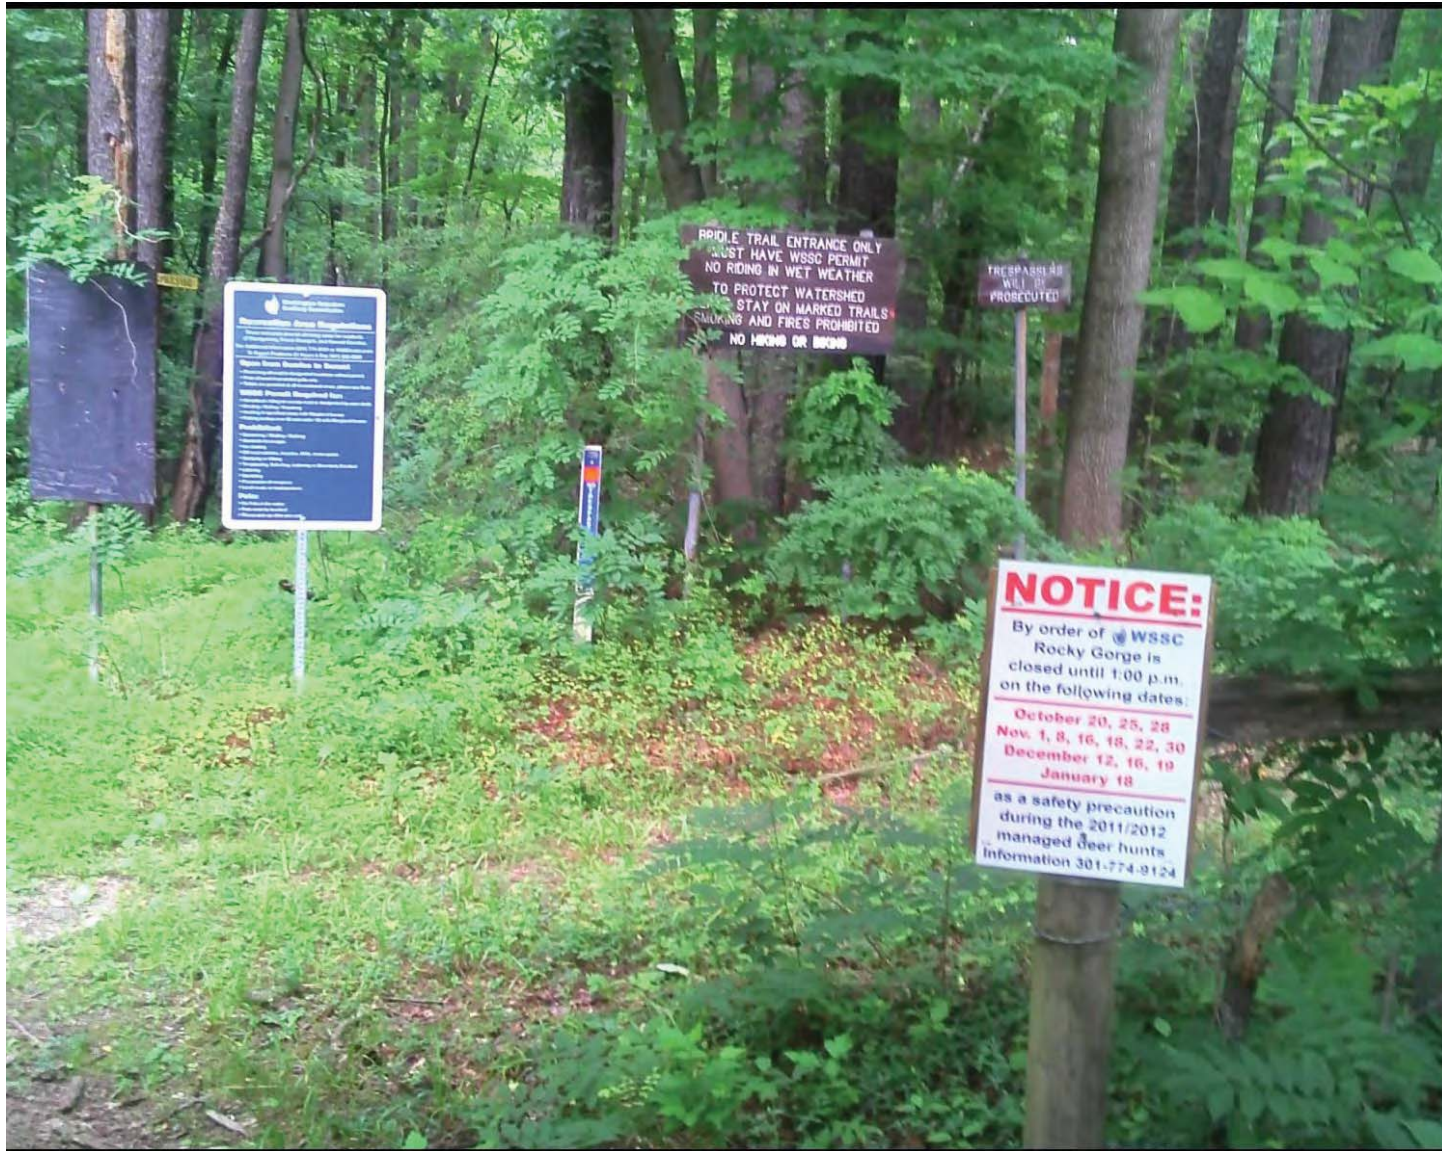
Photo 6-10: Example of confusing signage
